# KENO VALLEY/DUBLIN GULCH ENVIRONMENTAL BASELINE ASSESSMENT

VOLUME III: Keno Valley Sites #21 to #40

Prepared for  
Waste Management Program  
Indian and Northern Affairs Canada

March, 2000

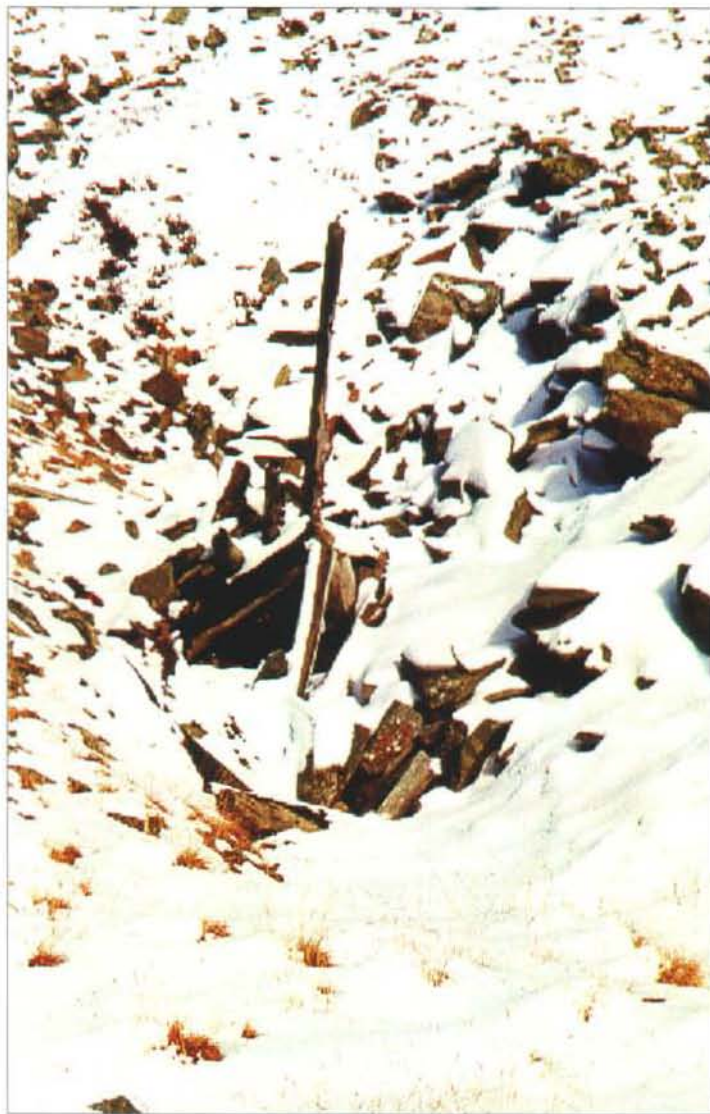
Condition: The log cribbing has collapsed and there is roughly 2m<sup>3</sup> of wood debris scattered around the adit.

Photo 36-1 : Keno No.9 Collapsed log timbers mark the location of the No.5-2 Vein Adit.  
(Azimuth 025° )

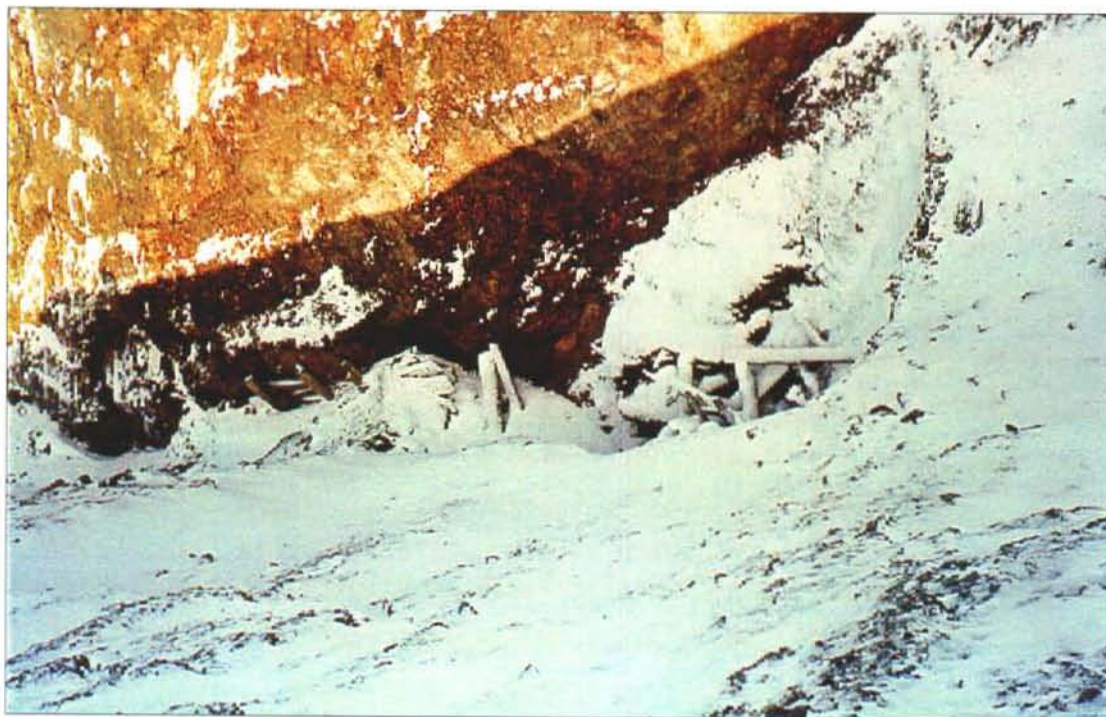
Condition: The support structure for the adit has been broken up by the later pitting.

Photo 36-3 : Keno No.9 The log square sets and ladders of the No.3 Vein Adit exposed in the bottom of the No.3 Vein Pit. (Azimuth ~350°)

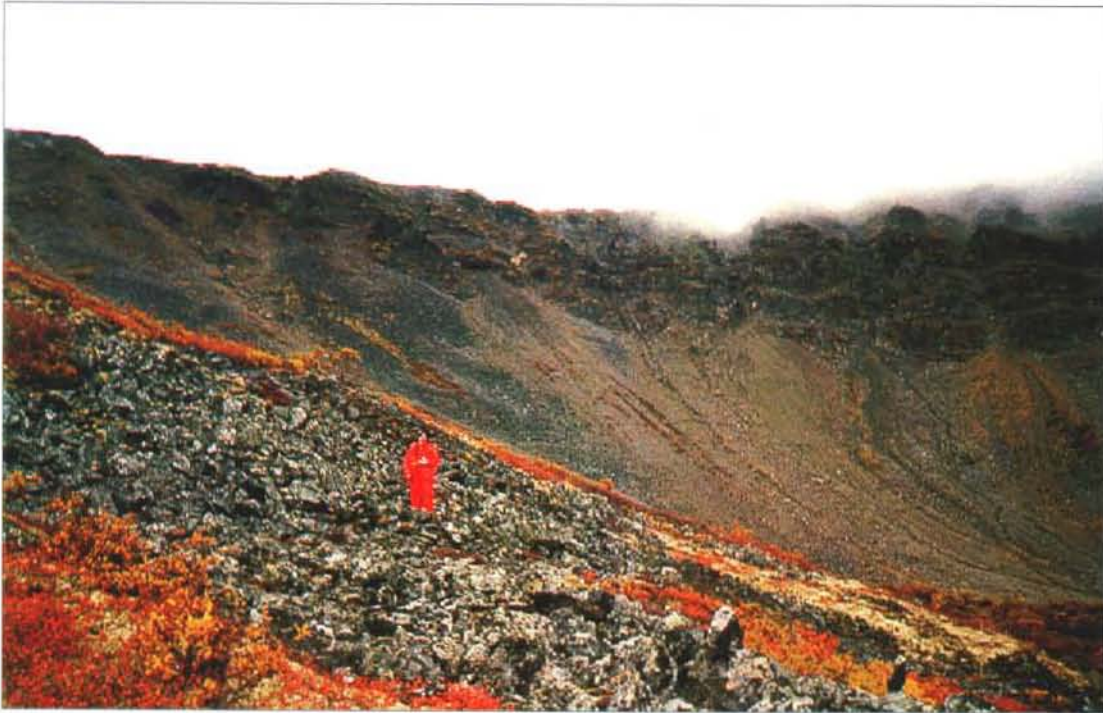
Condition: Condition of the portal structure is not known.

Photo 36-4 : Keno No.9 Faro Gulch cirque headwall with Faro Gulch Portal / Dump shed visible above person. Cuts along skyline left of person are (from left to right), No. 9 Vein and No.3 Vein Pits. Note waste rock dumps associated with each of the Pits and the Portal. Also note meltwater channels in waste rock from the No.3 and No.9 Vein Pits.

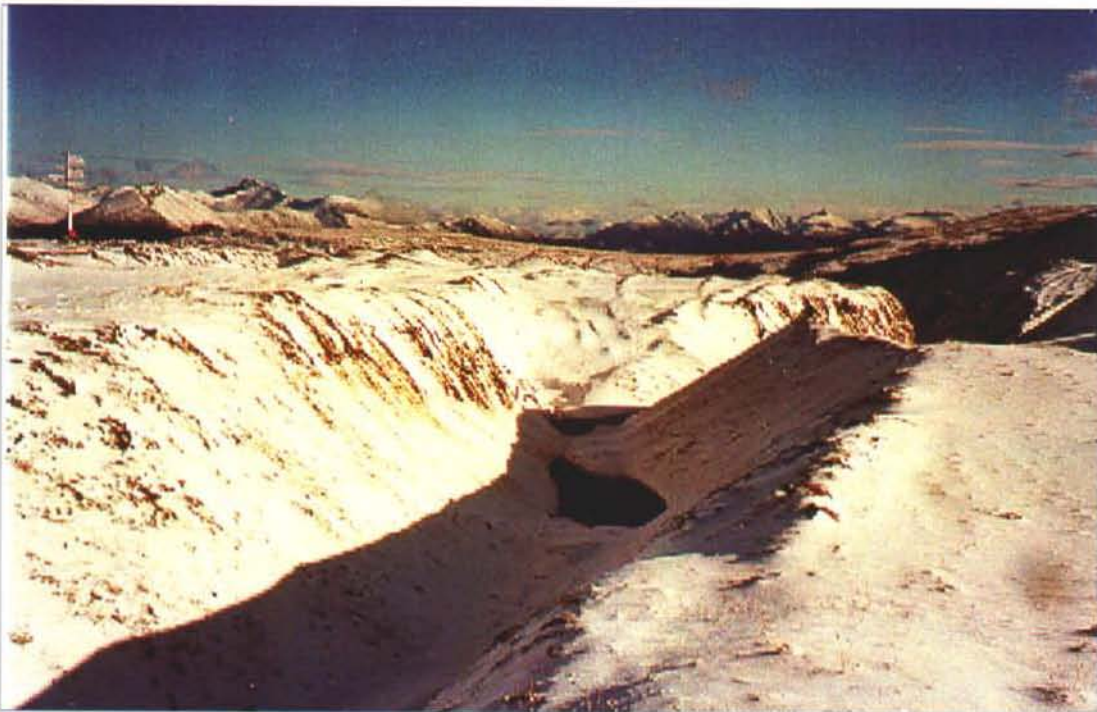
Condition: The pit walls were stable at the time of the site visit.

Photo 36-5 : Keno No.9 No.3 Open Pit. Note signpost on the left hand side and two of three ponds present.

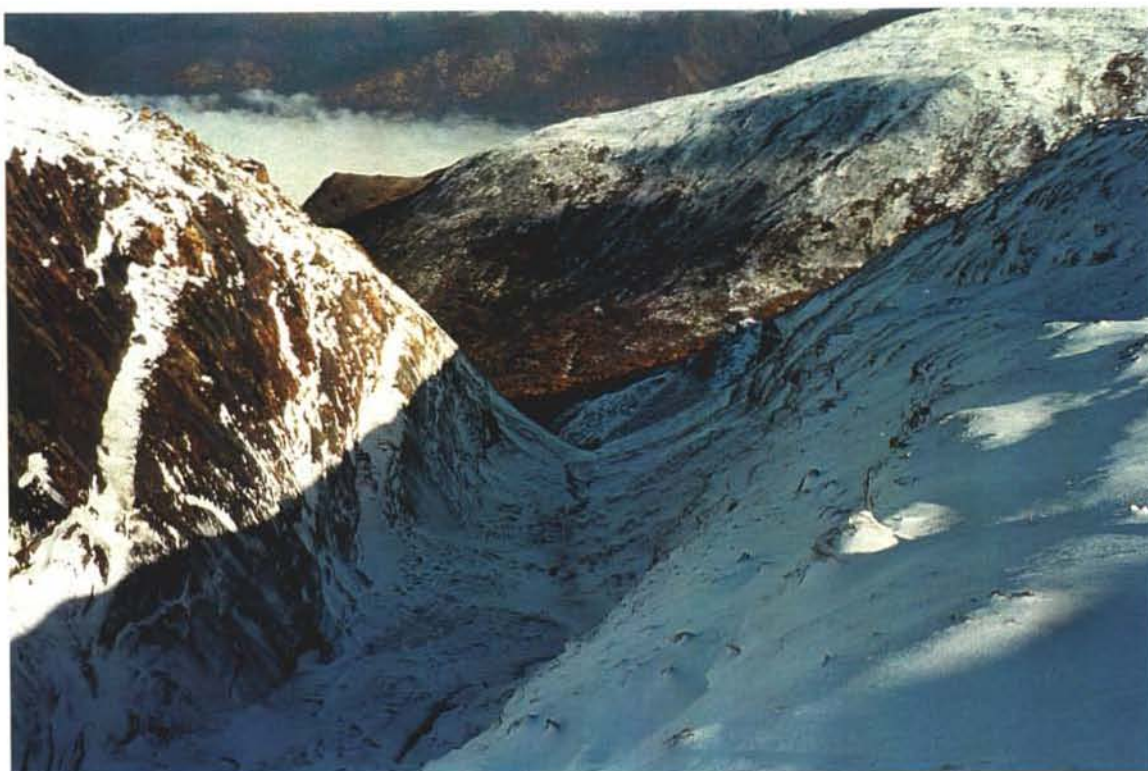
Condition: The boulders at the bottom of the trench likely are from the steep western pit wall. The pit wall is fairly stable but given the boulders at the base, occasional rocks do break off. The eastern wall is a gentler slope and appeared stable at the time of the site visit.

Photo 36-6 : Keno No.9 No.9 Vein Open Pit.

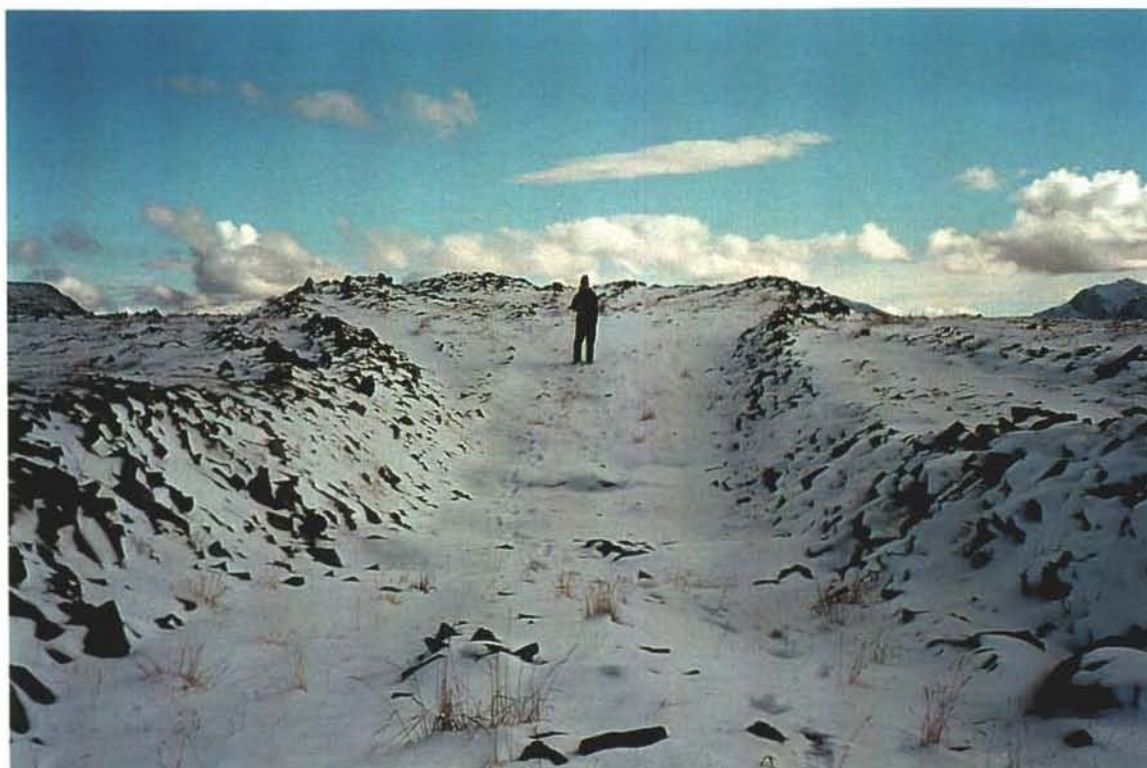
Photo 36-7 : Keno No.9 View of Trench L5 located on the No.4 vein. (Azimuth  $130^{\circ}$ )

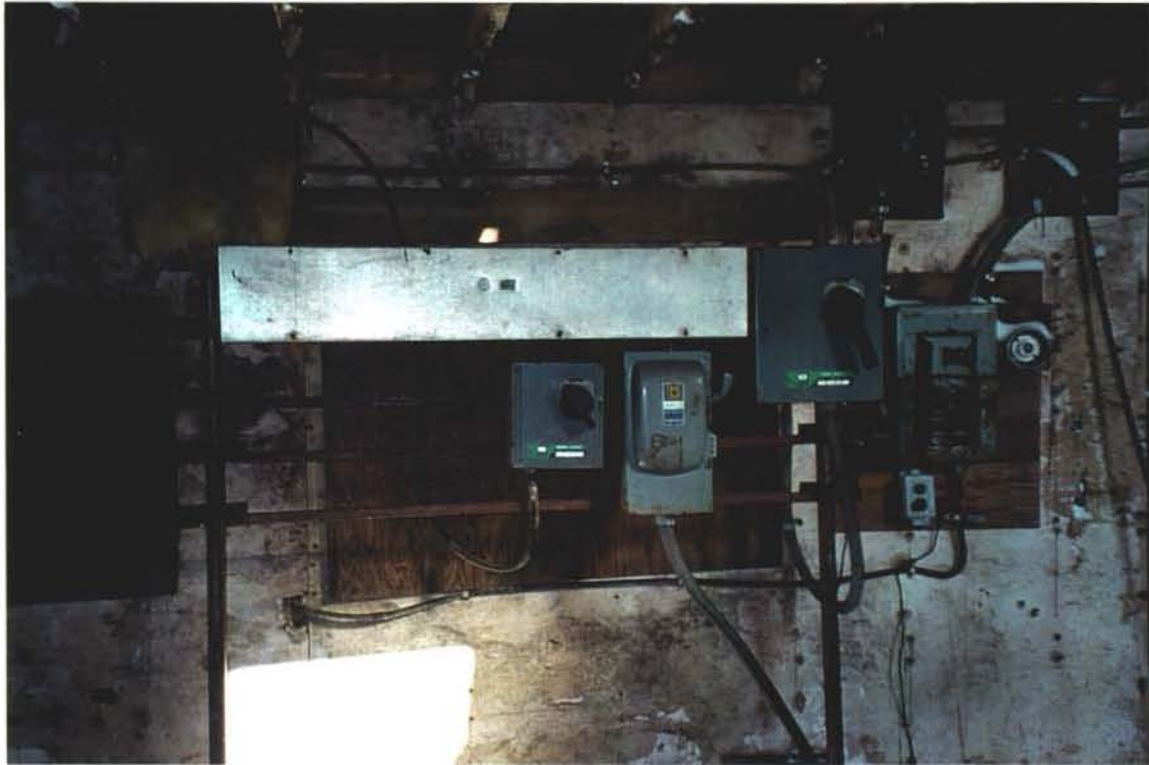
Non-Hazardous Contents: There is an electrical panel inside of the building.

Photo 36-8: Keno No. 9 Electrical panel inside Building 36A.

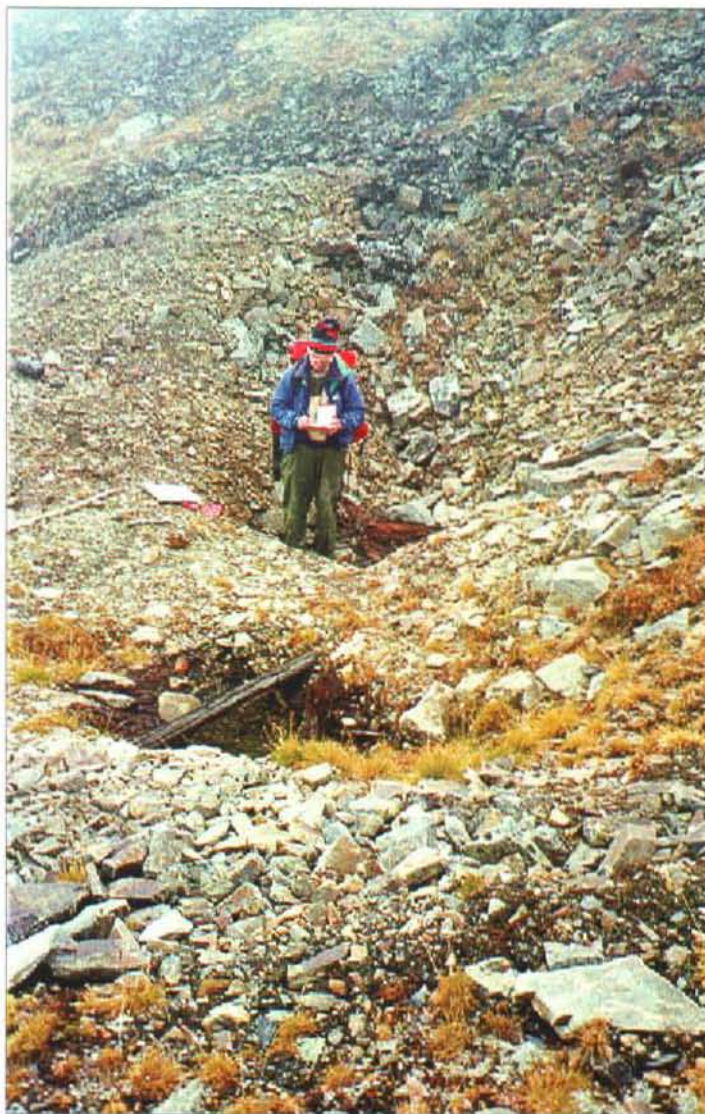
Photo 37-1 : Gold Hill No. 2. View of the Discovery shaft and showing. (Azimuth  $320^{\circ}$ )

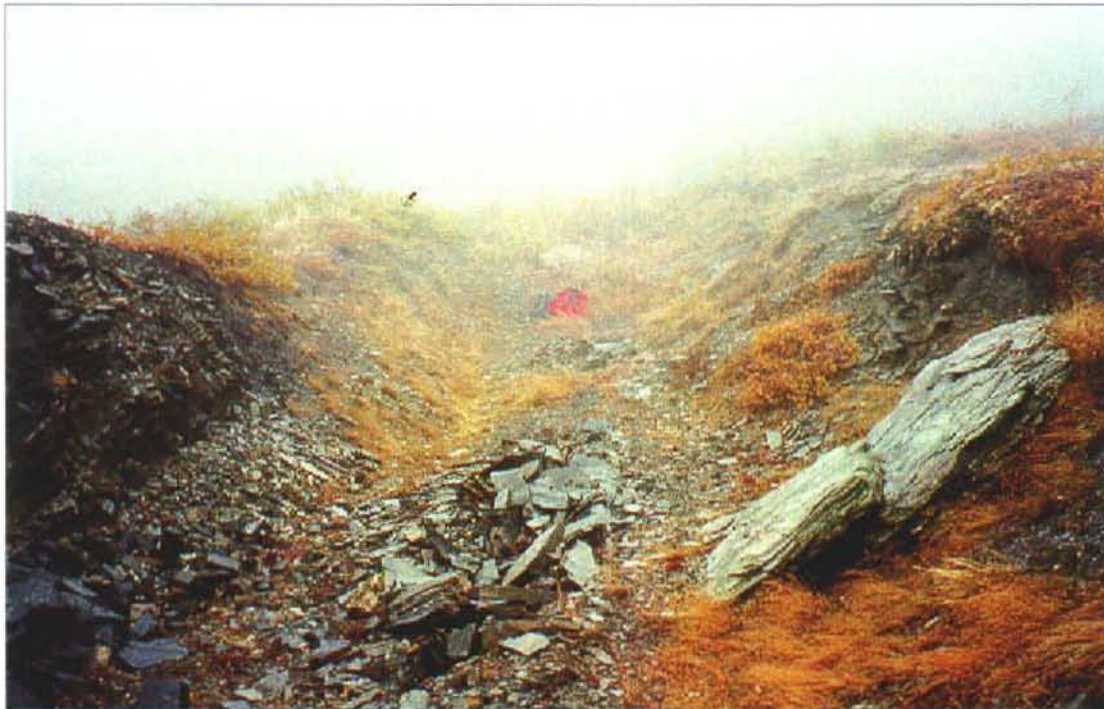
Photo 37-2 : Gold Hill No.2. View of Trench #5. (Azimuth $340^{\circ}$ )

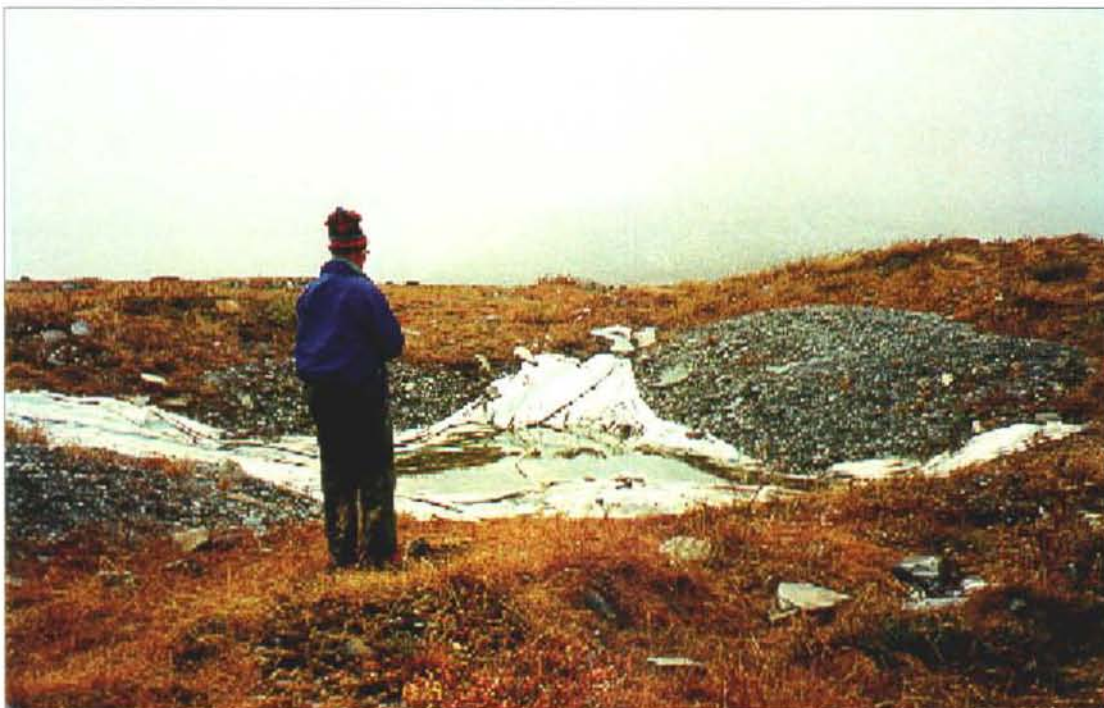
There are no buildings at the Gold Hill Number 2 site. On the western side of the Monument Hill Trail, there is a 10m x 10m x 2.5m sump (photo 37-3) lined with old style geotextile that was used for holding drill water. A hose leads from the sump to a metal tank at trench #4 (photo 37-4). No other mine site infrastructure was encountered at the site.

Photo 37-3 : Gold Hill No.2. Lined sump used for holding water for diamond drilling.  
(Azimuth $280^{\circ}$ )

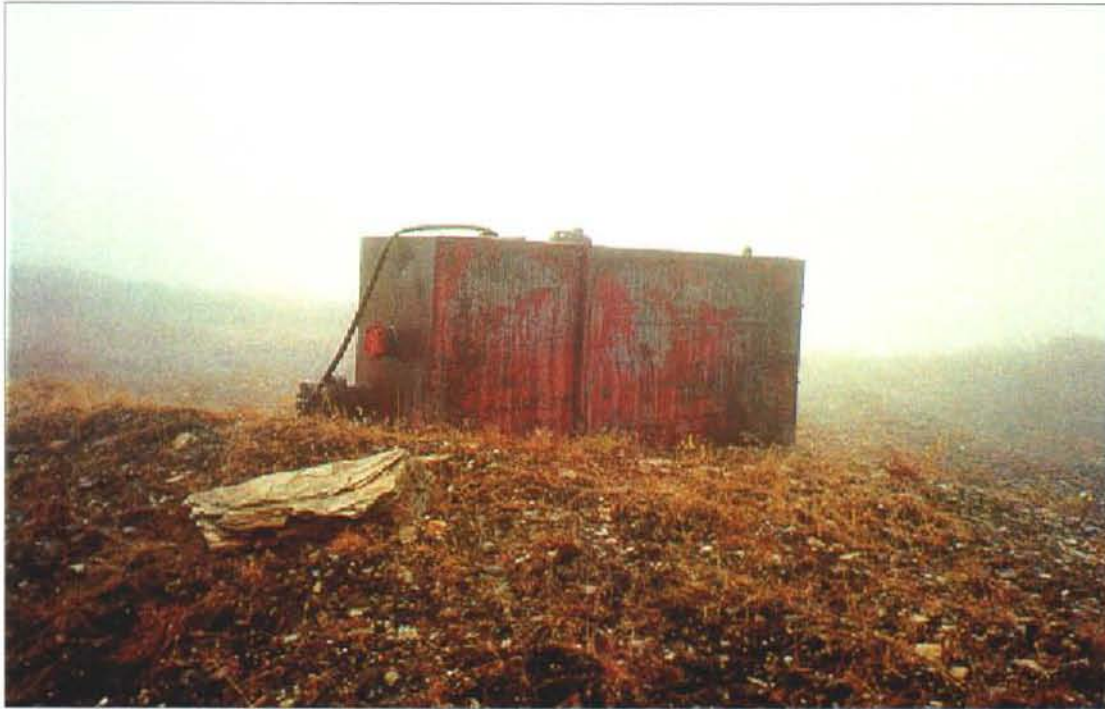
Photo 37-4 : Gold Hill No.2. Metal water tank near Trench #4. (Azimuth 212°)

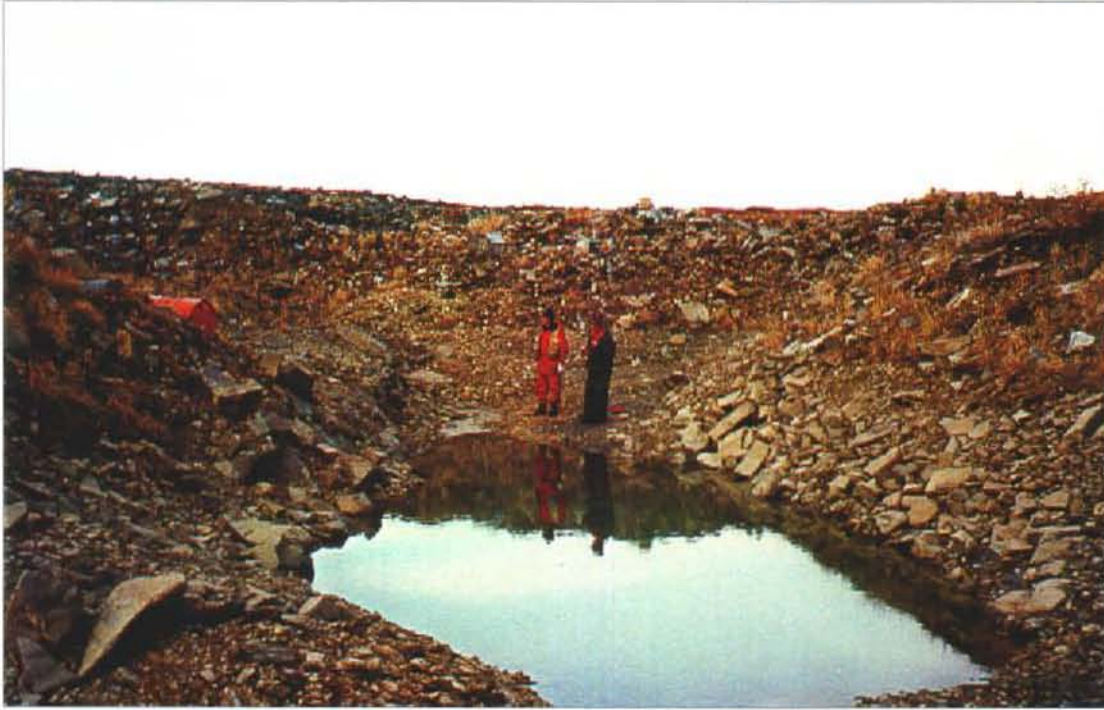
Photo 38-1 : Fox. Water ponded at the base of Trench #1. (Azimuth 020<sup>o</sup>)

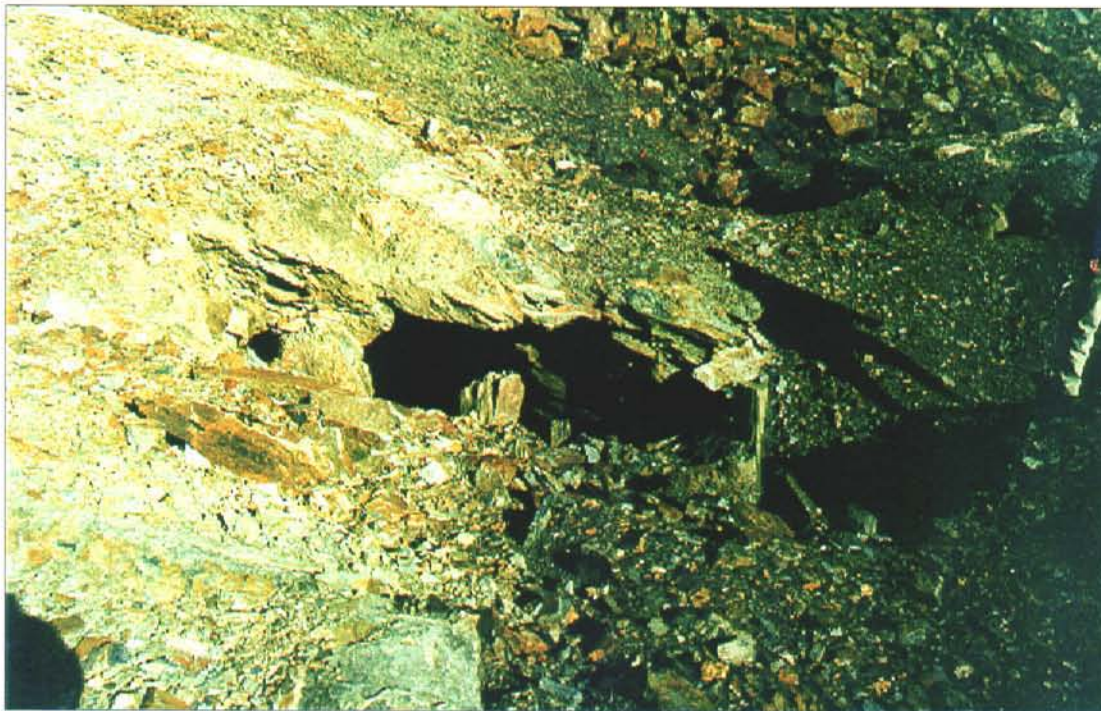
Photo 39-1 : Caribou. Caribou adit; portal exposed by bedrock striping. (Azimuth 080 °)

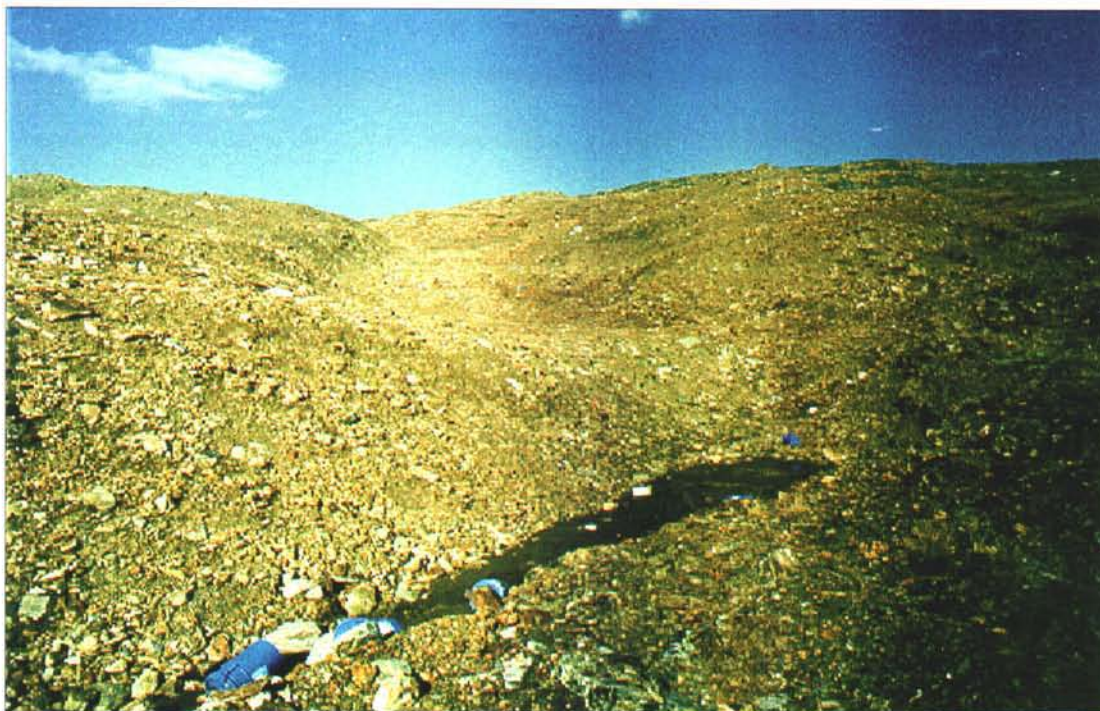
Photo 39-2 : Caribou. View of bedrock trench at Caribou. Note empty plastic pails and water sample site in foreground. (Azimuth ~000 °)

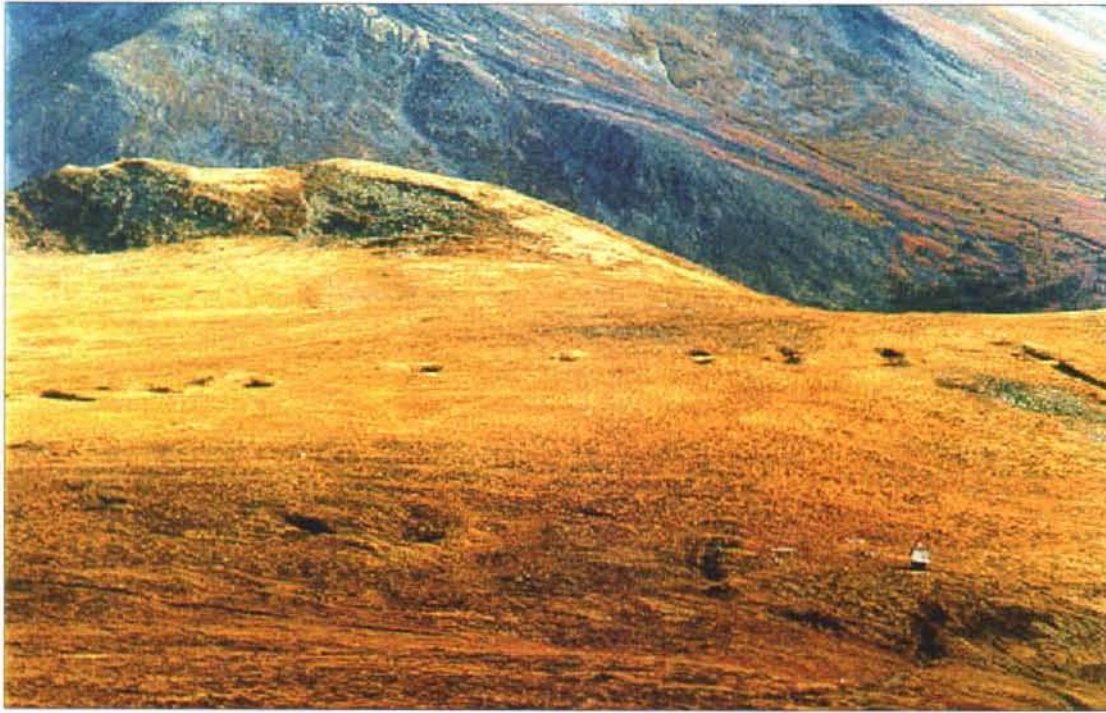
Photo 40-1 : Divide. View to southeast of trench areas. B (background) and C (foreground) at Divide. Note Building 40A in bottom right. (Azimuth 120°)

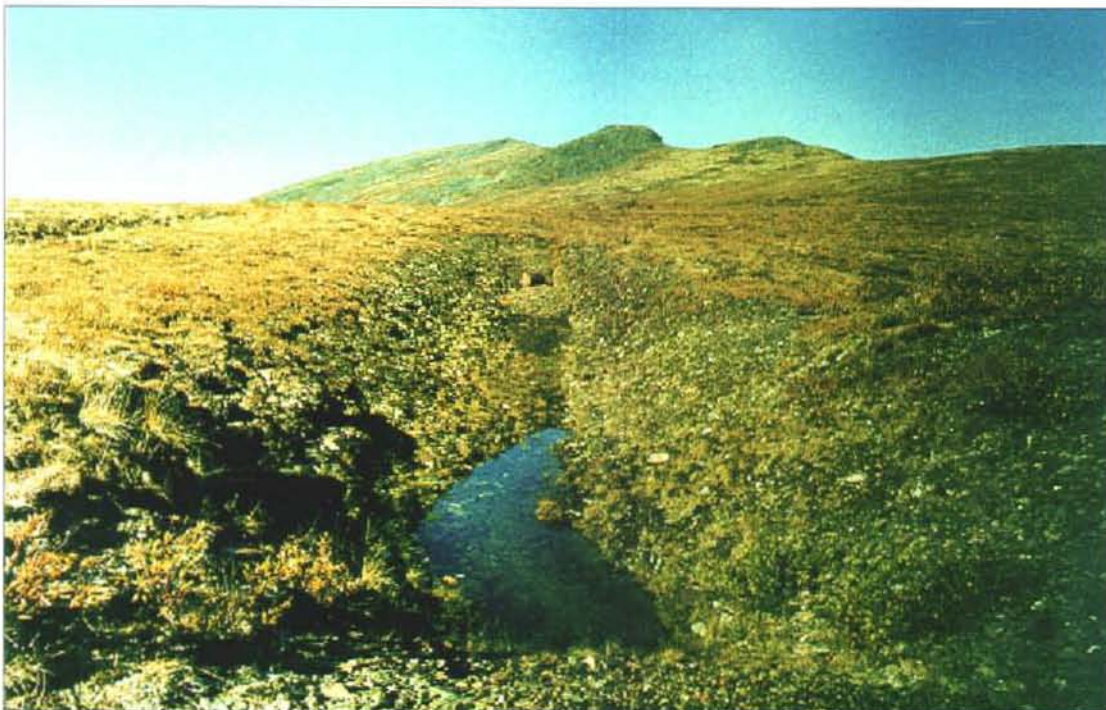
Photo 40-2 : Divide. Trench B10: note ponded water and partially full barrel. (Azimuth 290°)

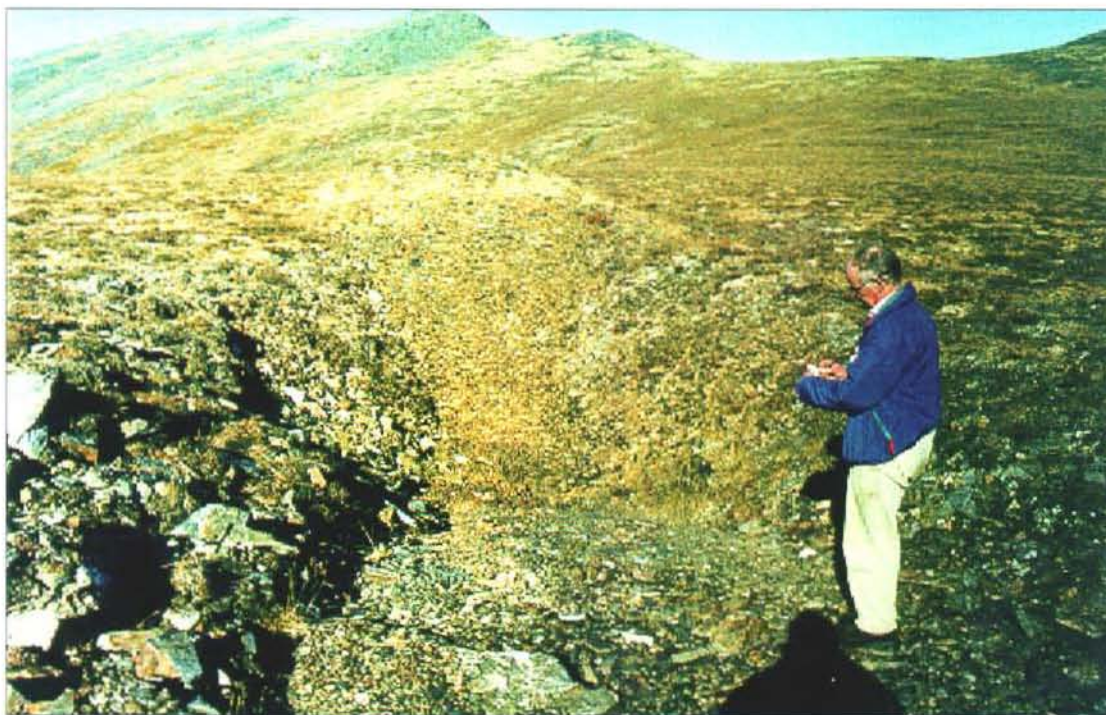
Photo 40-3 : Divide. Trench b6; site of rock sample Divide-Waste Rock - Sept. 14/94.  
Note building 40A in center background. (Azimuth ~130 °)

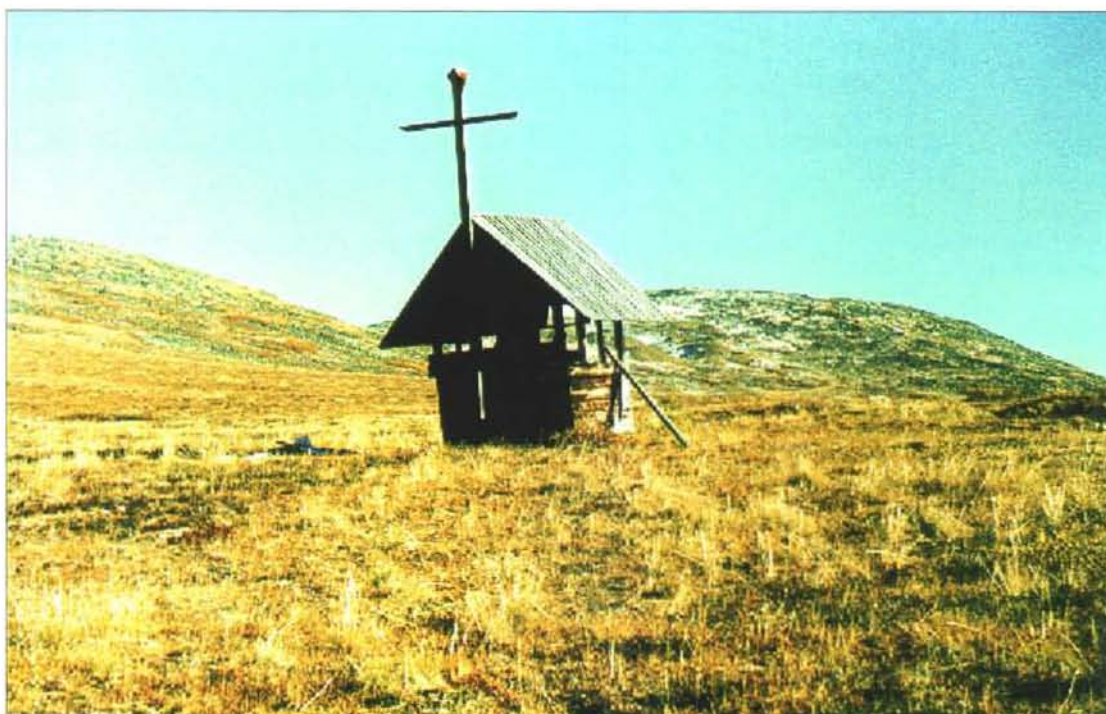
Photo 40-4 : Divide. View of Building 40A. (Azimuth ~050 °)
