# KENO VALLEY/DUBLIN GULCH ENVIRONMENTAL BASELINE ASSESSMENT

VOLUME V: Keno Valley Sites #71 to #73, #75 to #81

Dublin Gulch Sites #85 to #86, #88 to #94, and #96

Prepared for Waste Management Program Indian and Northern Affairs Canada

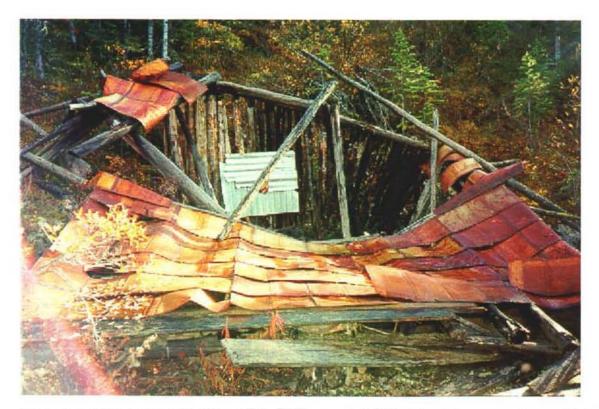
A wooden building (Building 71-1; photo 71-5) is located at the Christal camp site (see figure 1). Wooden debris provides evidence of other structures that used to occupy this site. A collapsed shed (Building 71-2; photo 71-1) is located over Shaft 2.

Photo 71-1: Collapsed shed building (Bldg. 71-2) over shaft A02. Note pully on cross beam. (Azimuth 140°)

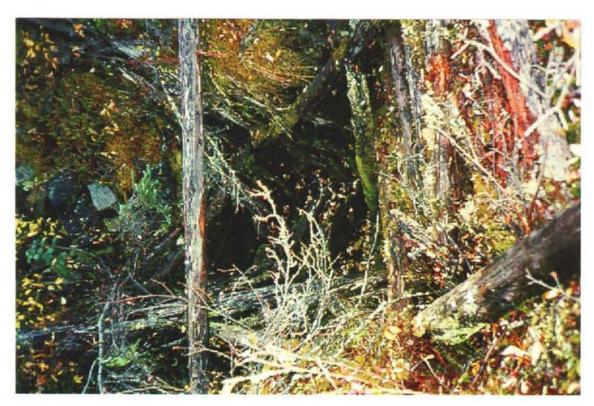
Shaft 1 (photo 71-2)

Photo 71-2: Shaft A02. (Azimuth 150°)

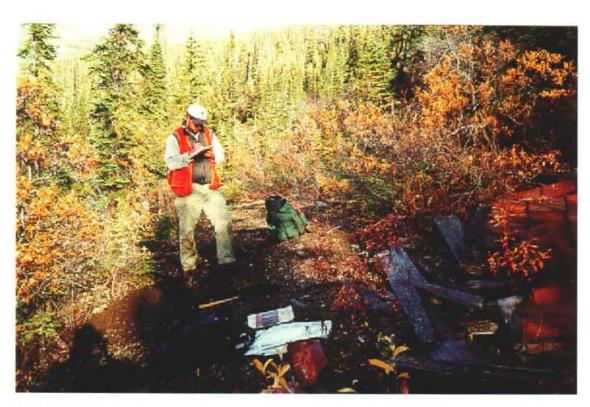
A waste rock pile was found next to Shaft 2 (photo 71-3). It was approximately 10 m long, 5 m wide and of unknown depth. This waste rock pile was almost entirely revegetated.

Photo 71-3: Waste rock dump below shafts A01 and A02. Note natural revegetation. (Azimuth 040°)

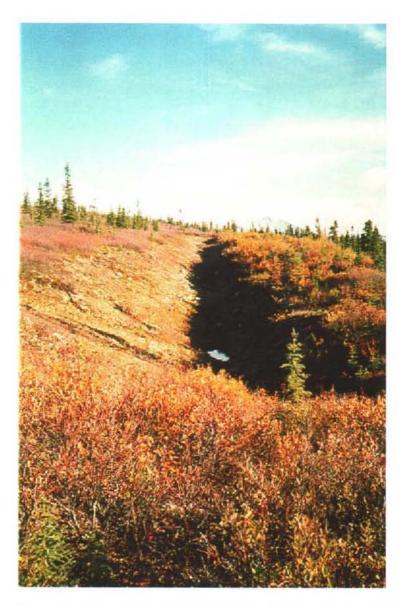
The trenches located about 500 m east of Shaft 1 can be roughly assembled into three groups based on their location, size, and orientation. Trench Group A is series of 7 trenches located almost due east from Shaft 1 (photos 71-8 and 71-9). The trenches in Group A range in length from 30m to 100 m. Trench Group B, located south of Group A, consists of 8 parallel trenches that follow the contour of Keno Hill at an elevation of about 1350 m (photo 71-10). Another trench in Group B lies perpendicular to the rest. The trenches in Group B range in length from 30 m to 60 m. Trench Group C, located east of Group B is a series of three long, deep trenches about 200 m in length (photo 71-4).

Photo 71-4: Recent cat trench; trench length 220m. (Azimuth 130°)

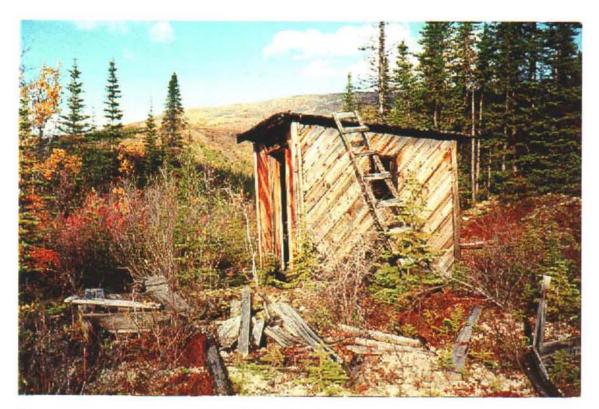
Photo 71-5: Mine shed (Bldg. 71-1). (Azimuth 000°)

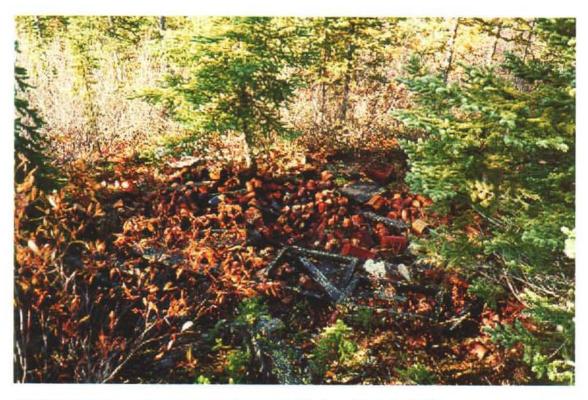
A dump of cans and other debris was observed at the Christal site about 10 m north of Building 71-1 (photo 71-6).

Photo 71-6: Camp garbage site; mostly cans and bottles. (Azimuth 280°)

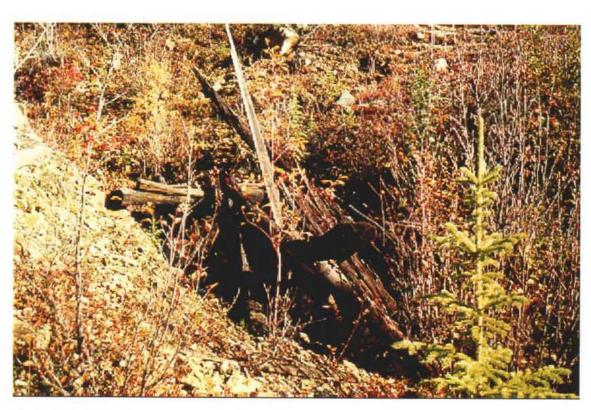
Adit 1 (photo 72-1)

Condition: adit is collapsed

Photo 72-1: Collpased adit Ironclad portal. (Azimuth 000°)

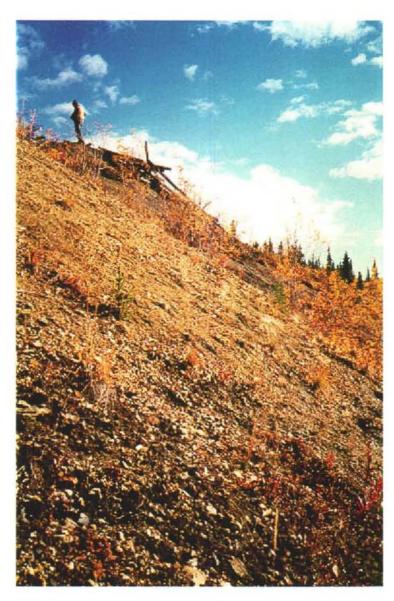
Waste rock pile #1 (photo 72-2)

blocky rusty and weathered quartzite. It also consists of about 10% phyllite and 5% quartz vein material. Minor siderite veining and greenstone were also observed in this pile. A 47 cm test pit (Test Pit 72WR01) dug at Waste rock pile #1 revealed four distinct layers of material (photo 72-3). The layers consisted of 8 cm of green yellow to green brown sandy quartzite and quartz veining overlaying 2 cm of dark grey graphitic phyllite, 27 cm of leached pale yellow sandy quartzite and quartz veining, and 10 cm of yellow brown to light brown sandy quartzite and quartzite. Waste rock samples were taken from the pale yellow layer (sample 72WR01-01) and the yellow brown to light brown layer (sample 72WR01-02). The field paste pH and conductivity of sample 72WR01-01 were 7.1 and 10 µS/cm respectively. The field paste pH and conductivity of sample 72WR01-02 were 7.4 and 20 µS/cm respectively. Laboratory analysis data is provided in Attachment B.

Photo 72-2: Waste Rock pile 72WR01 looking towards tresel structure on WR01. (Azimuth  $090^{\circ}$ )

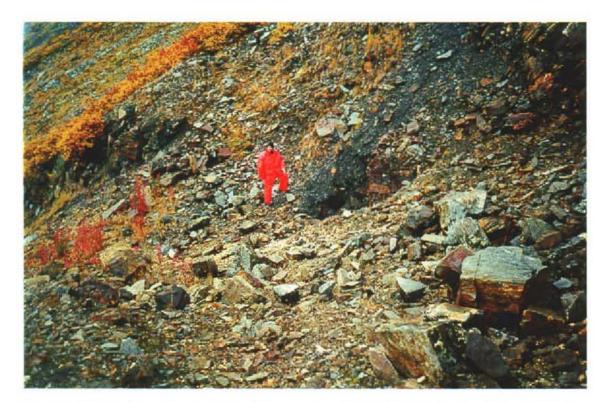
### Lower Adit (Photo 73-2)

Photo 73-2: Overview of lower adit level from upper adit level. Photo Direction (Azimuth 060°)

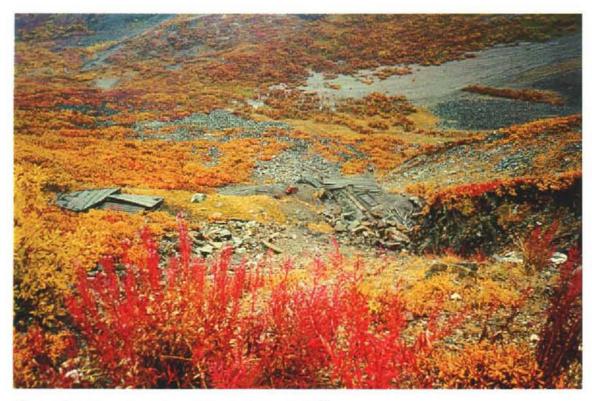
### Upper Adit (Photo 73-3)

Photo 73-3: Upper Gambler adit level. (Azimuth 170°)

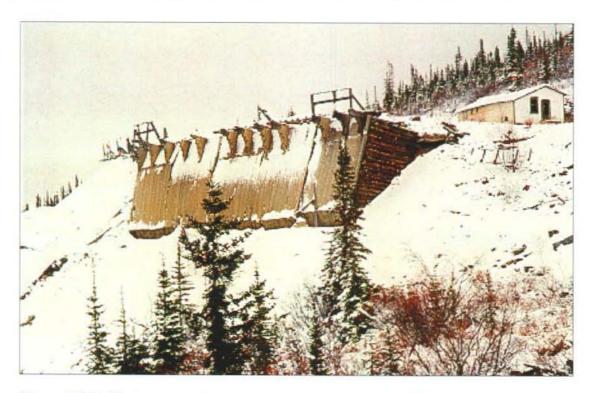
There are two buildings at the site. Building 76A serves as a workshop and office accommodations on two separate levels. Building 76B is the portal entranceway. There was building debris scattered around the site, however, there was no visual sign of staining on the surrounding soils. Wood cribbing and some wood sheathing (photo 76-1) is located to the west of the road to reinforce a waste rock dump that was used as a loading area (photo 76-2).

Photo 76-2: Timber retaining structure for the loading area.

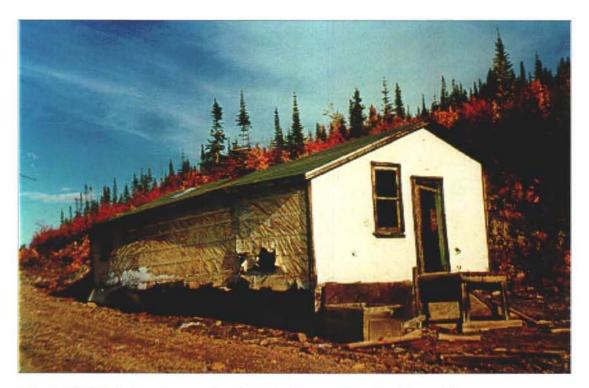
Building 76A – Office/Workshop (photo 76-3)

Photo 76-3: Timber frame structure to the northeast of the adit.

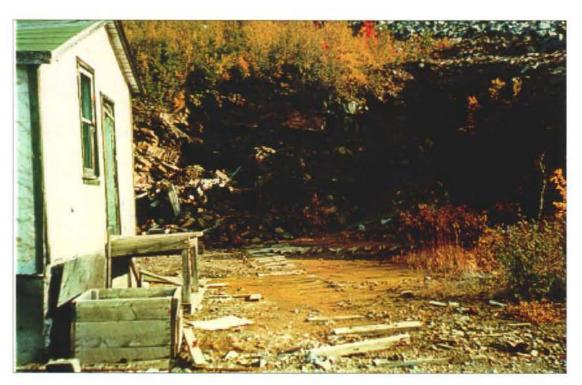
Building 76B - Adit Entrance (photo 76-4)

Photo 76-4: Tcollapsed adit in the background.

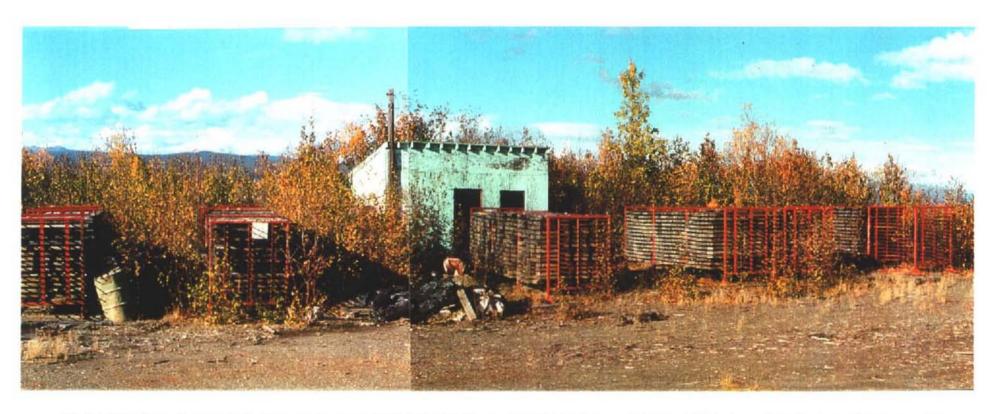
### Building #1: Green Shack (photos 78-1, 78-2)

Photo 78-1 : Elsa. Core racks in the sawmill area, with Building #1 (Green shack) in background. Drums with fuel are stored between the core racks to the left of the Green shack area. (Azimuth 360°)

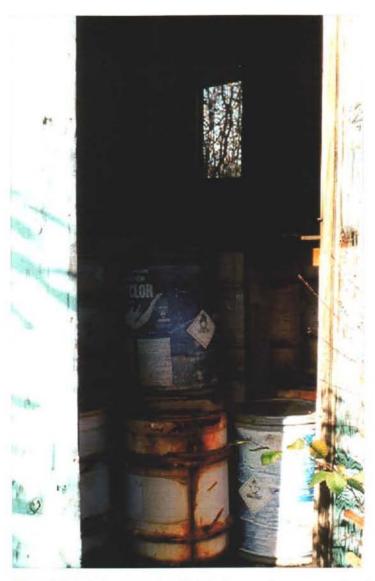
Photo 78-2 : Elsa. Building #1 is being used to store pails of calcium hypochlorite. (Azimuth 360  $^{\circ}$ )

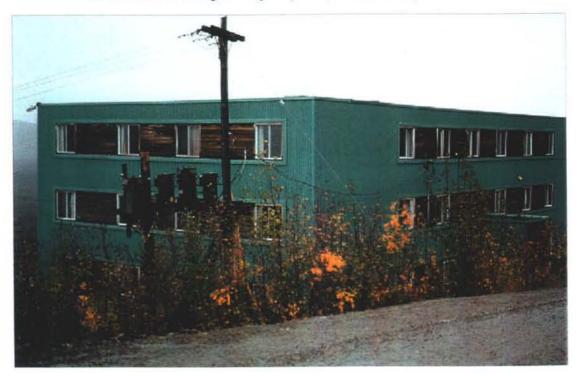
# Electrical Equipment Area #3: Transformers outside of Bunkhouse #7 (photo 78-5)

Photo 78-5 : Elsa. Building #7 is one of the newer bunkhouses. Note transformers in the foreground. (Azimuth  $010^{\circ}$ )

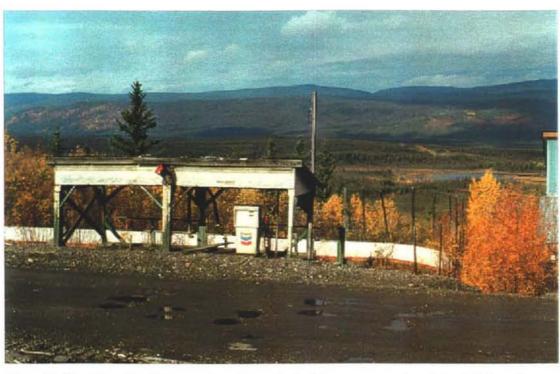
#### Fuel Storage Area #2: Diesel Fuel Pump Station (photo 78-23, photo 78-39)

Photo 78-23 : Elsa. Fuel Storage Area #2, a single Chevron pump, located uphill from the skating rink. (Azimuth  $030^\circ$ )

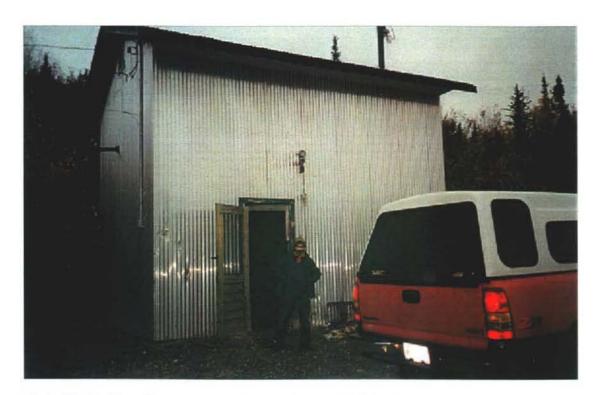
### **Building #52: Storage Shed (photo 78-35)**

Photo 78-35 : Elsa. Storage shed below mine houses. Note pails full of waste oil. (Building # 52)

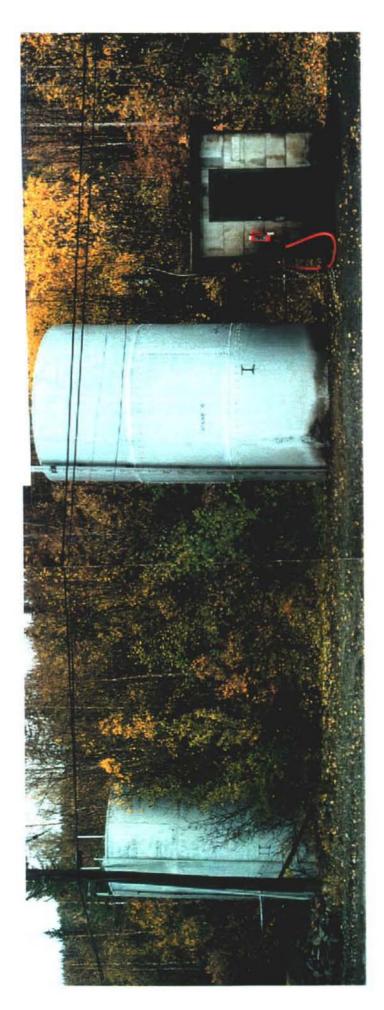
#### Fuel Storage Area #3: Oil Storage Tank (photo 78-40)

Photo 78-40 : Elsa. Fuel Storage Area #3 - an oil storage tank located beside the rescue building. There are numerous oil stains around the tank. (Azimuth 290 °)

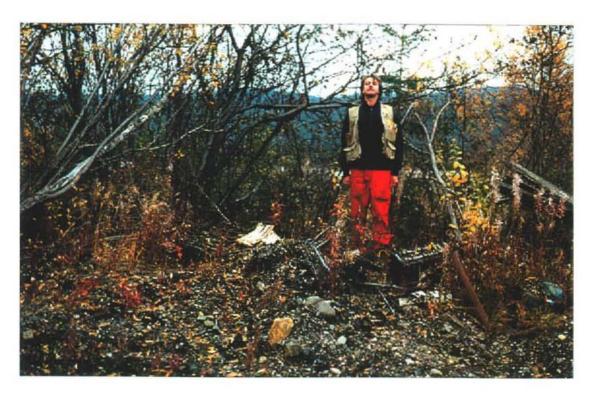
Photo 78-52: Elsa. Solid Waste Dump Area #1, metal debris pile. (Azimuth 130°)

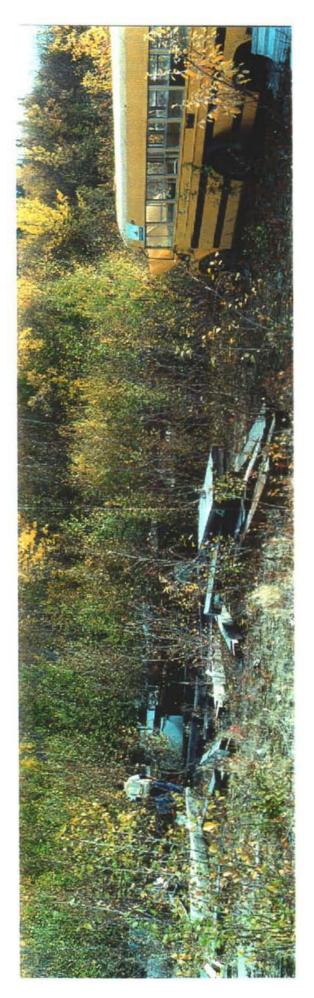
#### Solid Waste Dump Area #2: Battery and Drum Dump (photo 78-53, photo 78-54)

Photo 78-54 : Elsa. Solid Waste Dump Area #2 : empty 45-gallon drums and other metal debris. (Azimuth  $310^{\circ}$ )

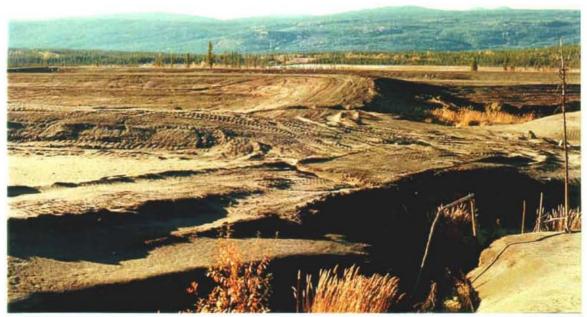
In 1996, a toe berm was placed to reinforce Dam No. 1 (Photo 79-1). Five tailings cells were also constructed behind Dam No. 1 to hold future tailings, however, these cells have not been used (Photo 79-2). During this time, work was done on the Porcupine diversion ditch, and active lime treatment of the pre-1960 tailings decant was begun.

<u>Breakthroughs</u>: The dam was breached several times from 1962 to 1972. A toe berm was placed on the downstream side of Dam No. 1 in 1996 (Photo 79-1). The toe berm extends about halfway up the dam and is approximately 5 m wide. It is constructed of gravel underlain by a layer of synthetic mesh added to limit piping of the dam. The mesh is porous but keeps the fines from being washed away with any seepage through the dam. No evidence of erosion of Dam No. 1 or the toeberm was seen.

Photo 79-1. Toe berm (light-colored material) at the base of Dam No. 1, looking northwestward.

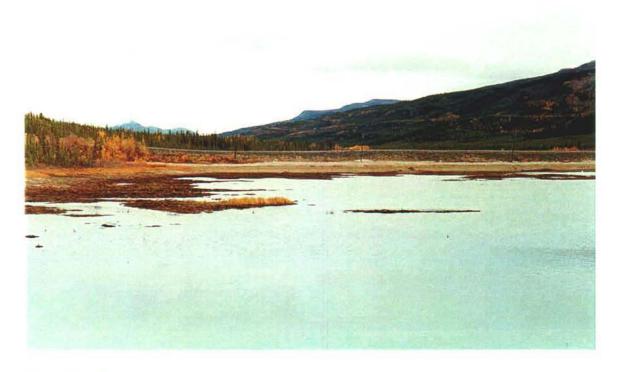
Some tension cracks were seen in the dam (Photo 79-6). Ponding immediately below the dam has abundant red iron oxide precipitate (Photo 79-7). Grasses are growing in this ponded water.

Photo 79-7. Ponded water below Dam No. 2. Note red iron-oxide precipitate in water.

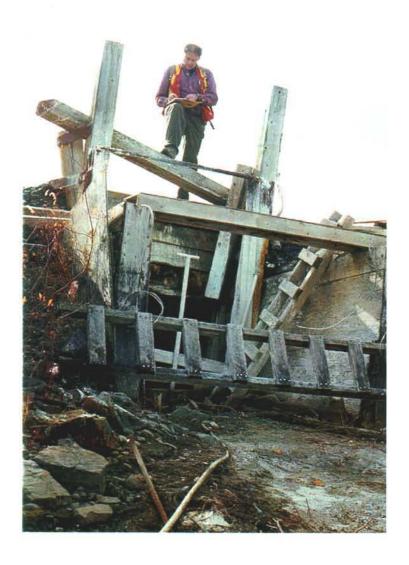
Oxidation: All of the tailings behind Dam No. 2 are saturated (Photo 79-8). UKHM (1996) reported no evidence of oxidation in this material.

Photo 79-8. Tailings pond No. 2, taken looking eastward from Dam No. 2.

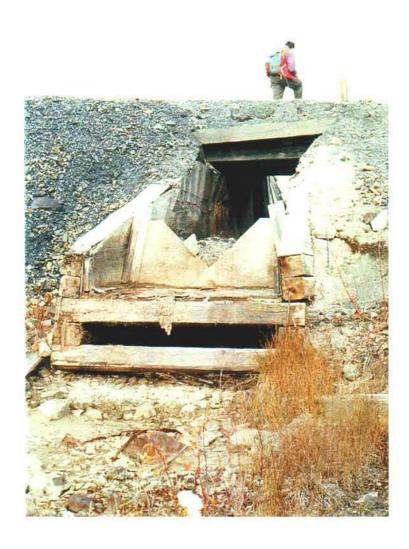
Photo 79-10. Decant in Dam No. 2, downstream side. Note lime precipitate around decant.

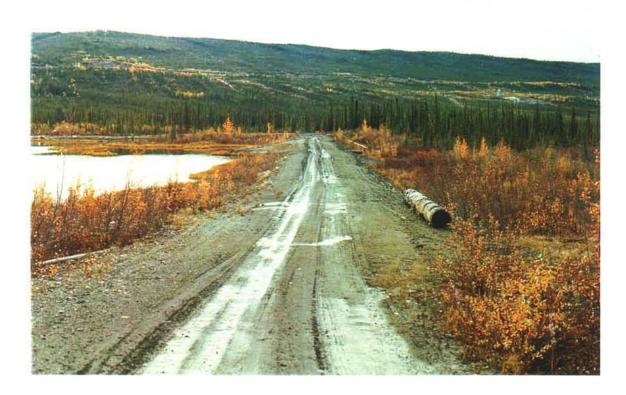
Photo 79-11. Tailings Dam No. 3, looking south.

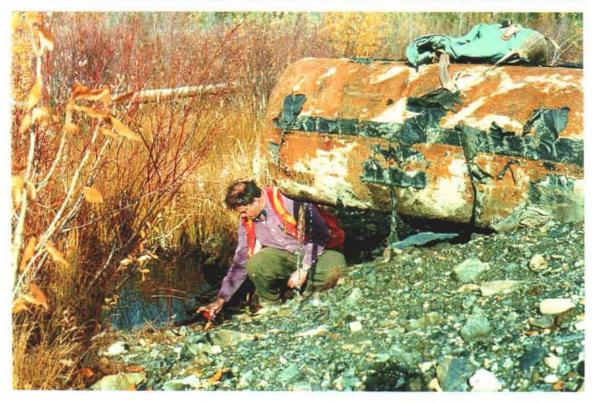
Photo 79-14. Pipe on downstream side of decant on Dam No. 3. This is also sampling site 79-WQ-02.

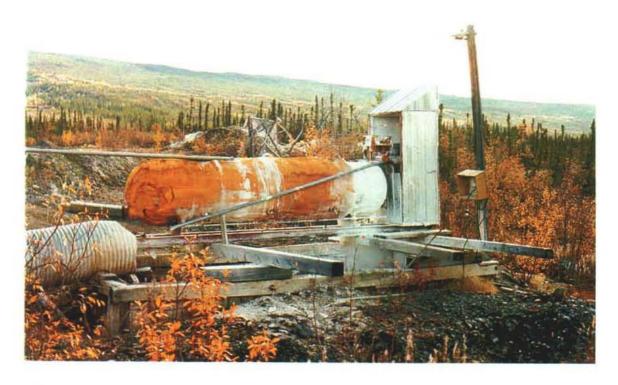
Photo 79-15. Lime treatment plant on Dam No. 1.

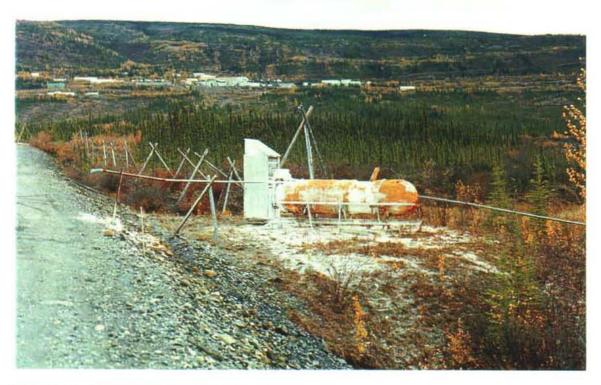
Photo 79-16. Lime treatment plant on Dam No. 2.

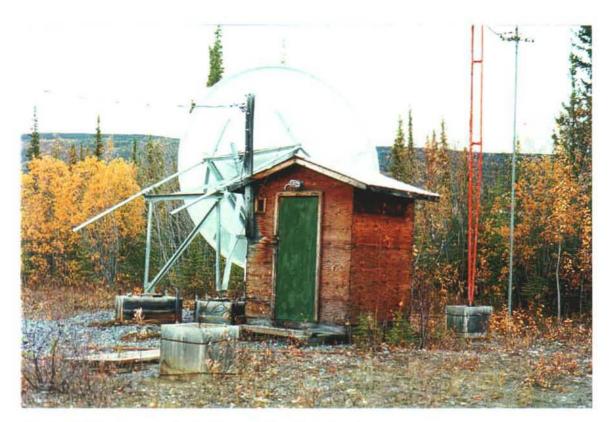
Photo 79-17. Transmission building (79A) and satellite dish.

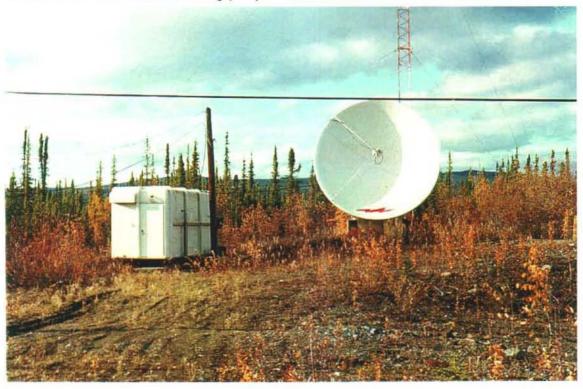
Photo 79-18. Northwestel building and satellite dish (Building 79C).

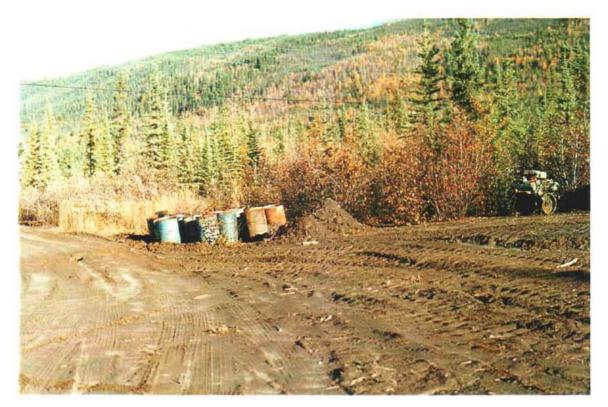
Photo 79-19. Barrels stored in boneyard.

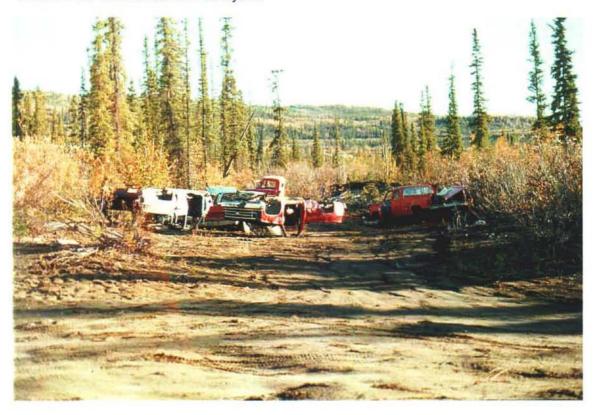
Photo 79-20. Old vehicles stored in boneyard.

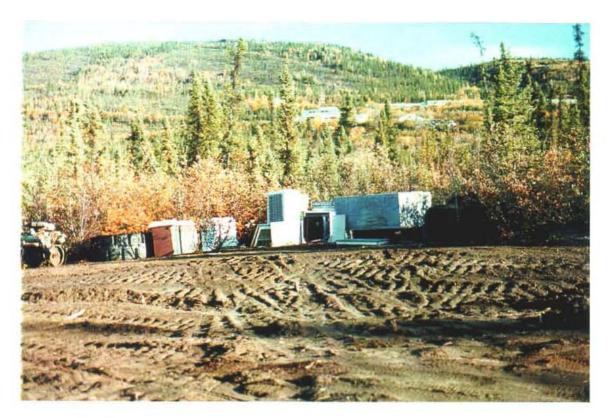
Photo 79-21. Old household appliances stored at boneyard.

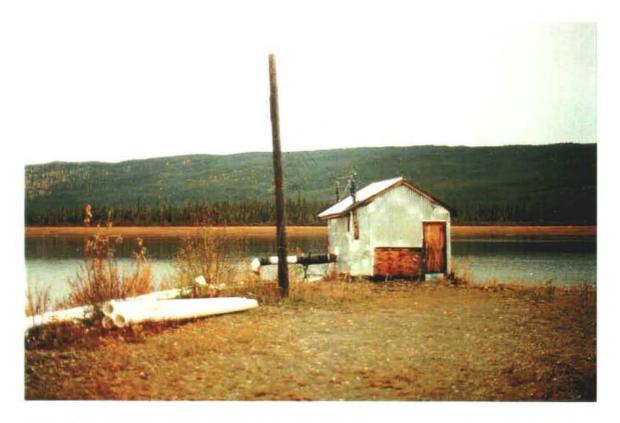
Photo 79-22. Pump house on unnamed lake that is the fresh water supply for the Elsa townsite.

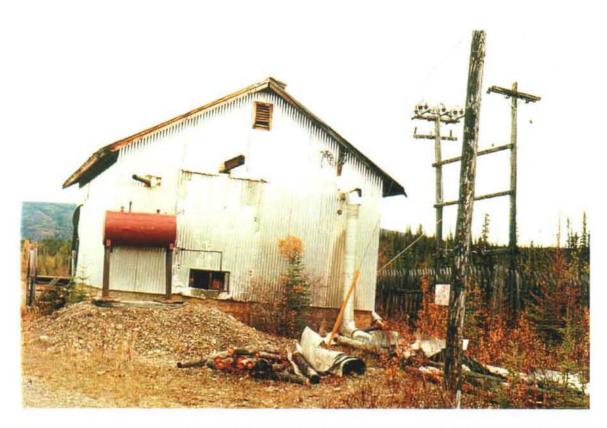
Photo 79-23. Pressure pump house that pumps the fresh lake water to the Elsa townsite. Note picket fence to the right of the house that contains the transformer that is in use.

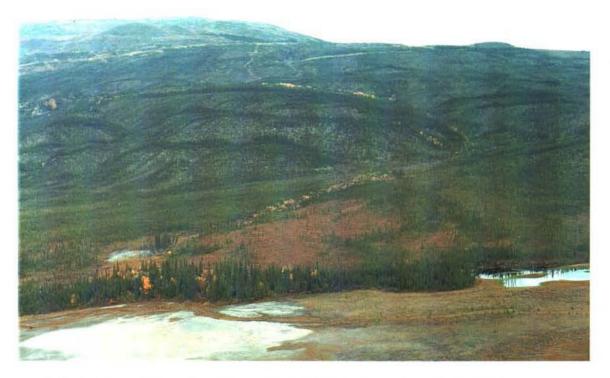
Photo 80-1. View of small creek (visible by line of yellow willows) which carried tailings into the lake.

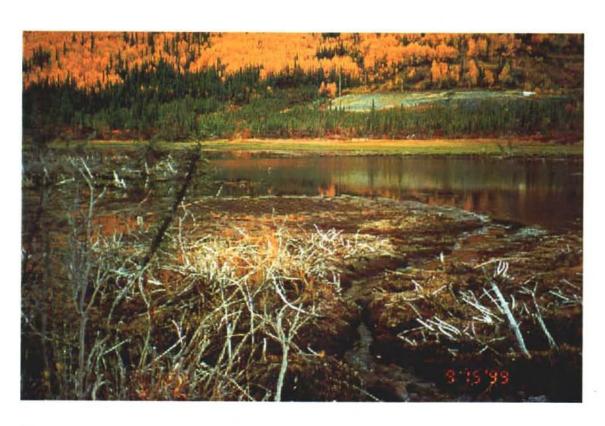
The tailings area abuts directly on the lakeshore, with some tailings noted in the lake (photos 81-3 & 81-4). A portion of the tailings also forms a fan at the mouth of Christal Creek at the north end of the site (photo 81-5). The site slopes gradually down to the lakeshore to the west. East and south of the tailings area is a mature spruce forest. A seasonal creek flows through the forest, entering the lake immediately south of the tailings area (photos 81-1 & 81-6).

Photo 81-1: Mouth of unnamed creek at Christal Lake.

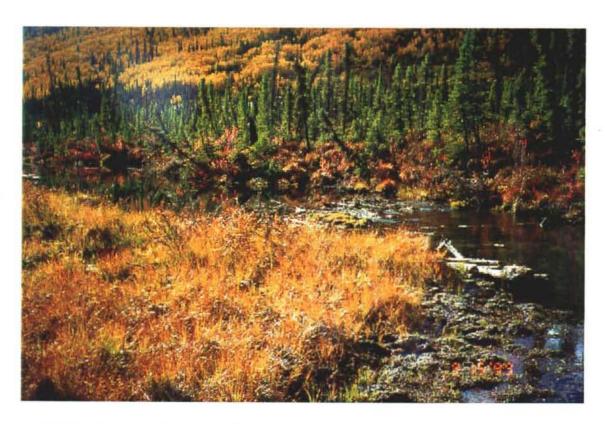
<u>Breakthroughs</u>: No breakthroughs were noted, however, the beaver dam is not an engineered structure and some tailings probably escape the impoundment area. As well, the dam is not a permanent structure but appears to have been present for some time.

Photo 81-4: Upstream from small tailings to near mouth of Christal Creek.

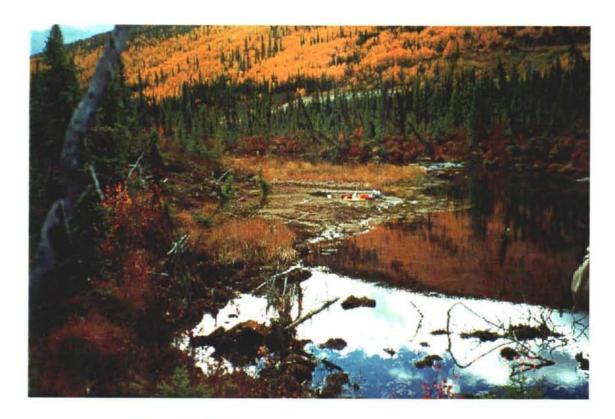
Photo 81-5: Upstream to small tailings fan on Christal Creek.

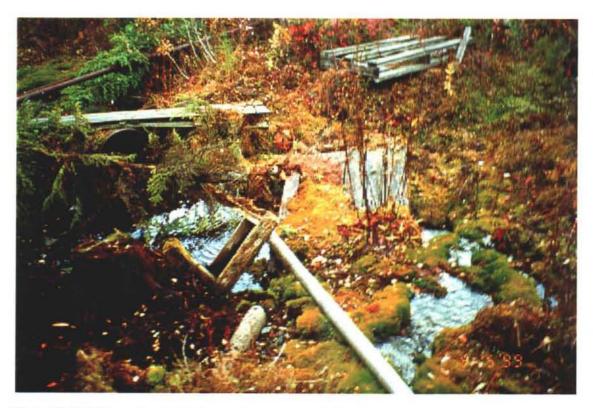
Photo 81-6: Tailings pipeline in forested area north of millsite.

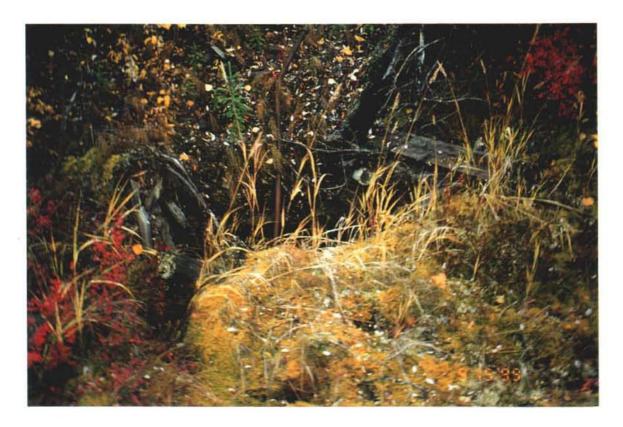
Open Pits (photo 81-7)

One small test pit was found near the millsite.

Condition: Timbers are rotten, site is revegetated.

Photo 81-7: Small timber-lined test pit south west of millsite.

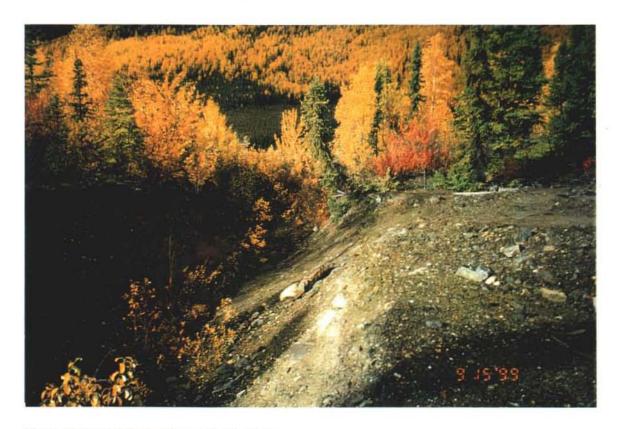
Trenches (photo 81-8)

<u>Condition</u>: Fairly stable; partially revegetated.

Photo 81-8: Trench directly south of millsite.

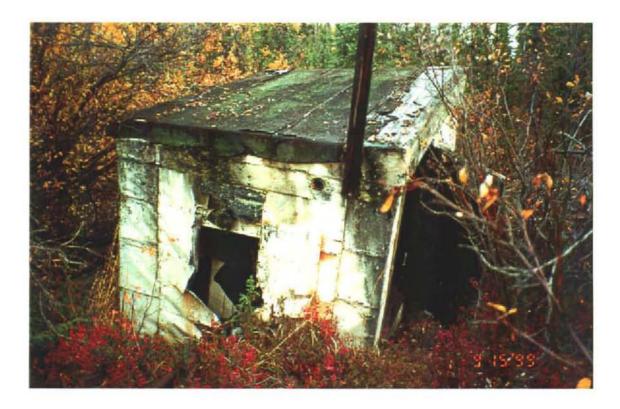
Building 81A- Pumphouse (photo 81-9)

<u>Pump house</u>: Small wood frame structure straddling small unnamed creek (photo 81-9); used to pump both tailings and water to adjacent tailings area.

Pumphouse consists of a small deteriorated wood building positioned over a small creek.

Photo 81-9: Tailings pumphouse in forested area north of millsite.

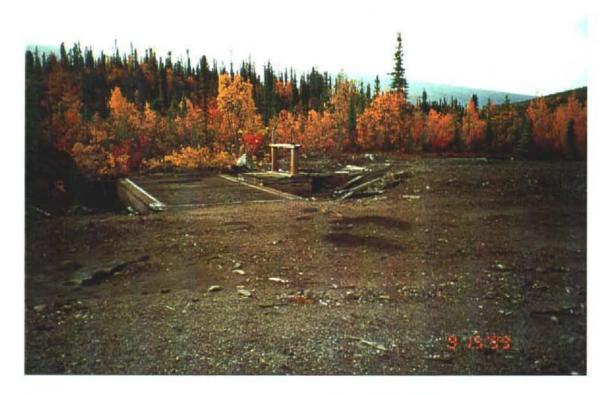
Building 81B – Weigh Scale (photo 81-10)

All that remains of the scale is concrete foundation and scale well.

Construction: Concrete foundation well covered with timbers.

Photo 81-10: Concrete foundation of weigh scale at south end of millsite.

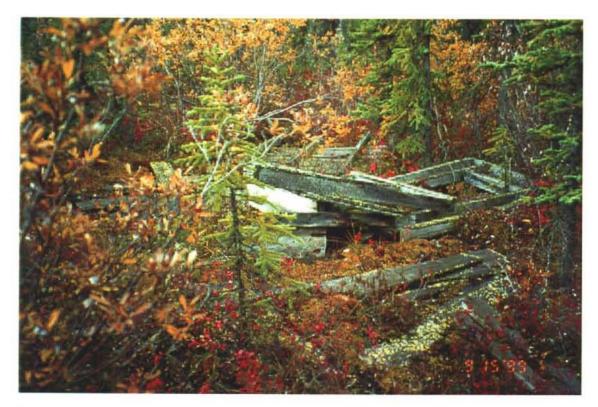
Photo 81-11: Wood debris remaining from former shack south west of millsite.

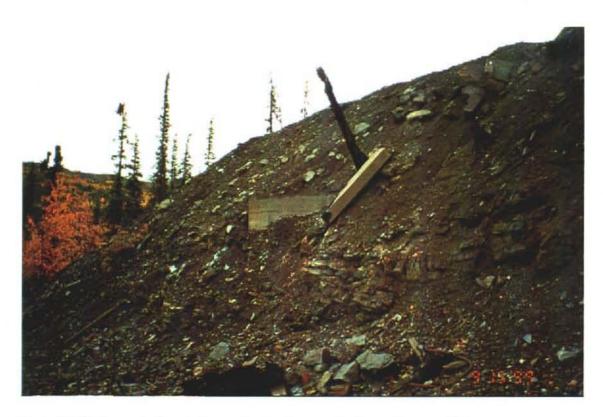
Photo 81-13: Concrete foundation protruding from north slope of upper millsite area.

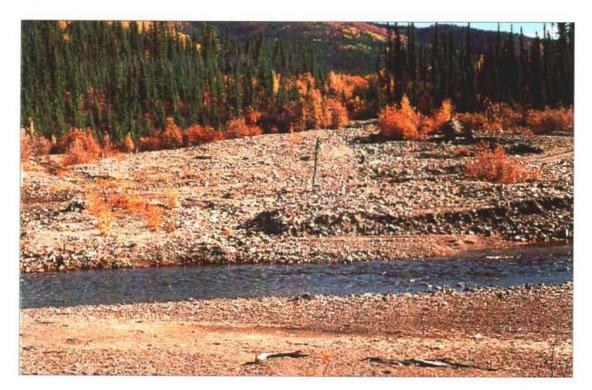
Natural revegetation is being obscured by on-going placer mining activities along Haggart Creek which are also significantly altering surface drainage throughout the area (see Photo 85-1). There is no evidence of any reclamation measures at this site.

Photo 85-1: Barker Site looking N.E. water sample location downstream of Dublin Gulch (general).

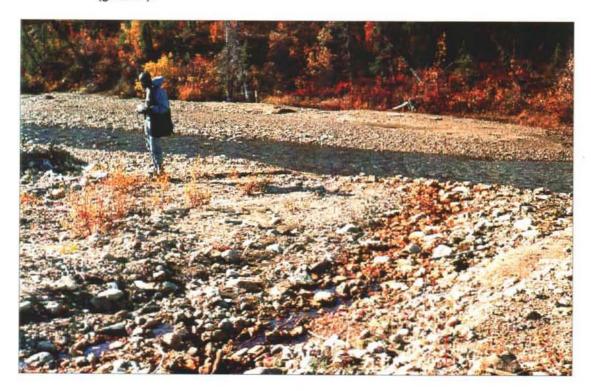
One surface water quality sample was collected just downstream of the confluence of Haggart Creek with Dublin Gulch (proper) (99-85-WQ-01, Photo 85-2). Results of the geochemistry are listed in Attachment 2.

Photo 85-2 : Barker Site looking S.W. water sample location downstream of Dublin Gulch (general).

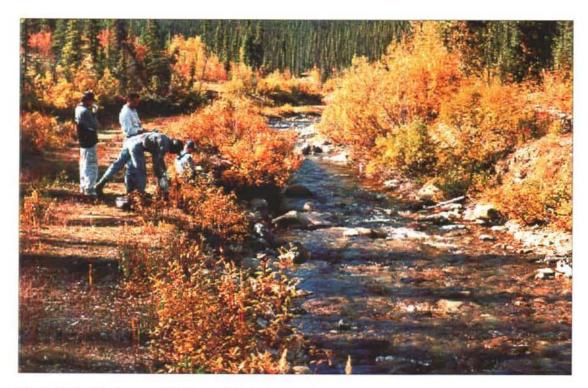
The site faces north-northwest along a series of raised shoreline out-wash terraces on the south site of Haggart Creek, approximately 850 m northeast of its confluence with Iron Rust Creek (Photo 86-1). The presence of permafrost soils could not be ascertained; however, the presence of smaller trees and the high elevation suggests the possibility of discontinuous permafrost.

Photo 86-1: Upstream of Meilecke Site looking west.

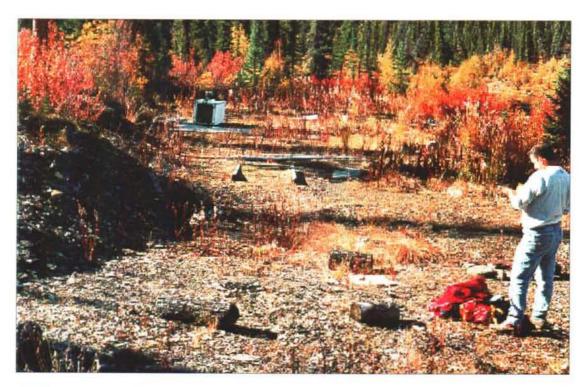
Possible old trench along terrace on south shore terrace by Haggart Creek running east-west; recently used as camp site (Photos 86-2 and 86-3).

Photo 86-2: Meilecke Site. Camp site located in old trench (looking west).

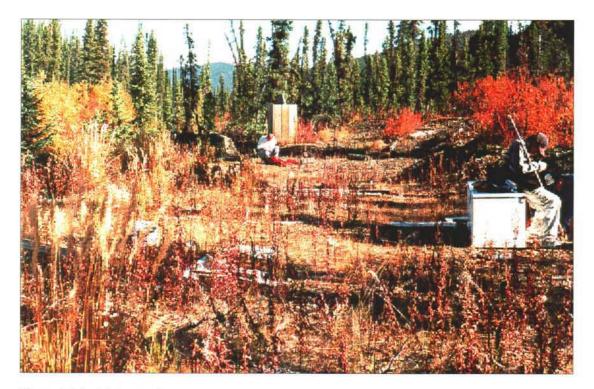
Outhouse (86A) - Wood construction with no roof, dimensions (L x W x D): 0.75 m x 1 m x 2 m (see Photo 86-3).

Natural revegetation is beginning to occur at the site along the suspected trench area, where the camp site is located, including grasses, forbs (e.g., fireweed) and young trees such as spruce and willow (see Photo 86-3). No evidence of any reclamation measures at this site.

Photo 86-3: Meilecke Site camp looking east.

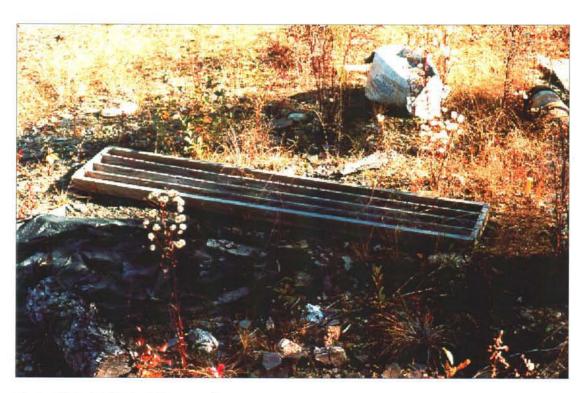
No apparent waste dumps; however, scattered debris over site including core boxes, wood, plastic, appliances (fridge and stove), cans, wooden flowerbox, plastic and metals cans containing ash from camp fire, old mattress and other camp equipment, number of empty 10 gallon cans, old portable generator and car battery (Photo 86-4 and 86-5).

Photo 86-4: Meilecke Site, core box.

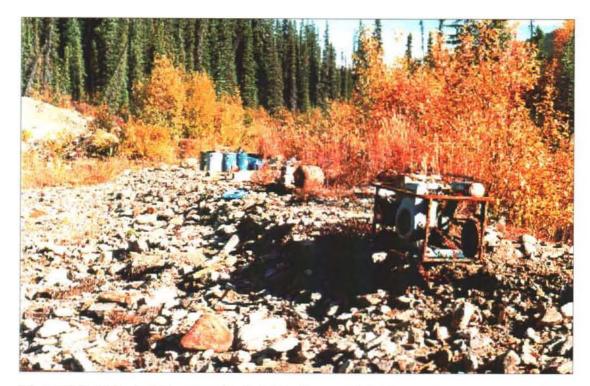
Photo 86-5: Meilecke Site, generator & debris along creek looking east.

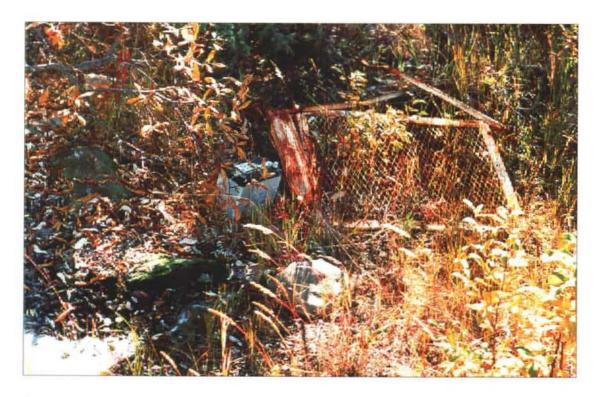
Old car battery located 100 m SW of camp above stream bank. No samples taken, given isolated location of material from stream (Photo 86-6).

Photo 86-6: Meilecke Site, battery near stream (100m S.W. of camp site).

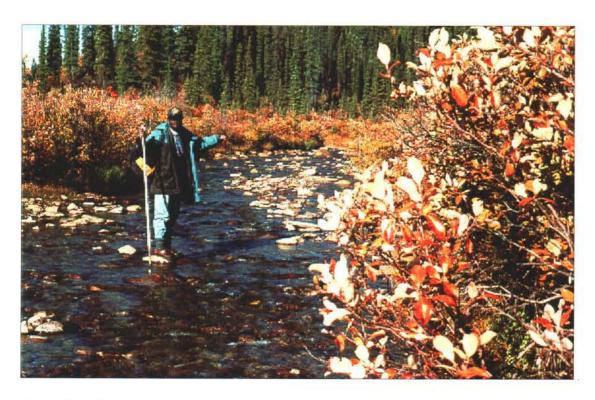
Surface water quality samples were collected 160 m upstream (background) of the site (99-86-WQ-01) and downstream, approximately 50 m east and upstream of the Iron Rust Creek confluence (99-86-WQ-02, Photo 86-7). Results of the geochemistry are listed in Attachment 2.

Photo 86-7 : Meilecke Site. Downstream water sample location 50m E. of confluence of Haggart & Iron Rust Creeks.

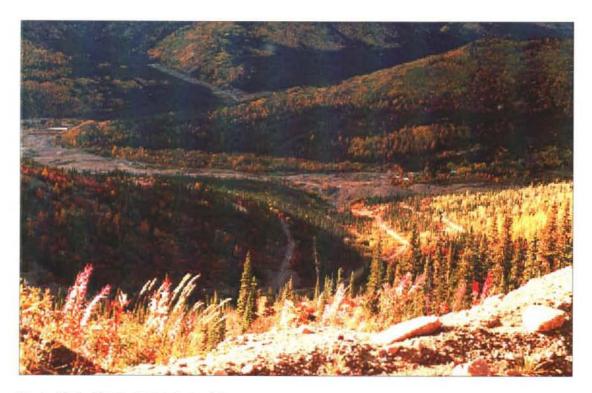
The main exploration camp is located along the north site of Dublin Gulch along a raised shoreline out-wash terrace approximately 20 m north from the gulch tributary. Over-burden from placer activities in the Gulch have also significantly altered surface hydrology in the area (see Photo 88-1). The presence of permafrost soils could not be ascertained; however, the presence of small trees and the high elevation suggests the possibility of discontinuous permafrost.

Photo 88-1: Dublin Gulch facing N.

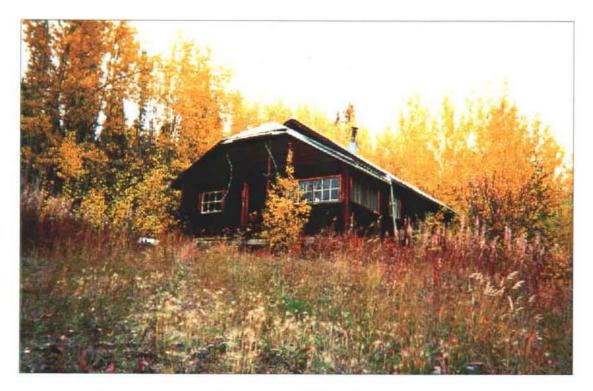
### Building 88-A (Photo 88-2)

Photo 88-2 : Dublin Gulch. Exploration Camp - cabin 1 looking N.W.

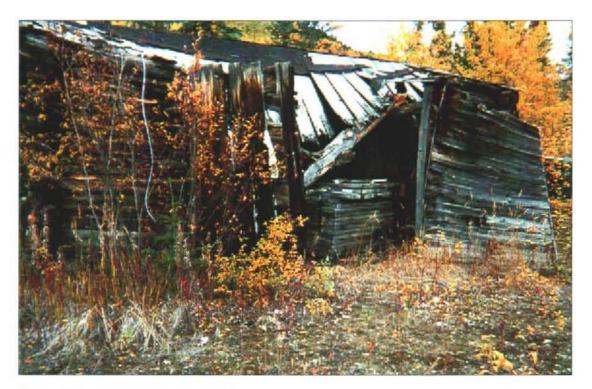
#### Building 88-D (Photo 88-3)

Photo 88-3: Dublin Gulch. Exploration camp - cabin 2 looking N.W.

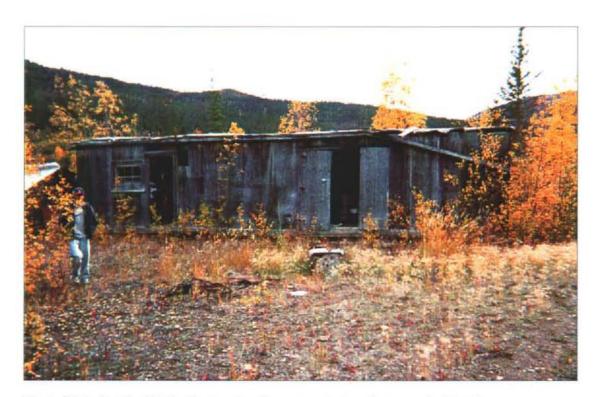
Photo 88-4: Dublin Gulch. Exploration Camp - workshop & storage looking S.

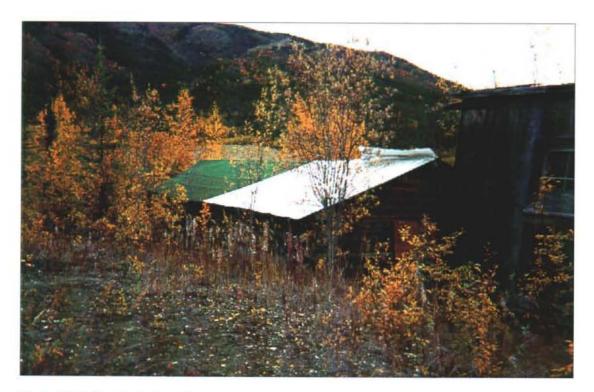
Photo 88-5 : Dublin Gulch. Exploration Camp - cabin 4 looking S.E.

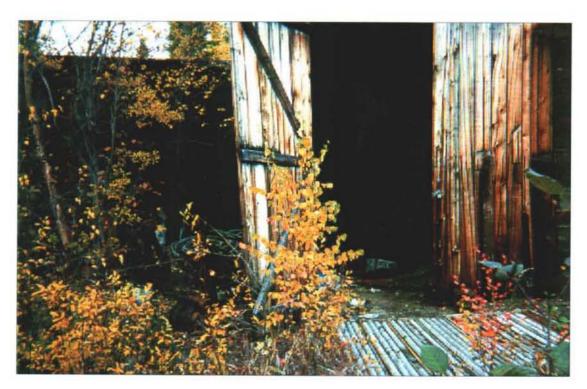
Photo 88-6: Dublin Gulch. Exploration Camp - equipment building & garage looking N.E.

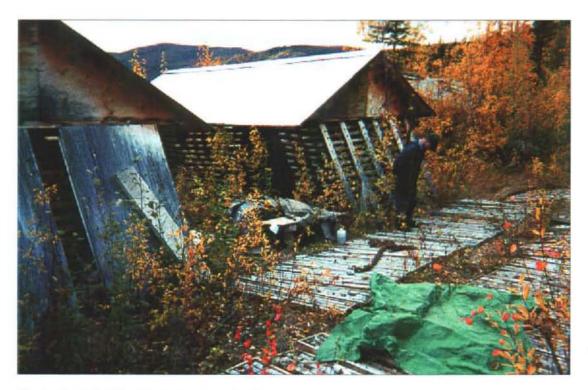
Photo 88-7: Dublin Gulch. Exploration Camp - core shack looking W.

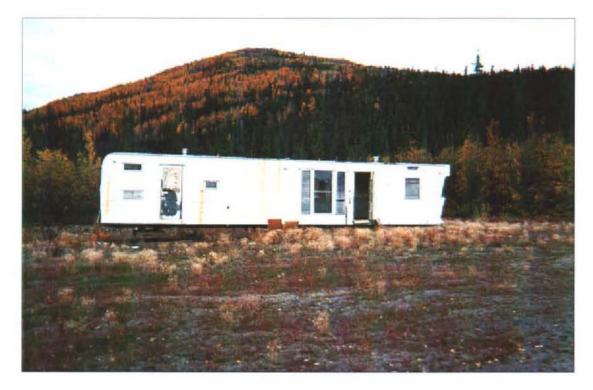
Photo 88-8: Dublin Gulch. Exploration Camp - trailer along access road - possibly used for placer mining (looking N.W.)

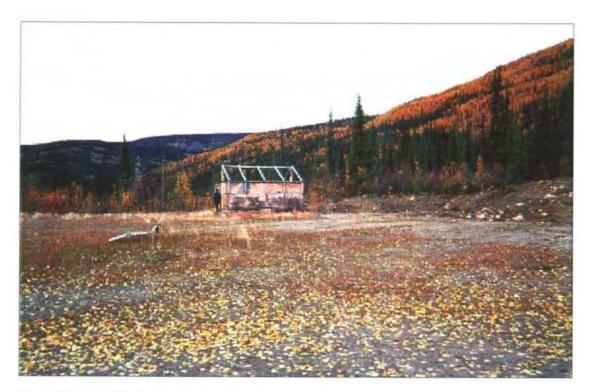
Photo 88-9: Dublin Gulch. Exploration Camp- tent frame near access road (looking N.W.).

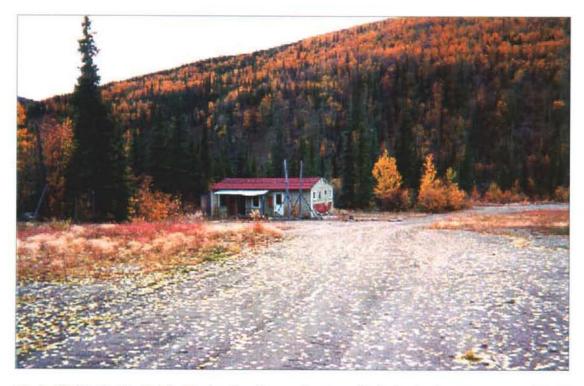
Photo 88-10 : Dublin Gulch. Exploration Camp - "watermellon" shack along access road (looking S.)

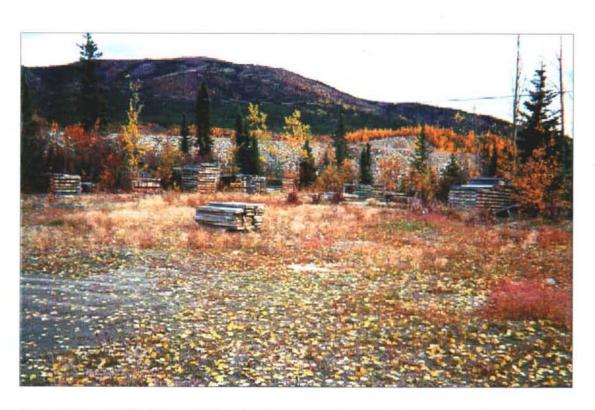
Photo 88-11: Dublin Gulch. Exploration Camp - core boxes along access road near "watermellon" shack.

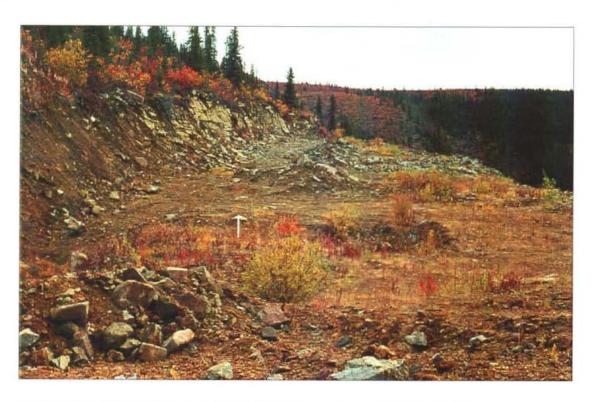
The site is located along the southwest side of a relatively-dry ridge straddling Olive Gulch, 400 m due southwest, and Bawn Bay Gulch, 600 m due northeast. Both gulches join Dublin Gulch to the northwest. The presence of permafrost soils could not be ascertained; however, the presence of smaller trees and the high elevation suggests the possibility of discontinuous permafrost (Photo 89-1).

Bulldozer trenching running for a short distance southeast off Dublin Gulch Road along slope, approximately 30 m up-slope from the suspected adit site. (Photos 89-1 and 89-3)

<u>Condition</u>: loose packed overburden; some natural re-colonization evident (see Photos 89-1,2 and 3); appears to be stable

Photo 89-1: Olive. Further along trench line from access road (looking S. E.).

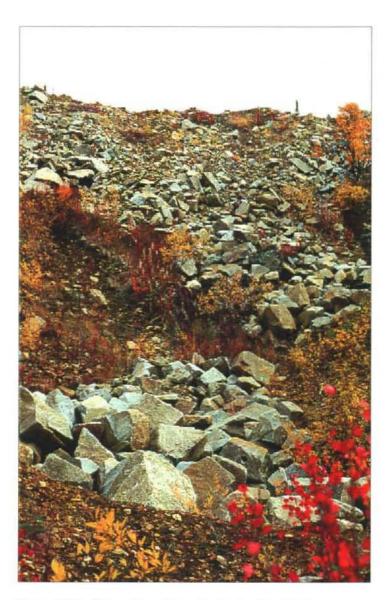
Possible adit site in dugout along side of northwest facing slope of Olive Gulch, approximately 50 m along an old access road from Dublin Gulch Road. The area was covered with large boulders concealing any visible adit opening (Photo 89-2).

Photo 89-2 : Olive. Possible adit site looking N. E.

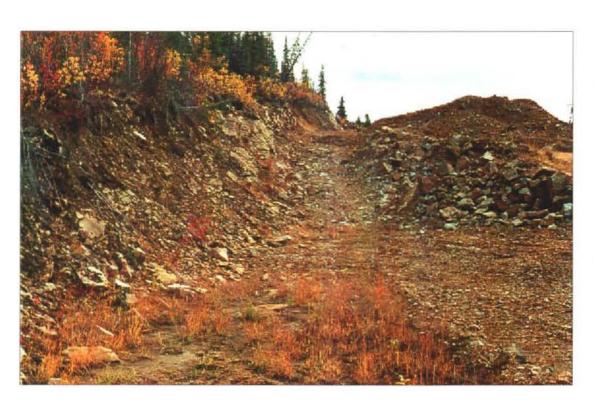
Photo 89-3: Trench line from access road looking S. E.

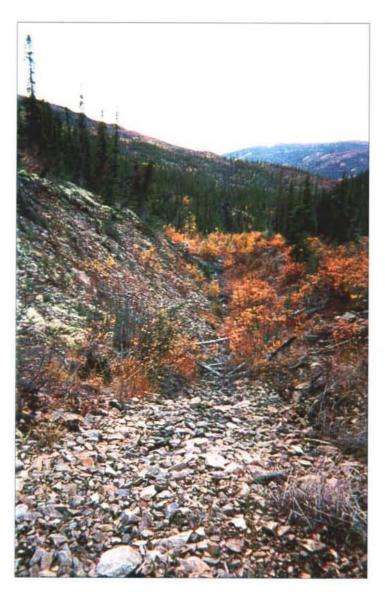
One large old bulldozer was located at the base of the south slope of Cascalleen Gulch, running southwest, near it's intersection with Bawn Bay Gulch. (Photo 90-1)

<u>Condition</u>: loose packed overburden; some natural re-colonization evident (see Photo 90-1); appears to be relatively stable and well away from any watercourses.

Photo 90-1 : Shamrock. Old trench along W. slope of Cascellan Gulch.

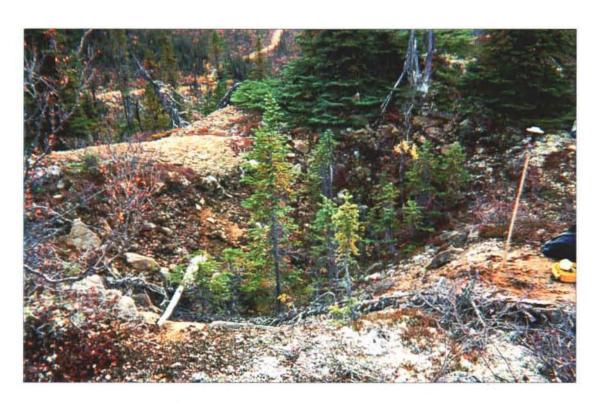
One small old hand dugout along the top of a ridge above the south slope of Cascallen Gulch (Photo 90-2).

Condition: loose packed soil and gravel; relatively stable and in a high, dry area well away from any watercourses.

Photo 90-2: Shamrock. Old 1914 trench along S. Ridge of Cascellan Gulch.

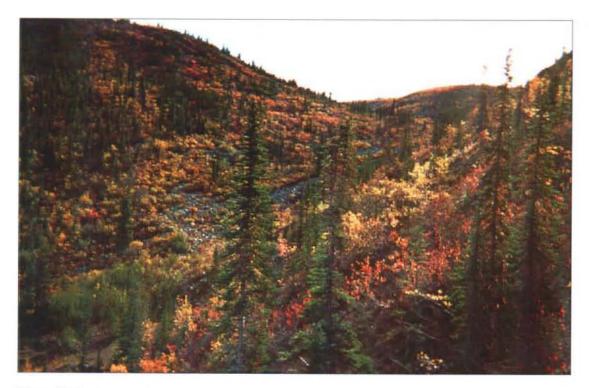
Photo 91-1: Stewart-Catto. View from hill looking at top of gulch upstream & east of site.

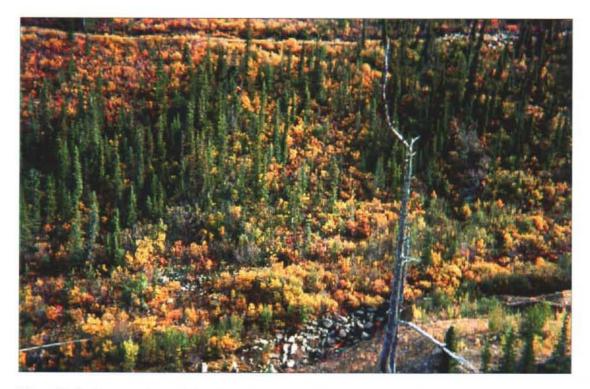
Photo 91-3: Stewart-Catto. View from hill looking E. Showing "upstream area" of camp site.

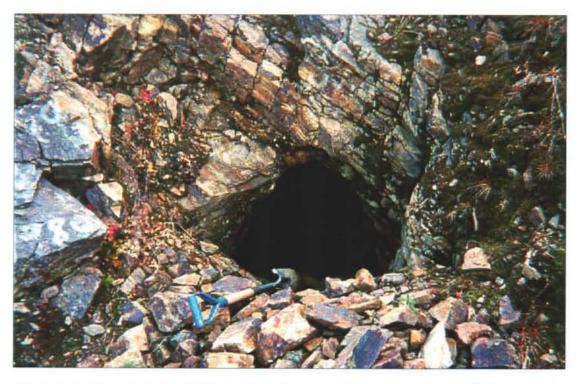
Photo 91-4: Stewart-Catto. Old1914 mine adit along old access road to top of hill.
