# KENO VALLEY/DUBLIN GULCH ENVIRONMENTAL BASELINE ASSESSMENT

VOLUME V: Keno Valley Sites #71 to #73, #75 to #81

Dublin Gulch Sites #85 to #86, #88 to #94, and #96

Prepared for Waste Management Program Indian and Northern Affairs Canada

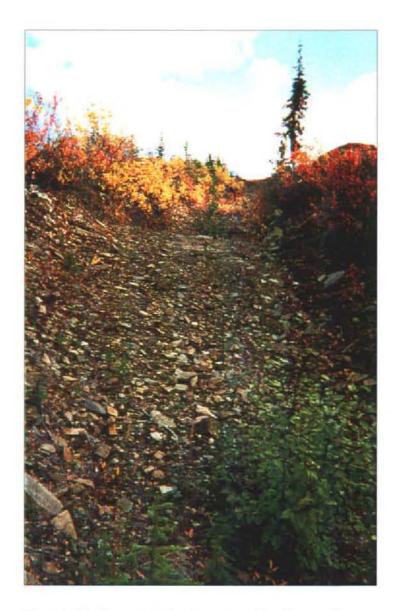
Condition: loose packed overburden; some natural re-colonization evident (see Photos 91-5 and 91-6); appear to be relatively stable

Natural revegetation is beginning to occur both in the trench areas above the adit (see Photo 91.5) and less disturbed areas around the camp site (see Photo 91-7). No evidence of any reclamation measures at this site aside from local salvaging operations.

Photo 91-5 : Stewart-Catto. Long trench looking upslope & S.W. to hill top.

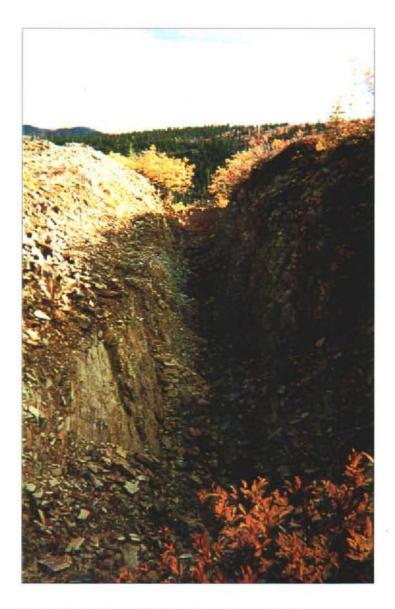
Photo 91-6 : Stewart-Catto. One of many bulldoze trenches near top of hill looking N.E.

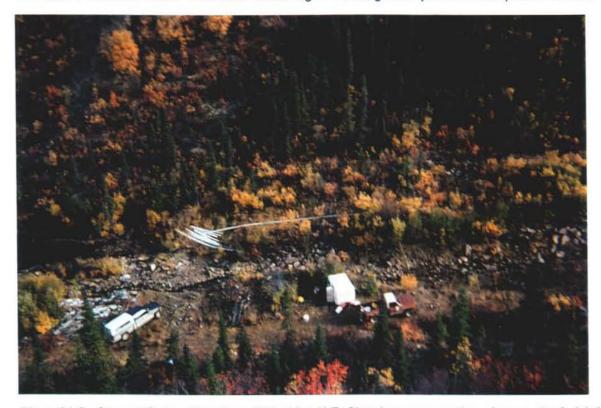
No apparent intact buildings, aside from two trailers being used as a camp for current placer mining and salvage activities (Photos 91-7 and 91-8). Two miners were camping on site at the time of the 1999 investigation. Two old, collapsing burned-out log cabins were located on the opposite side of the watercourse, in addition to an old demolished wood and siding building by the campsite along the southwest side of the watercourse.

No apparent waste dumps; however, wood and metal debris (pieces of mining equipment and siding) were scattered across the site. Some PVC piping was also recently piled on the opposite side of the watercourse from the camp (Photos 91-7 and 91-8).

Photo 91-8: Stewart-Catto. View from hill looking N.E. Showing upper portion of camp site & debris.

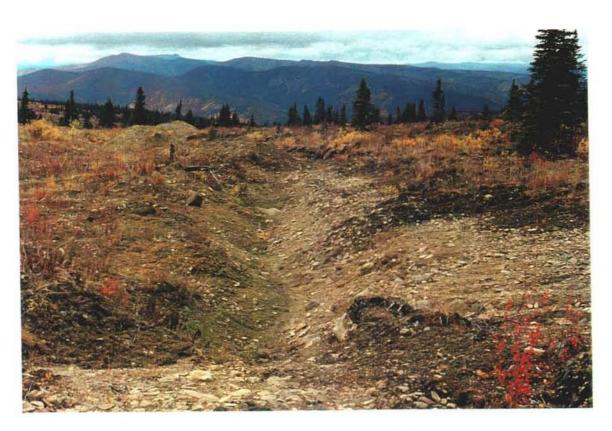
Small number of bulldozed trenches along the southwest side of Dublin Gulch Road (Photo 92-1).

Natural revegetation is beginning to occur in the trench areas and other disturbed locations of the site along Dublin Gulch Road (see Photo 92-1). No evidence of any reclamation measures at this site.

Photo 92-1 : Potato Hill (proper) showing extensive trench work along access road (over-burden) looking S.

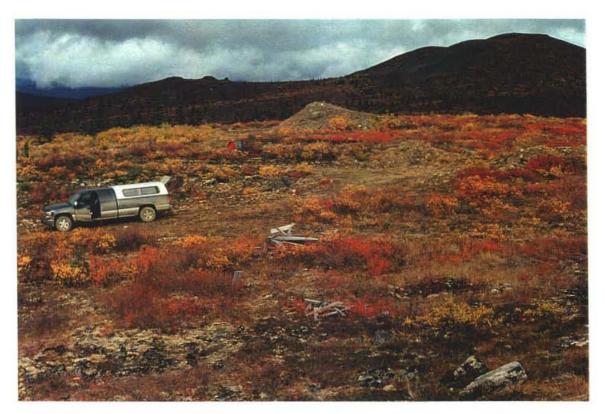
Location: Along Dublin Gulch road approximately 80 m northeast of surveying peak (see Photo 93-1).

Photo 93-1 : Garnet. Looking N. rom peak to camp debris, wash rock pile & Potato Hill (background).

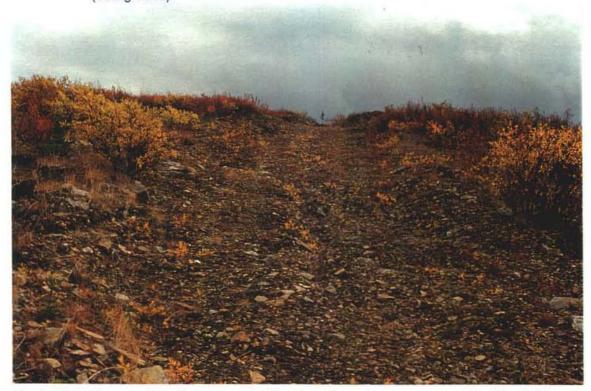
Photo 93-2: Garnet. One of numerous bulldoze trenches along access road (looking N.E.).

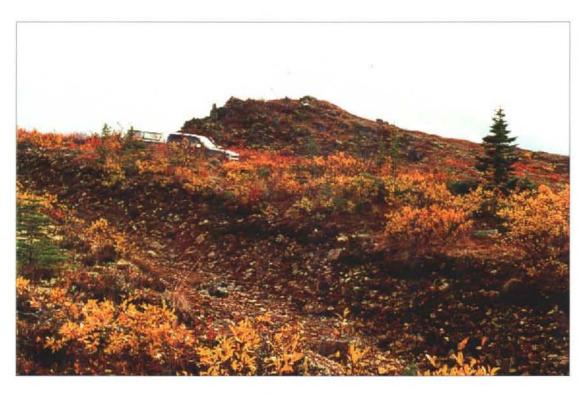
Photo 93-3: Garnet. Bulldoze trench along access road looking S.E. to peak.

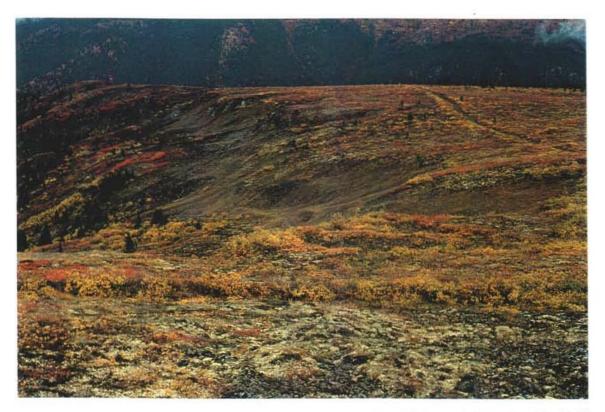
The site faces north to northwest along the top of a dry, unnamed gulch running north-northwest. This gulch eventually meets the beginning of Haggart Creek further to the north. The site is above the treeline, located in alpine tundra terrain with characteristic vegetation. Raised frost-heave areas, polygons and the high altitude suggest the presence of continuous permafrost in the area (Photo 94-1).

Two old bulldozed trenches from early 60's along the northeast slope of gulch approximately 1500 m down the side of the slope (Photos 94-1 and 94-2).

Photo 94-1: Potato Hill (Ellis). One of 1964 bulldoze trenches (3) (centre) #1 looking N. - N.W.

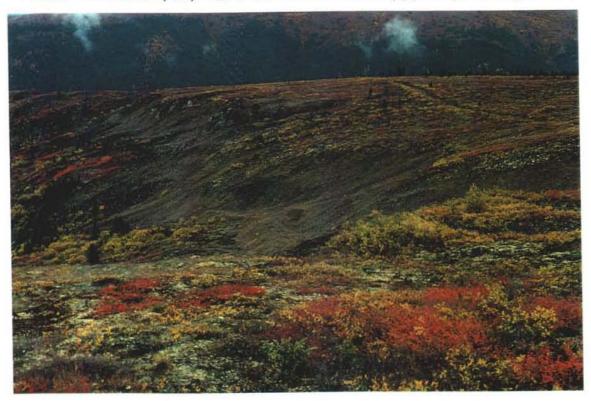
Waste rock was associated with trenching along the northeast slope of gulch (see Photo 94-2). This was limited to soil overburden and a limited volume of host rock as well as quartz vein material for the trenches along the northeastern slope. There was no evidence of sulphide mineralization in the associated waste rock.

Photo 94-2 : Potato Hill. One of 1964 bulldoze trenches (centre) #1 looking N. - N.W. from access trail.

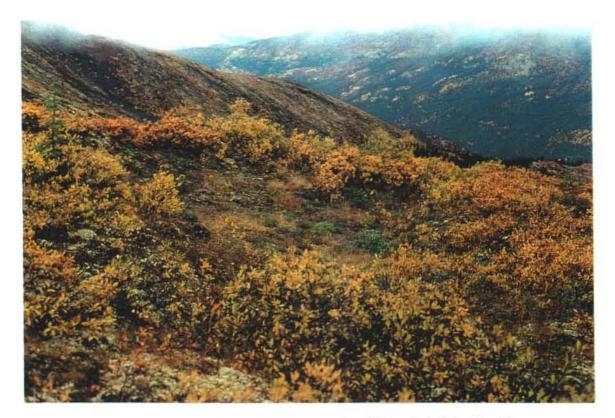
Two old bulldozed trenches from early 60's at top of gulch along access trail at 45 degree angles from each other leading north and north-northeast (Photo 94-3 and 94-4).

Photo 94-3: Potato Hill. One of 1964 bulldoze trenches (3) (centre) #2 looking W.

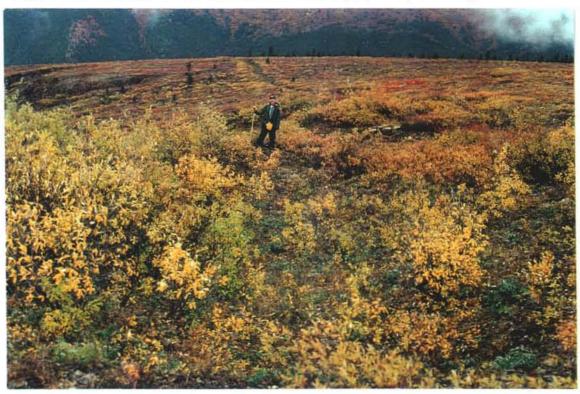
Photo 94-4: Potato Hill. One of 1964 bulldoze trenches (3) (centre) #3 looking E. (upslope).
