**RAILWAY INVESTIGATION REPORT
R07V0109**

NON-MAIN-TRACK TRAIN DERAILMENT

**KOOTENAY VALLEY RAILWAY (KVR)
0700 TRAIL YARD ASSIGNMENT
MILE 19.0, ROSSLAND SUBDIVISION
TRAIL, BRITISH COLUMBIA
23 APRIL 2007**

Report Number R07V0109

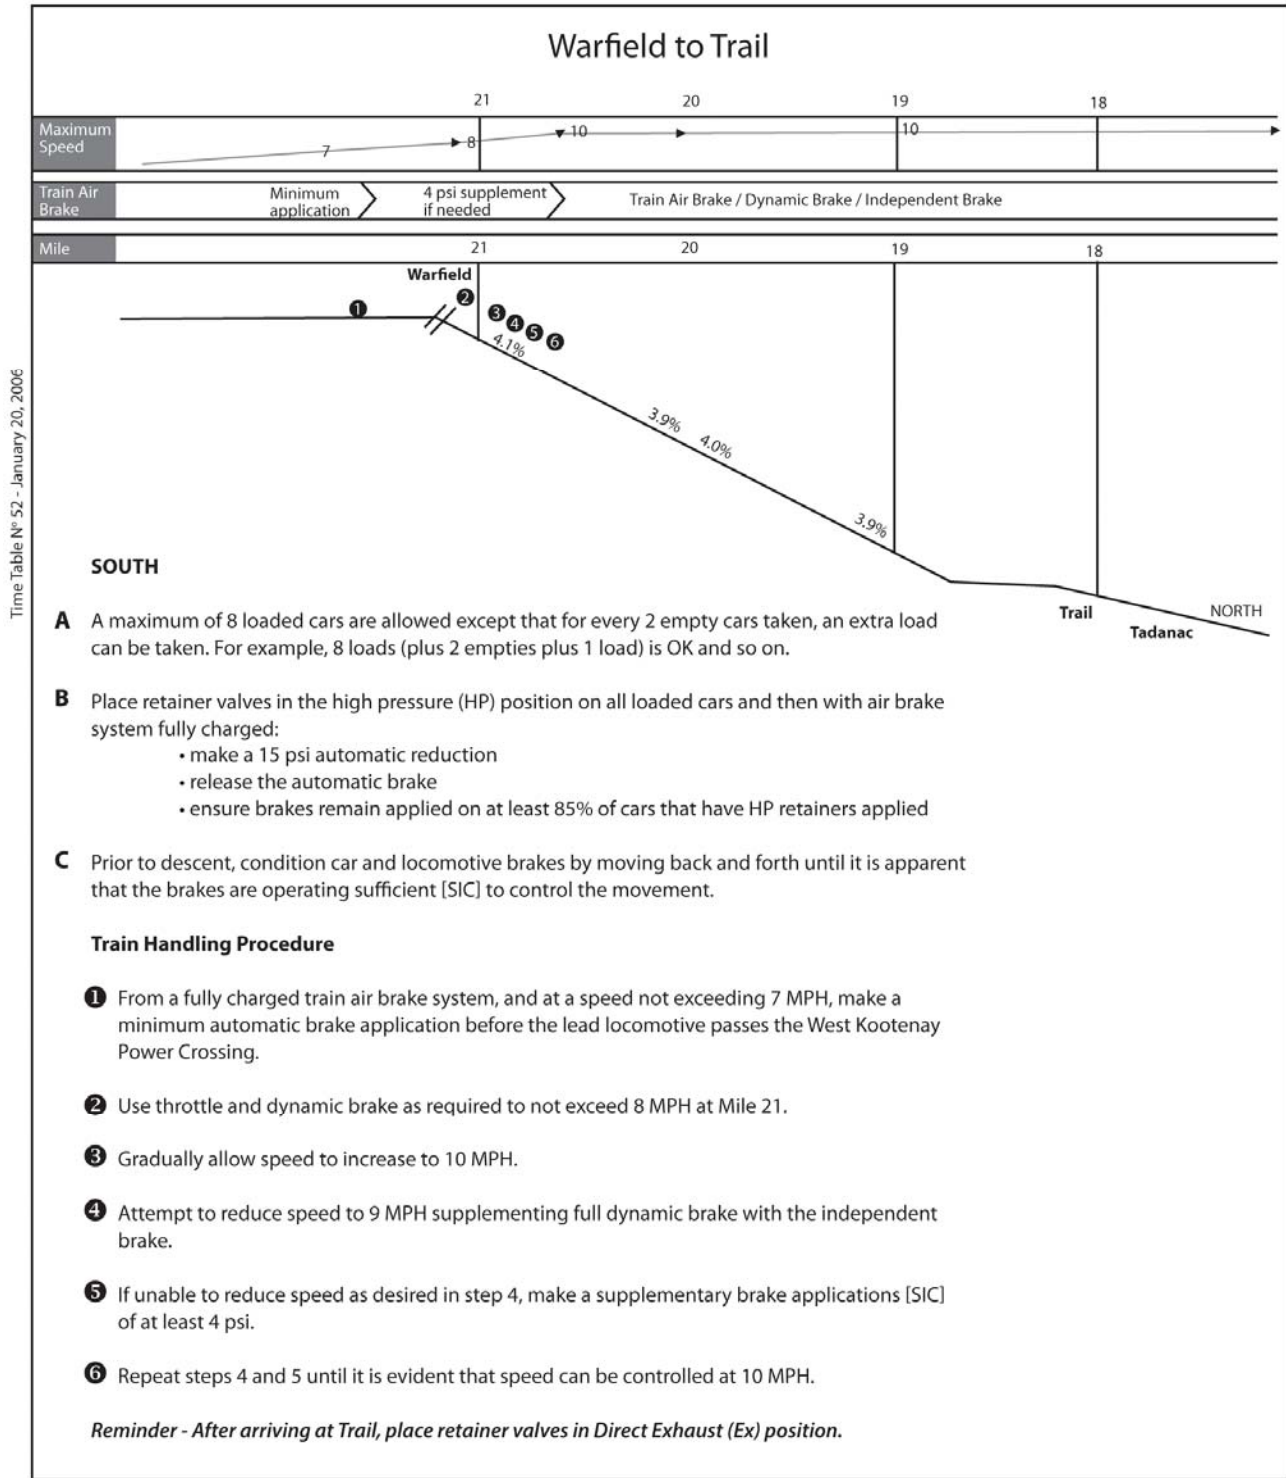
Figure 3. CPR's Train-Handling Procedures

CPR Timetable 52, for the British Columbia Interior Service Area, contains specific operating instructions and train-handling procedures for trains descending Warfield Hill (see Figure 3). These procedures specify the locations and actions that must be taken on the grade and are the most restrictive on any trackage in the CPR system. Compliance using dynamic braking, supplemented by air brakes, to control train speed is intended to avoid brake shoe friction fade and to prevent uncontrolled movements.
