**RAILWAY INVESTIGATION REPORT  
R08W0058**

**MAIN-TRACK COLLISION AND DERAILMENT**

**CANADIAN PACIFIC RAILWAY  
FREIGHT TRAINS 498, 497, AND 292  
MILE 97.5, WEYBURN SUBDIVISION  
CENTENNIAL STATION, NEAR RALPH, SASKATCHEWAN  
07 APRIL 2008**

Report Number R08W0058

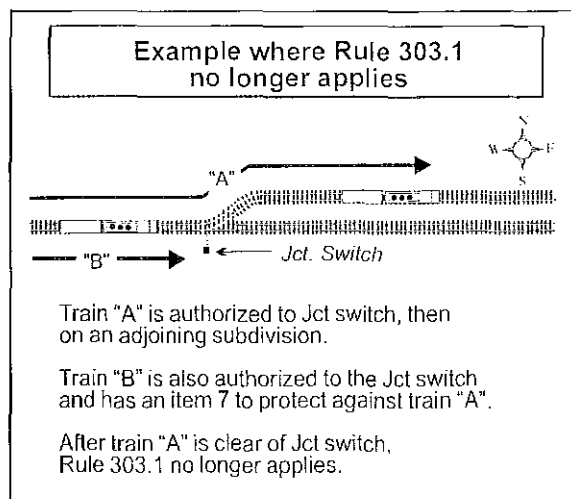
Examples: “Borden” cannot be used.

“Station Name Sign Borden”, “East siding switch Borden”, etc. must be used instead. The following diagram illustrates the application of the note in Rule 303.1.
