RAILWAY INVESTIGATION REPORT R12V0008

COLLISION BETWEEN A TRAIN AND A TRACK UNIT

**CANADIAN NATIONAL RAILWAY
TRAIN A41651 13 AND
TRACK UNIT 075765
MILE 14.5, CLEARWATER SUBDIVISION
MESSITER, BRITISH COLUMBIA
14 JANUARY 2012**

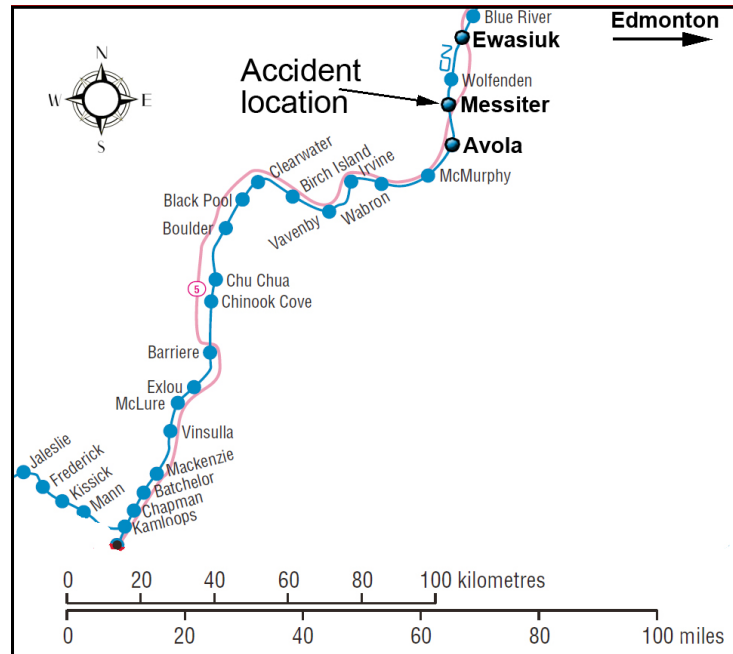
Figure 1. Accident location

At approximately 0230¹ on 14 January 2012, a signal maintainer (the foreman) was called to repair a malfunctioning signal at Mile 13.3 of the Clearwater Subdivision, near Messiter, British Columbia (Figure 1). To perform this work, the foreman required access to the signal bungalow situated near Mile 14.5.

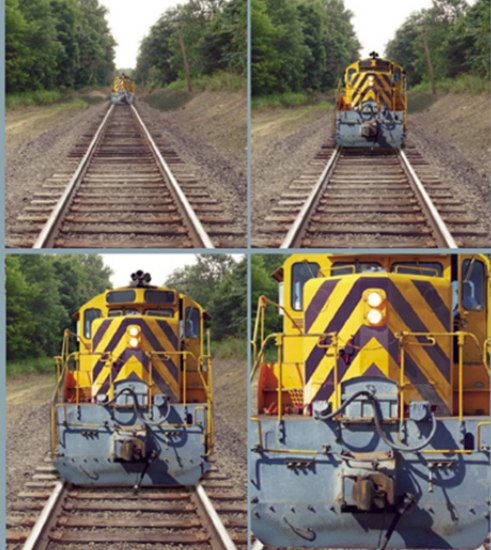
MAINTENANCE-OF-WAY SAFETY SYSTEM
Track-Watch Providing Advanced Warning Of Oncoming Rail Traffic

In the United States, some railroads (e.g., Union Pacific Railroad) use a system called Track Watch (Figure 3) to provide employees working on the track with advance warning of approaching trains. The system employs an optical track-mounted proximity device to detect the passing of a train. The system then sends a signal to a portable repeater, which relays the signal to personal receivers worn by each track worker. When a train is detected, the personal receiver device emits a loud audible alarm, a vibration alert, and a flashing light signal. There is also an optional track-side warning system which incorporates dual warning sirens and a strobe light. When operating in difficult terrain, a signal repeater can be used to increase the system's range.
