**AVIATION INVESTIGATION REPORT  
A12C0099**

**LOSS OF CONTROL AND COLLISION WITH TERRAIN**

**CESSNA 180G, N4695U  
TROUT LAKE, ONTARIO  
01 AUGUST 2012**

Report Number A12C0099

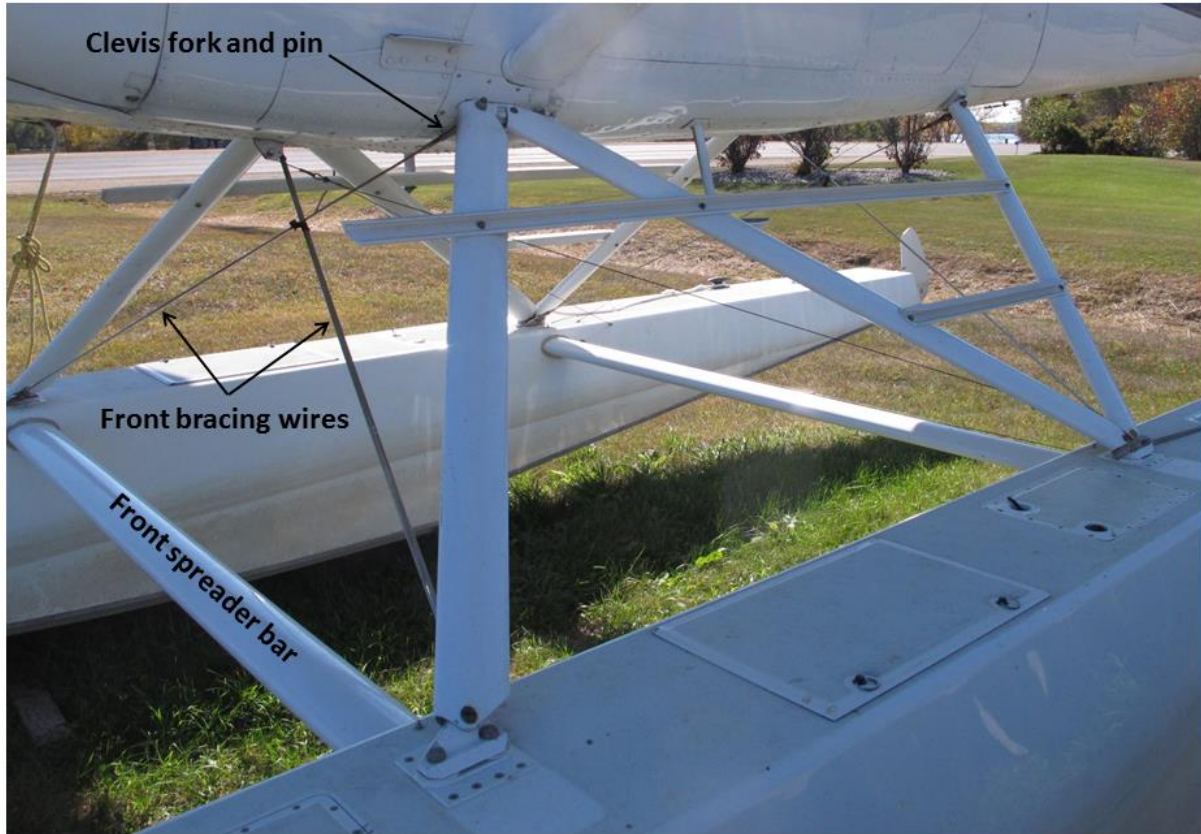
Photo 3. Exemplar strut assembly

The Aqua float design does not use horizontal boxing wires between the spreader bars. Forward and aft pairs of bracing wires cross diagonally from side to side to take up flight loads and keep the floats in alignment (Photo 3). The streamlined bracing wires are formed with left-hand and right-hand threads that allow adjustment by loosening jam nuts and rotating the wire, in half-turn increments, to maintain a streamlined alignment. The bracing wires terminate at a clevis fork connected to their respective fittings by a clevis pin secured with a washer and a cotter key (Photo 4).

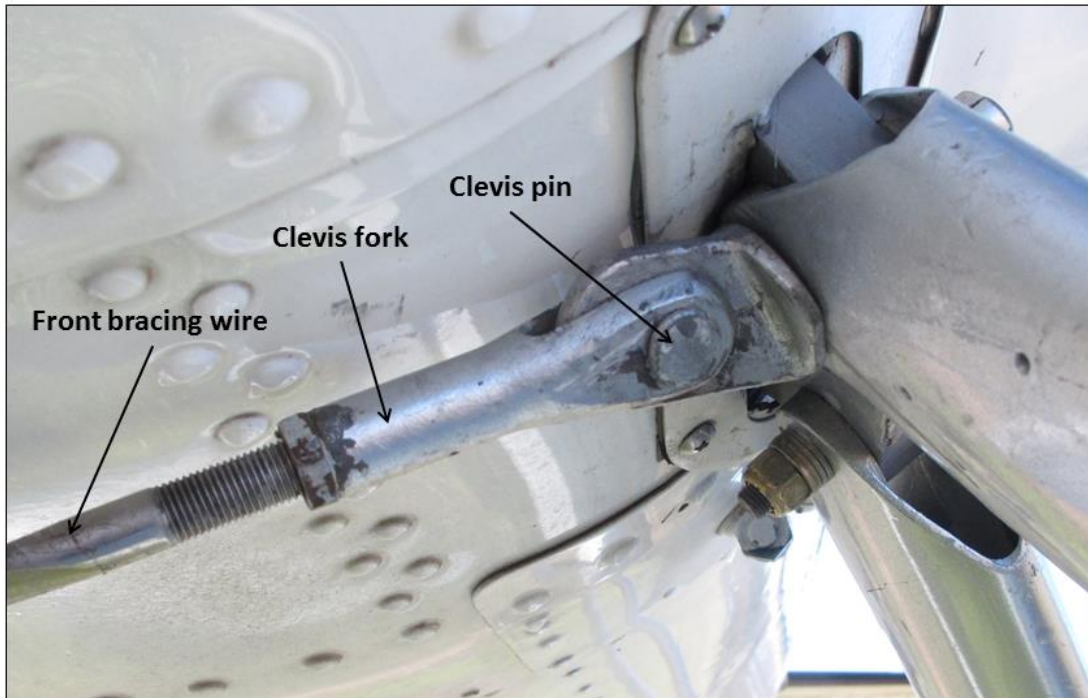
Photo 4. Exemplar clevis fork assembly

The orientation of the clevis pins and positioning of washers was not consistent at the various locations on the float installation. In some locations, such as the lower-aft left bracing wire attachment, the clevis pin was installed with the head down. The clevis pin on the right landing-gear attachment was installed with the head up and aft. It is common industry practice to install the clevis pin in this location with the head down and forward; however, the cotter key is hard to see in this orientation. The orientation of the missing clevis pin could not be determined. All of the bracing wires except one remained attached to their respective fittings. The bracing wire that had been connected between the right-front float fitting and the left landing-gear adapter was found lying loose in the wreckage. The lower clevis fork still retained the clevis pin, washers, and cotter key, and had been torn from the right-front float fitting wire-pull.
