**RAILWAY INVESTIGATION REPORT  
R13D0054**

**RUNAWAY AND MAIN-TRACK DERAILMENT**

**MONTREAL, MAINE & ATLANTIC RAILWAY  
FREIGHT TRAIN MMA-002  
MILE 0.23, SHERBROOKE SUBDIVISION  
LAC-MÉGANTIC, QUEBEC  
06 JULY 2013**

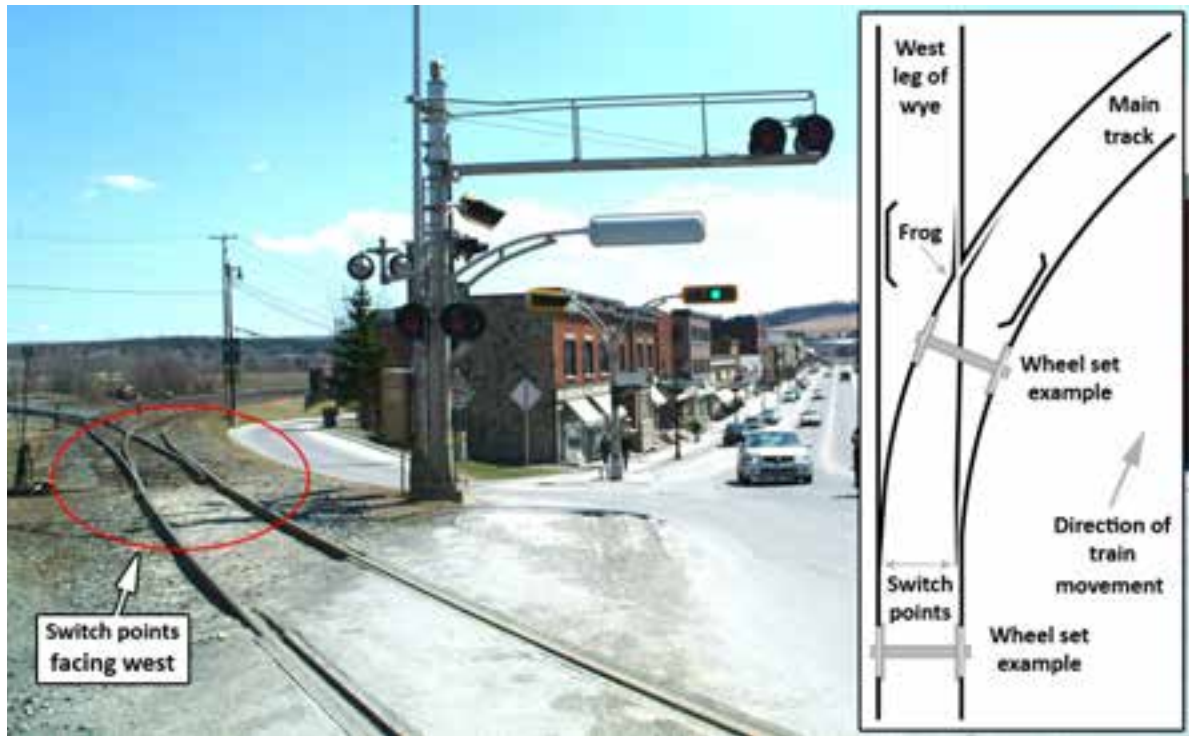
The MMA Megantic Station was located in a commercial district of Lac-Mégantic, where the Sherbrooke and Moosehead Subdivisions met. Frontenac Street, a main thoroughfare, ran through the centre of the town. The main track intersected with Frontenac Street just west of the Megantic West turnout and was maintained for a maximum speed of 15 mph. The turnout was located at Mile 0.23, with the switch points facing west (Photo 4).

Photo 4. Frontenac Street public grade crossing, looking eastward. The circled area denotes the location of the switch points and the frog for the Megantic West turnout (photo: Pierre Blondin, with TSB annotations).

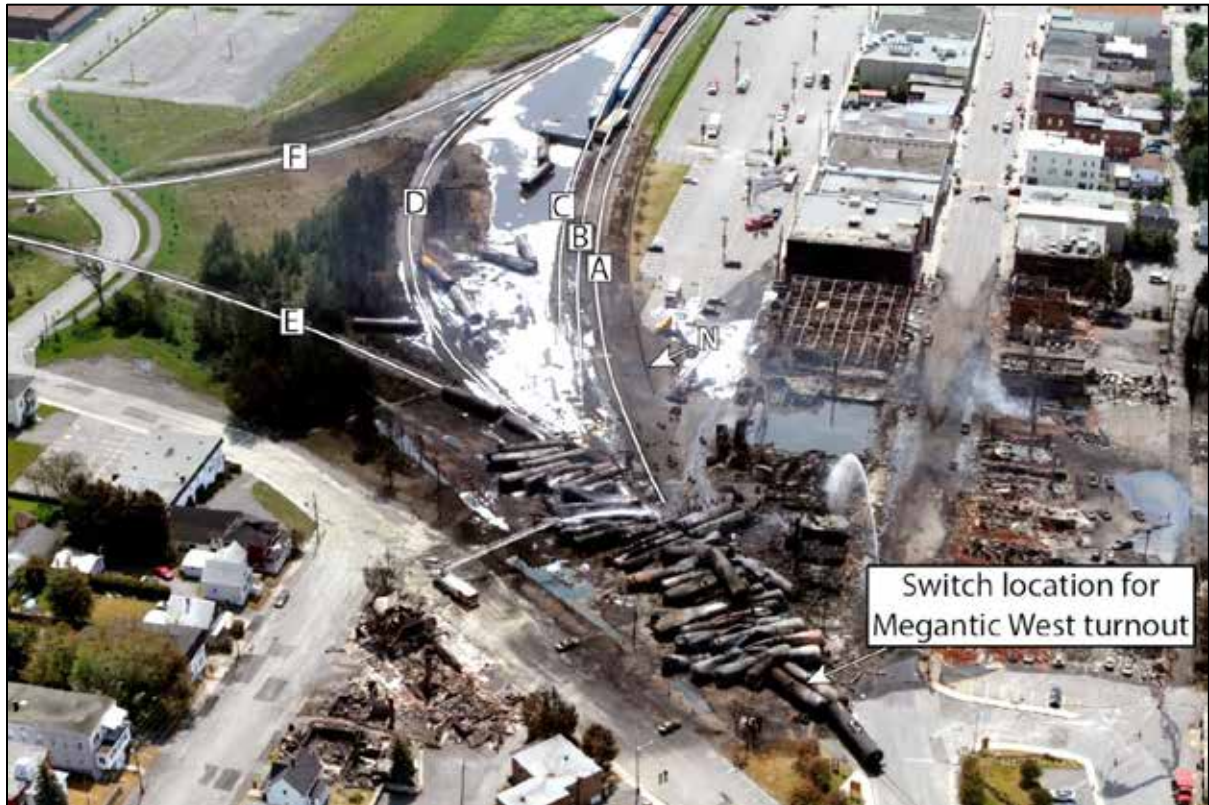
The derailed equipment covered the main track, 3 adjacent yard tracks, and the west leg of the wye, which is a triangular arrangement of tracks that can be used for turning rail equipment (Photo 5).<sup>11</sup> At the time of the accident, there were box cars parked in yard tracks 1 and 2.

Photo 5. Eastward view of the location of the tracks in relation to the first derailed cars: main track (A), yard track 1 (B), yard track 2 (C), yard track 3 (D), and the west and east legs of the wye tracks (E and F)

- The damage to the main track started approximately 20 feet east of Frontenac Street.
- The main-track turnout, approximately 400 feet of main track, and an additional 2000 feet of yard and wye tracks, including 3 turnouts, were destroyed.
- Approximately 500 feet from the crossing, the main track was shifted about 4 feet to the north.
- Yard tracks 1 and 2 were demolished from the west-end turnout for about 600 and 500 feet, respectively.
- Rails were curled and twisted, unsettled from tie plates, and moved randomly. Due to the severity of the fire, most track components were badly damaged.
- The Frontenac Street southeast public-crossing cantilever mast and the control box were shattered. Road traffic lights, electrical wires, lighting posts, and other appliances were also damaged.

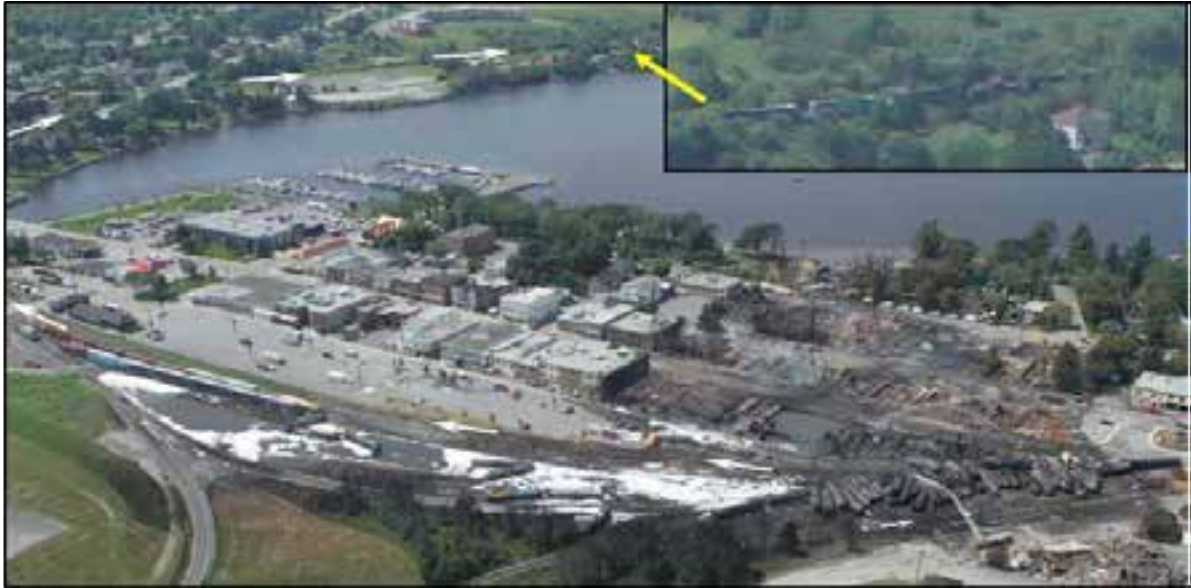
Photo 6. Location of the locomotive consist (Mile 116.41 of the Moosehead Subdivision) in relation to the derailment site. The white arrows denote the route of the locomotive consist, which followed the main track.

- There was no damage to the track between the derailment site and the location of the locomotives.
- There was a black oily residue, similar to the residue observed at Nantes, on the ground adjacent to the lead locomotive (MMA 5017), as well as about 600 feet east of where the locomotives came to rest.

- Hand brakes were applied on all 5 locomotives and the VB car.
- There was severe wear on some of the brake shoes and various degrees of blueing<sup>12</sup> on most of the wheels.

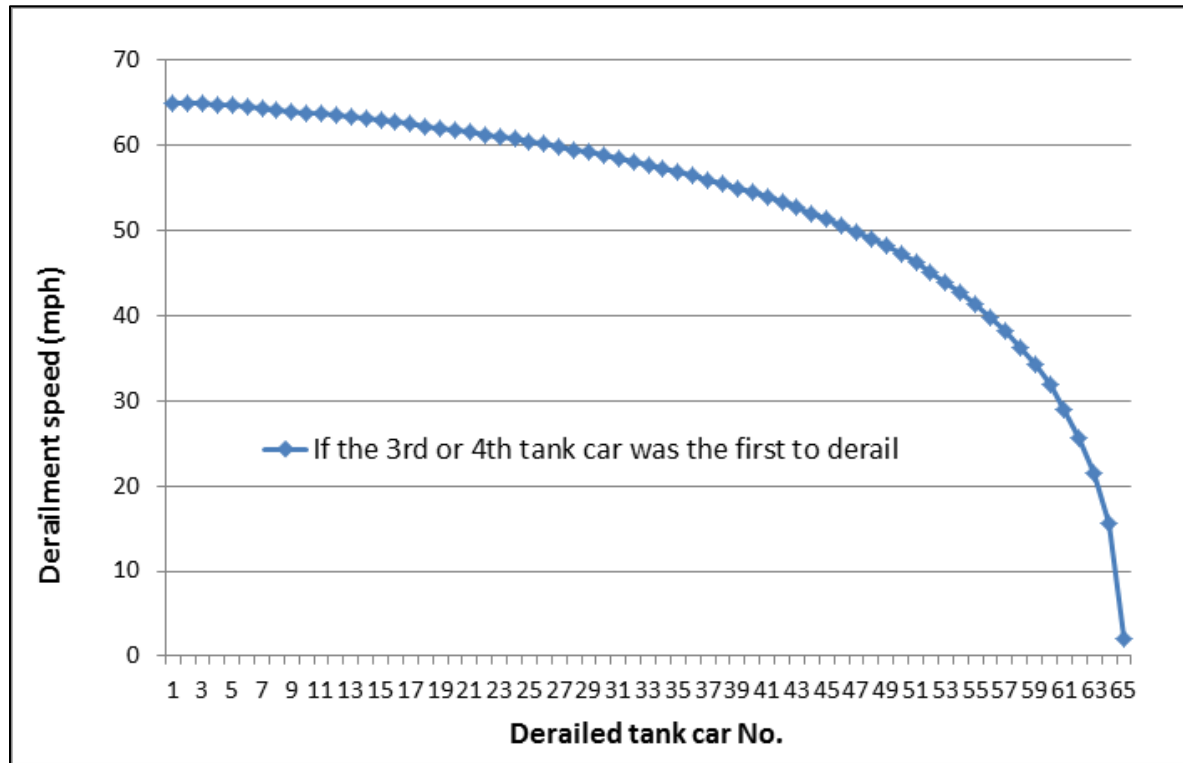
Figure 5. Estimated speed at which each car derailed if the third or fourth car was the first to derail<sup>32</sup>

At the time of the derailment, the train was near the Megantic West turnout. The train was analyzed to assess the in-train forces as it transitioned from the downhill grade of 1.26% to the relatively flat terrain of 0.2% at Megantic. A vehicle dynamics simulation of a Class 111 tank car negotiating the curve at Megantic Station was also conducted (see Engineering Laboratory Report LP188/2013 for complete details). It was determined that a combination of the centrifugal force and the dynamic forces generated by the track geometry conditions at a speed of 65 mph was sufficient to cause the derailment. With extremely high lateral forces on the high rail, gauge widening could occur. Furthermore, with complete unloading on the low rail, wheel lift could occur. Either of these conditions or a combination could cause track damage and a derailment.

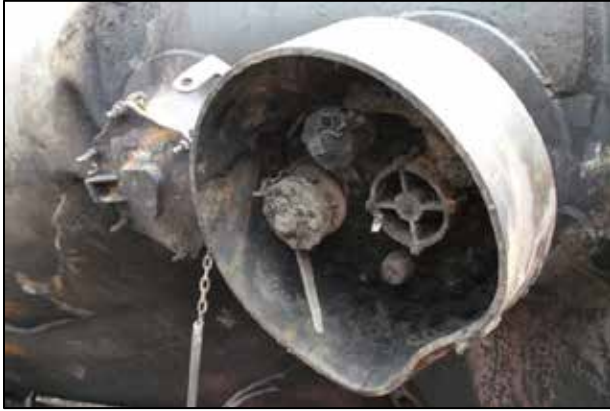
The top fittings of 32 of the 63 tank cars were housed in a  $\frac{3}{4}$ -inch-thick steel circular protective housing designed to provide top discontinuity protection in accordance with applicable AAR requirements<sup>40</sup> (Photo 21).

Photo 21. Protective housing providing top discontinuity protection for tank car fittings (removed cover)

- The top fittings were breached on 4 of the 27 cars (15%) that were equipped with top discontinuity protection housings and that sustained impact damage.
- The top fittings were breached on 16 of the 26 cars (62%) that were equipped with a hinged housing and that sustained impact damage.

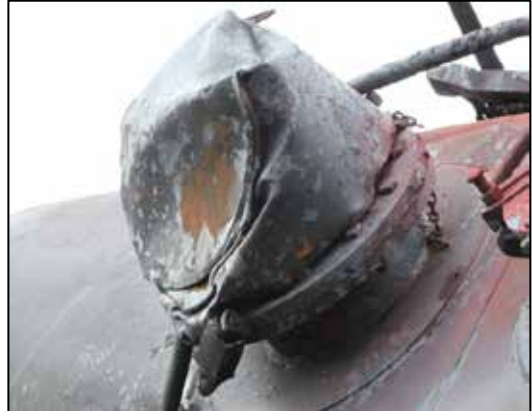
The top fittings of the remaining 31 tank cars were located in a hinged housing that did not have to meet any of the top discontinuity protection requirements (Photo 22).

Photo 22. Hinged housing for tank car fittings

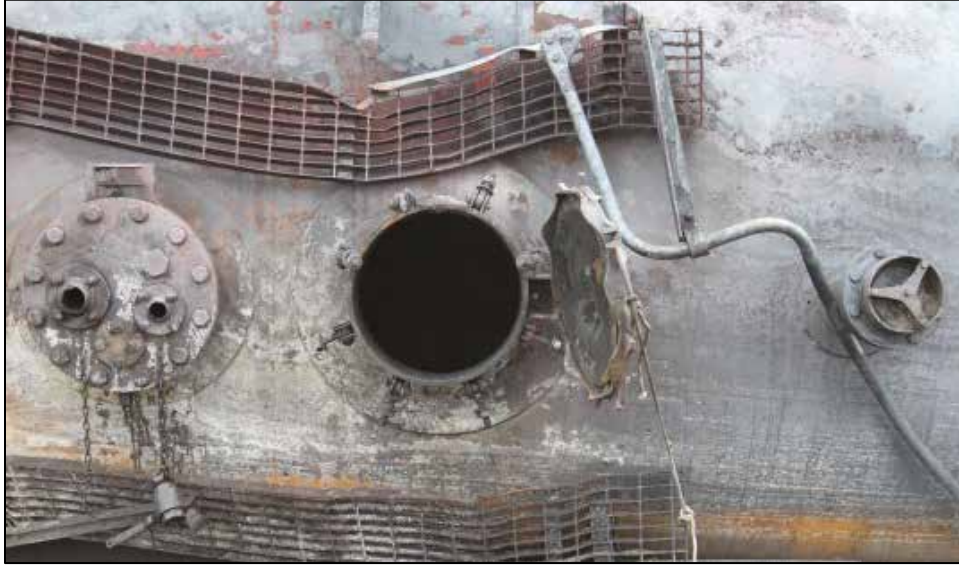
- The manway gaskets on most of the derailed tank cars were damaged by extended exposure to the post-derailment fire.
- The manway cover of 2 cars had separated as a result of impact damage.
- The manway cover hinges, bolts, or lugs of 22 tank cars exhibited impact damage that may have compromised their seals.

Photo 23. Manway cover and opening

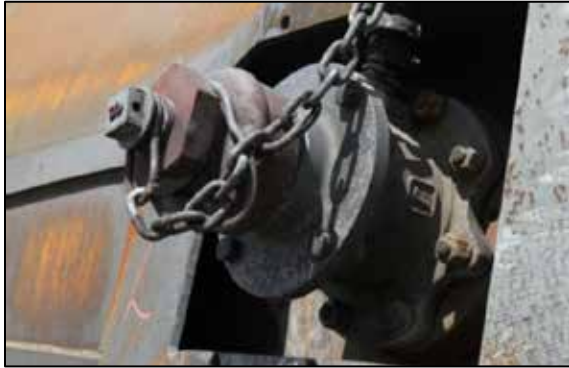
- There were 36 tank cars with sheared-off BOV nozzles (Photo 26).
- Seven of these tank cars had damaged or missing BOV handles, resulting in the ball valve being open or partially open, which led to a release of product.
- Six tank cars were equipped with internal plug-type BOVs. None of these BOVs were breached.
- The BOV handle assemblies of 43 tank cars were deformed, impact-damaged, or missing.

Photo 25. Bottom outlet valve

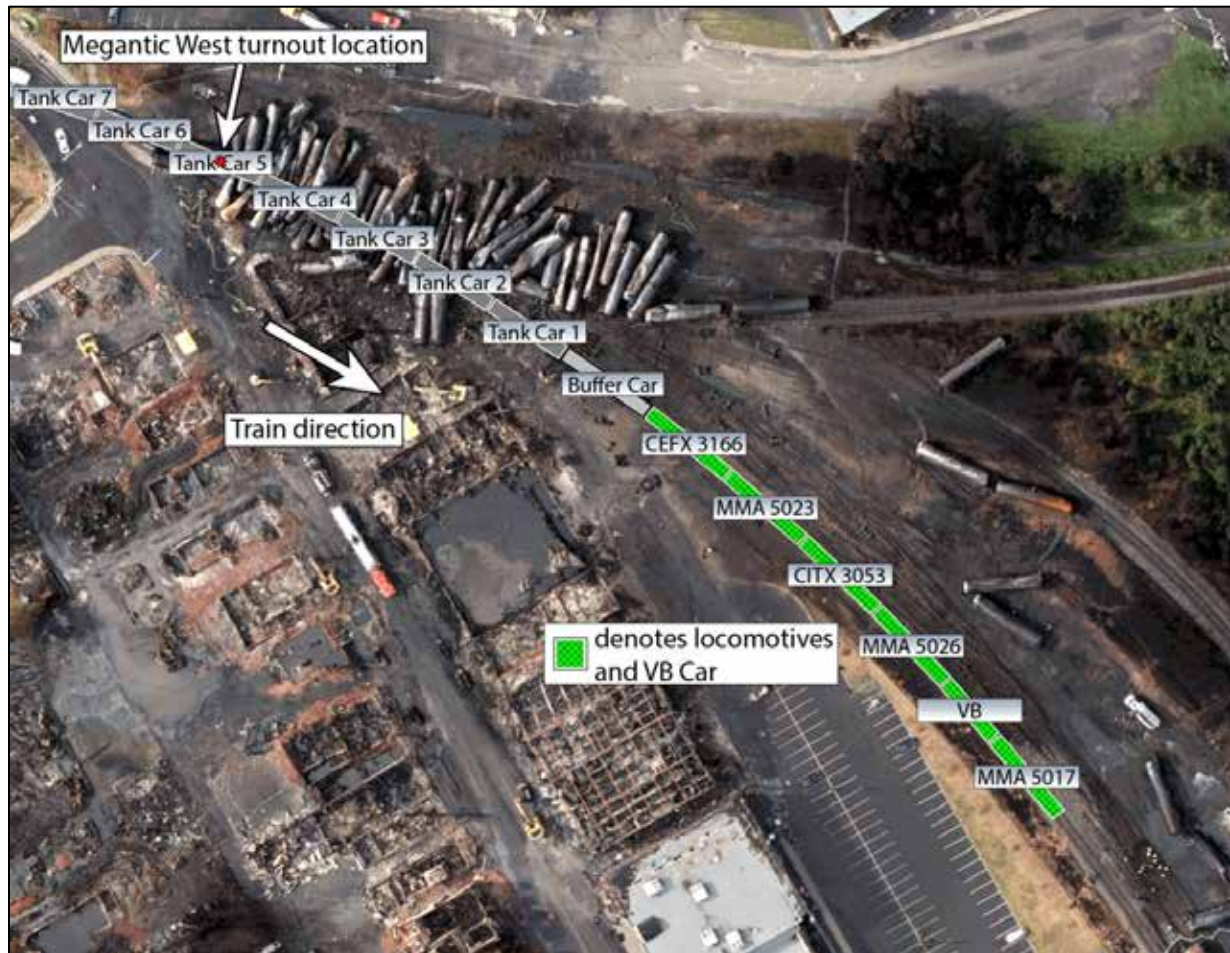
The general trajectory of the derailed equipment also confirmed that the point of derailment (POD) was at or near the Megantic West turnout. To determine which cars were most likely the first to derail, the TSB analyzed LER information to establish the locations of the cars when the brake pipe pressure dropped to zero, as this indicated the moment of separation caused by the derailed equipment. Results show that tank cars 4 through 6 were closest to the POD at that time (Photo 29).

Photo 29. Location of the train when the brake pipe pressure dropped to 0 psi (sources: AeroPhoto and locomotive event recorder data)

An examination of the damage and of the final resting locations of the first derailed cars, starting from the front of the train, allowed the investigation to conclude that the derailment most likely occurred ahead of the sixth tank car.

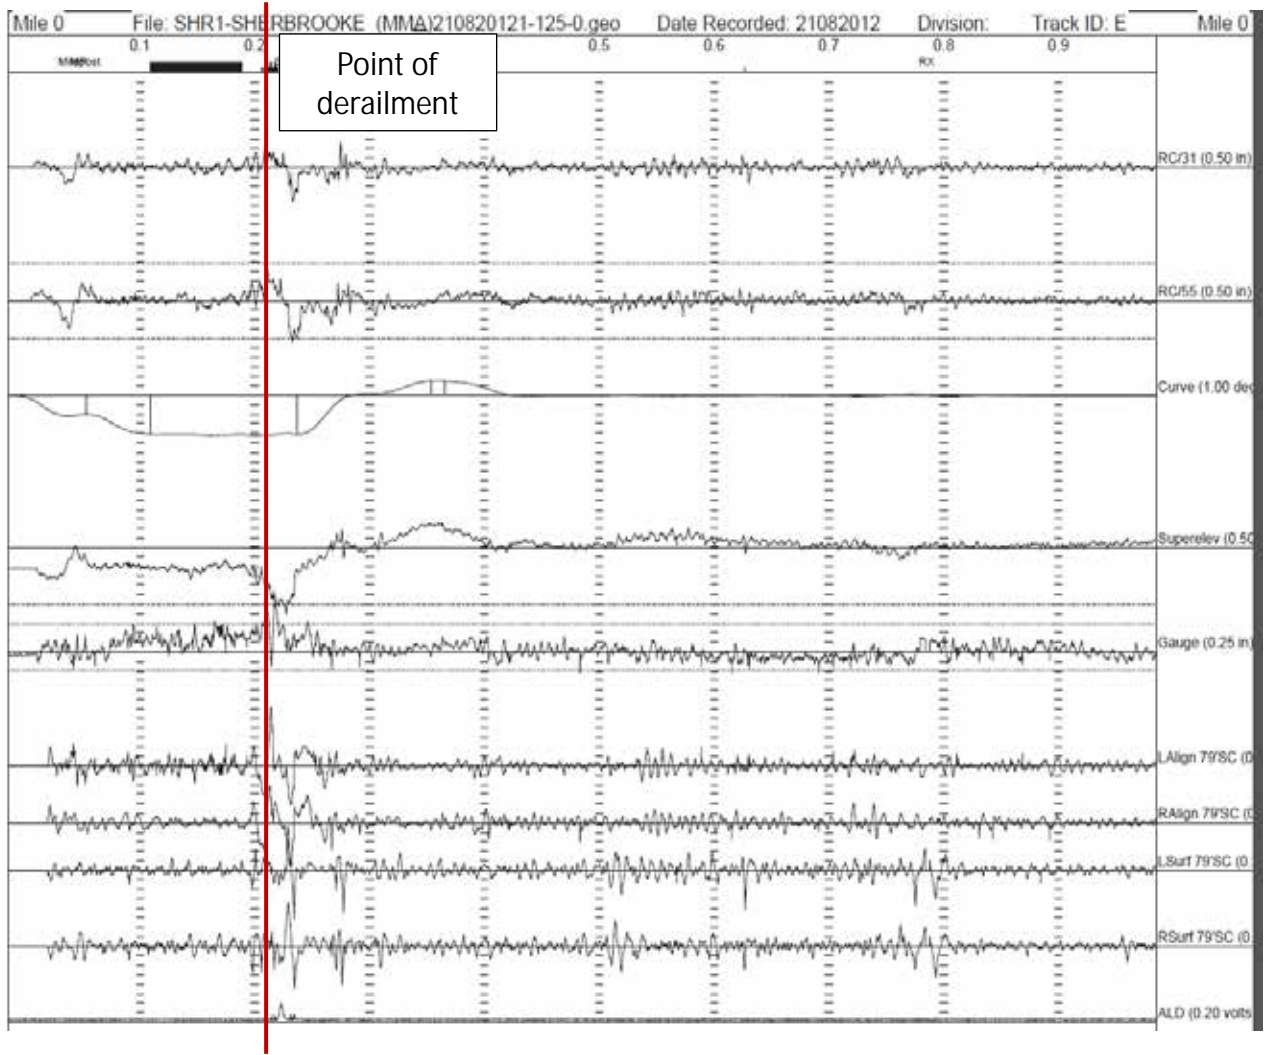
*Appendix E – Track geometry inspection of the Montreal, Maine & Atlantic Railway Sherbrooke Subdivision, between Mile 0.0 and Mile 1.0 (21 August 2012)<sup>159</sup>*
