Transportation Safety Board  
of Canada

**MARINE INVESTIGATION REPORT  
M13N0014**

**CAPSIZING OF TOW AND ACCIDENTAL DEATH  
TUG *WESTERN TUGGER* AND BARGE *ARCTIC LIFT I*  
33 NAUTICAL MILES SOUTHWEST OF BURGEO,  
NEWFOUNDLAND AND LABRADOR  
10 MAY 2013**

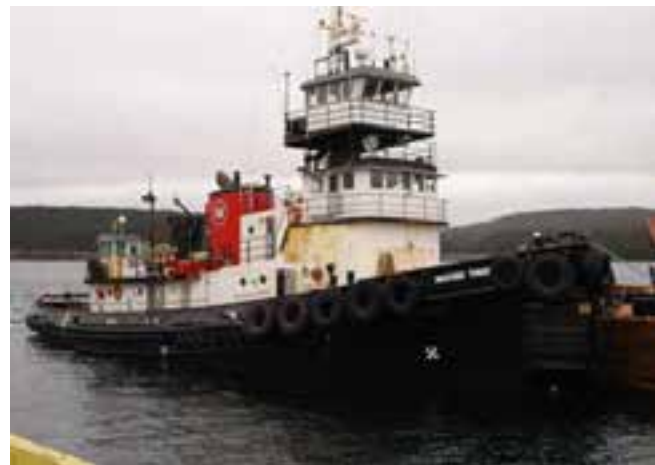
Photo 2. The *Western Tugger*

The *Western Tugger* is a coastal tug of steel construction that was built in 1943 and purchased by the current owner in 2007 (Photo 2). The vessel has a single propeller and rudder. The conning station, located in the wheelhouse that sits atop the deckhouse, is fitted with navigational equipment including radars, a very high frequency (VHF) radiotelephone, a global positioning system (GPS), an automatic identification system, an electronic chart plotter, and an autopilot. The deckhouse includes a galley, storerooms, and accommodations.
