RAILWAY INVESTIGATION REPORT

R16C0012

Non-main-track derailment

Canadian Pacific Railway

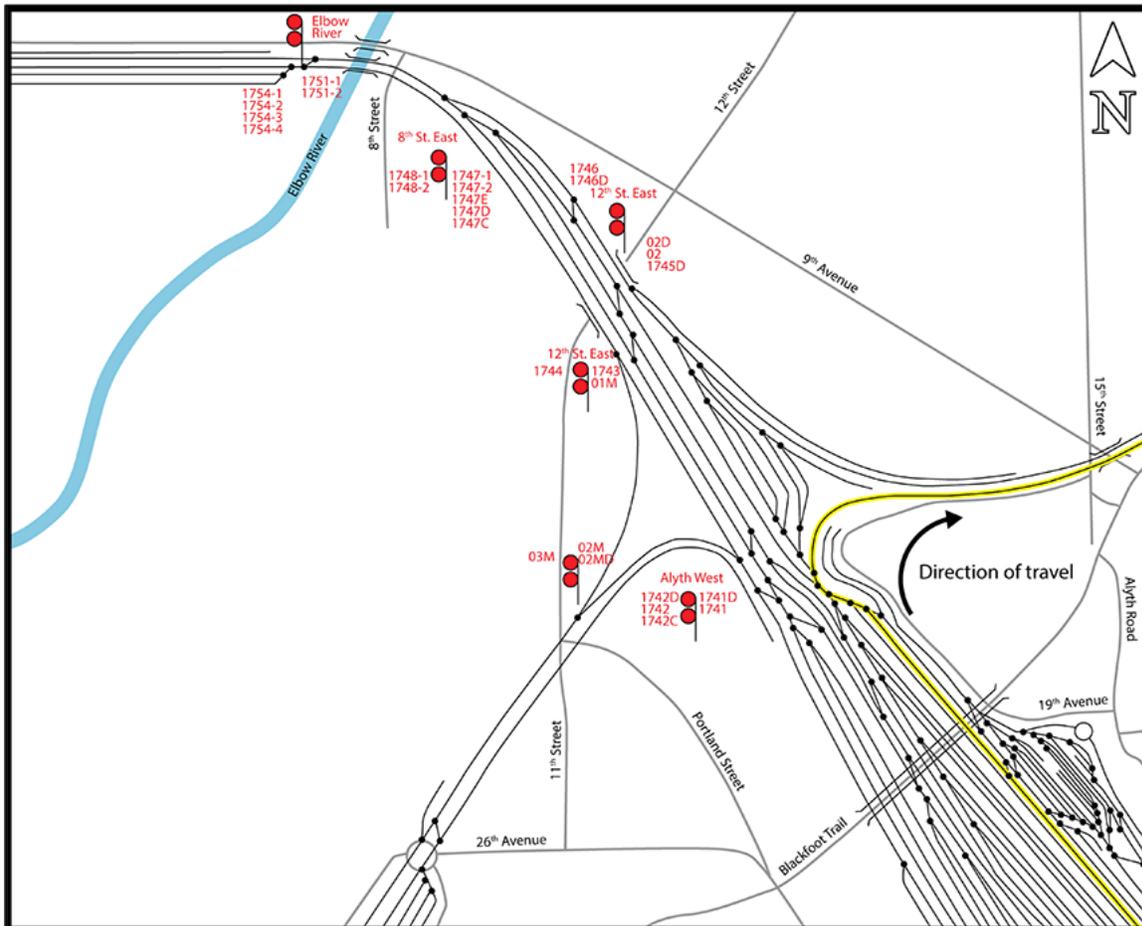
The train proceeded through track N14 and through the east leg of the north wye² (Figure 2) toward Bengal on the Red Deer Subdivision to facilitate the set-off.

Figure 2. Path (highlighted in yellow) of the train through track N14 and the east leg of the north wye (Source: Canadian Pacific Railway, with TSB annotations)

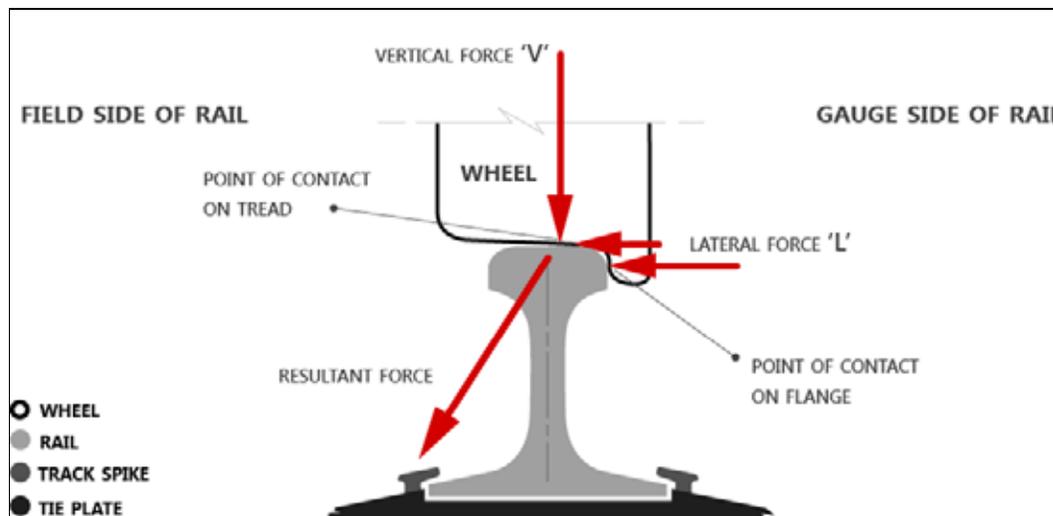
A combination of lateral (L) and vertical (V) forces exists at the wheel-rail interface (Figure 5). The ratio of lateral-to-vertical (L/V) force indicates the likelihood of a derailment. When a high lateral force and low vertical force are present (e.g., as with an empty car), the high lateral force will tend to push the wheel flange up and over the gauge face of the rail, resulting in a wheel-climb derailment.

climb or overturn the inside rail. Empty long centre beam bulkhead flat cars are particularly susceptible to these forces.

Figure 5. Lateral-to-vertical forces between wheel and rail (Source: Association of American Railroads, with TSB annotations)
