MARINE INVESTIGATION REPORT
M02C0030

SINKING AND LOSS OF LIFE

AMPHIBIOUS PASSENGER VEHICLE *LADY DUCK*
OTTAWA RIVER
NEAR THE HULL MARINA
GATINEAU, QUEBEC
23 JUNE 2002

Report Number M02C0030

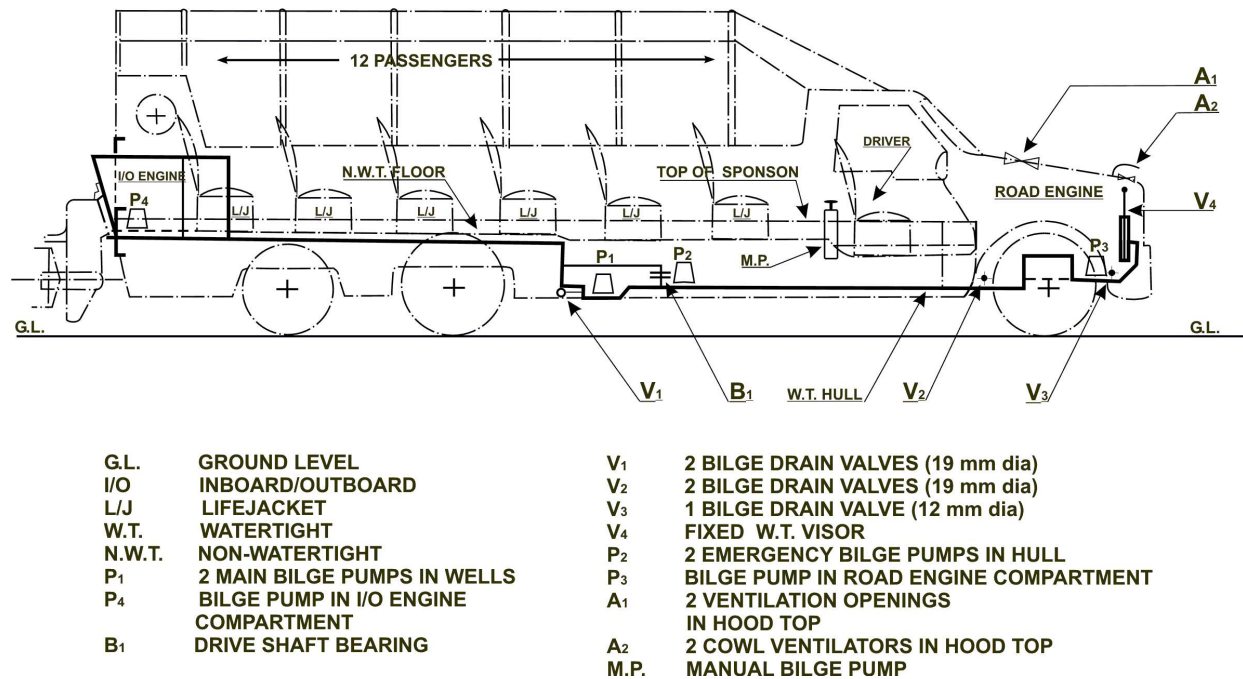
Figure 1. Construction profile outline

The bottom of the chassis was enclosed with welded and bolted steel plating and the sides were extended upward to enclose a buoyant structure. The original truck wheels and suspension were fitted outside the watertight hull. The effective breadth of the chassis was increased by the

The vehicle was fitted with five drainage points, each comprised of a hand-operated, ball check valve (seacock) with a swing-check, non-return valve immediately inboard, both of which were mounted on a common pipe spigot and closed with a screwed steel plug. Four of the drainage points were 19 mm ($\frac{3}{4}$ inch) in diameter; the fifth was 12 mm ($\frac{1}{2}$ inch) in diameter. Once on shore, the drainage points could be used to release accumulated water from the bilges (see Figure 1).

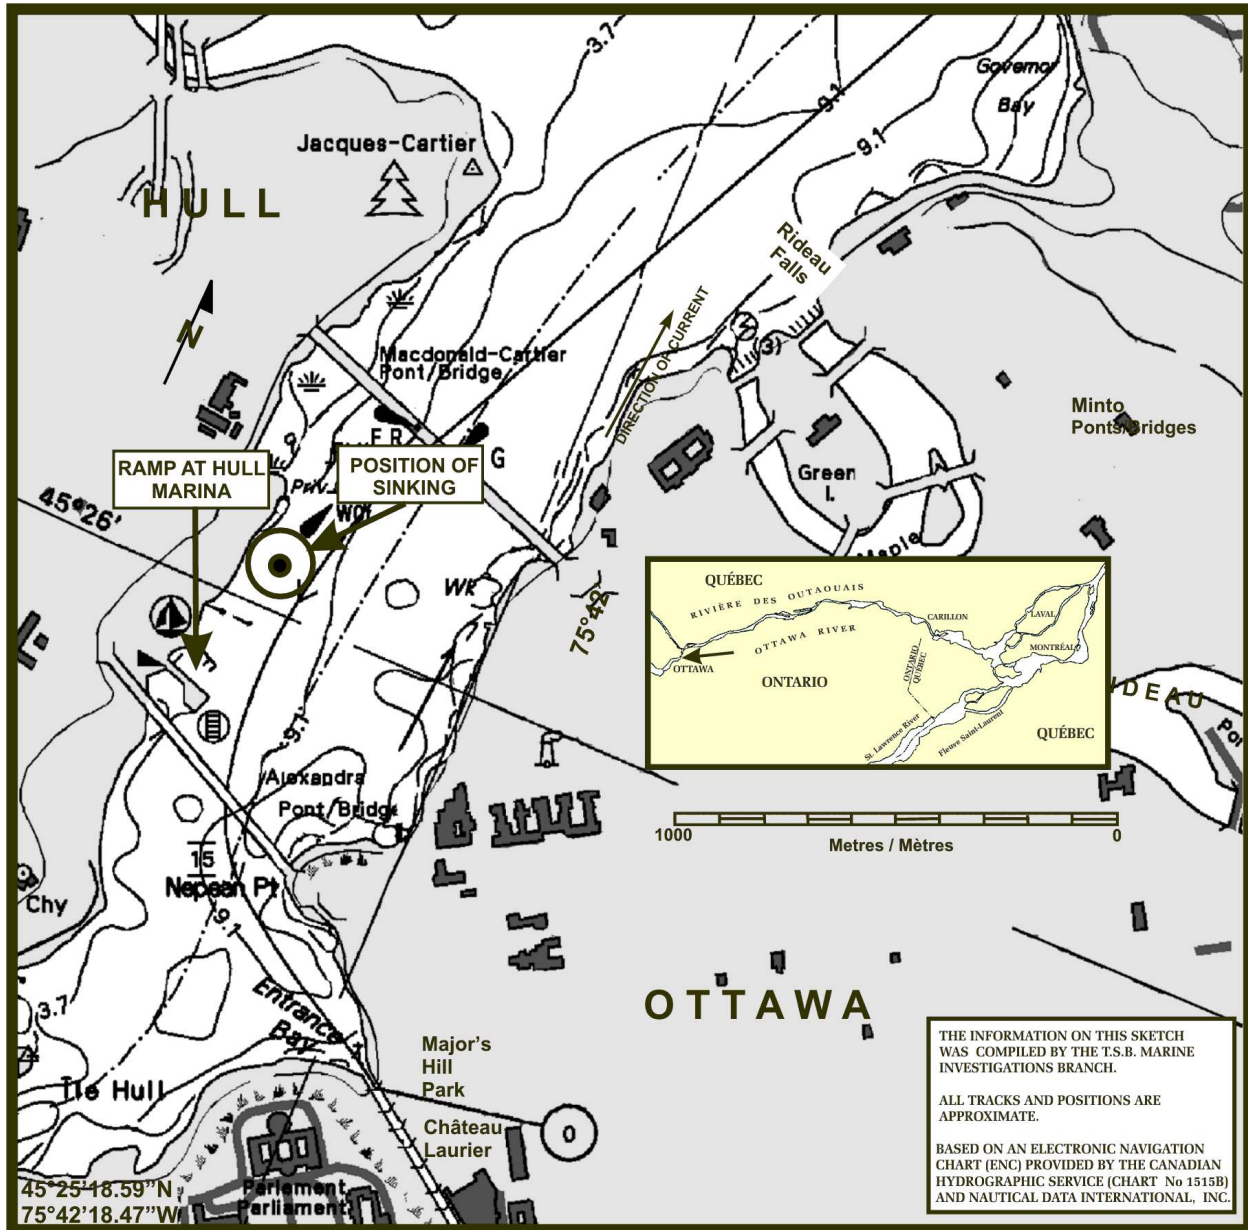
Figure 2. Chart of the occurrence area

The forward trim continued to increase and, realizing that the safety of the passengers was at risk, the driver instructed the tour guide to tell the passengers to don PFDs. At this time, he diverted the vehicle toward the nearest point on the Quebec shore. The driver then broadcast a MAYDAY on emergency VHF channel 16, identifying the *Lady Duck*, giving its position and the number of passengers on board. At about 1610, the situation deteriorated rapidly as more floodwater accumulated in the forward end of the vehicle. The driver then called on the passengers to abandon the sinking vehicle. The driver left the steering position, made his way aft and, with seven other persons, managed to get free of the sinking vehicle. The remaining four passengers became trapped under the fabric awning and sank with the vehicle in 8 m of water.

The driver, the tour guide, and four of the passengers who escaped as the vehicle was sinking were quickly recovered by the pontoon boat *Le Pirr'eau*, which happened to be near the *Lady Duck* as it sank. Two more passengers were recovered by the pleasure craft *Marina de Hull*, which had responded promptly after witnessing the sinking. The bodies of the four passengers who sank with the vehicle were recovered later and were subsequently examined by the coroner. The coroner determined the cause of death to be drowning associated with hypothermia.
