AVIATION INVESTIGATION REPORT A05F0047

LOSS OF RUDDER IN FLIGHT

AIR TRANSAT
AIRBUS A310-308 C-GPAT
MIAMI, FLORIDA, 90 nm S
06 MARCH 2005

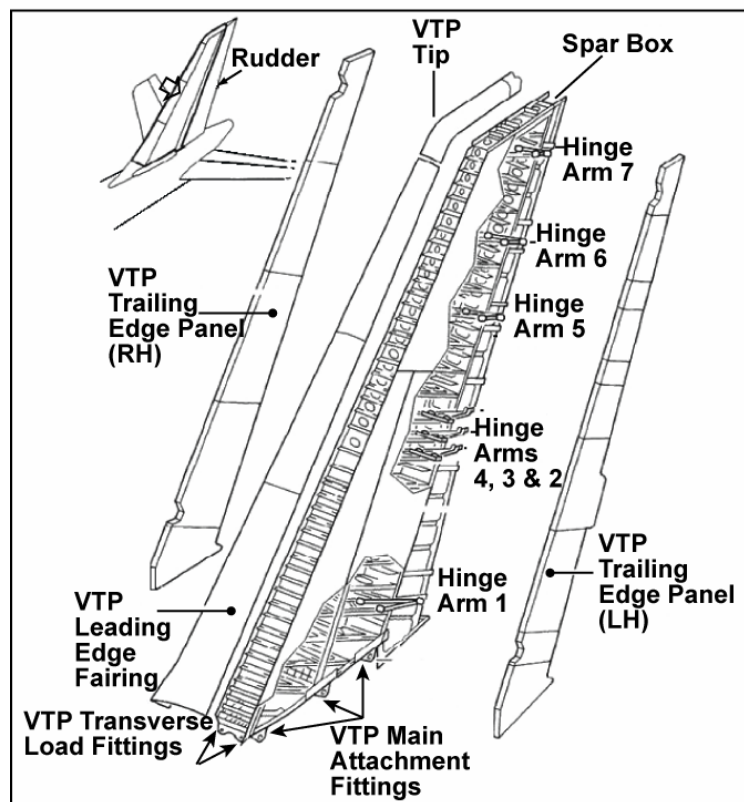
Figure 1. Schematic of the vertical tail plane

The VTP consists of a spar box, leading edge fairing, trailing edge panels, and tip (see Figure 1). The spar box consists of left and right side panels each composed of solid carbon fibre-reinforced plastic (CFRP) laminate skin and interior stiffeners. At the bottom of each side panel, there are three large integrally constructed CFRP lugs, known as the main attachment fittings, which attach to the fuselage. At the front and rear of the box, there are solid CFRP laminate spars running the length of the VTP, joining the left and right skin panels, forming the front and rear faces of the spar box.

In the centre of the box, there is a shorter solid CFRP laminate spar, which extends only up to rib 5. At the bottom of each of these three spars are two integrally constructed lugs, known as transverse load fittings, which attach to the fuselage. Within the box, there are a total of 18 solid CFRP laminate ribs, including closing ribs at the bottom and top. The leading edge and the tip are constructed of sandwich composite. Attached to each side of the rear spar, and extending aft, there is a flat trailing edge panel that acts as an aerodynamic fairing to fill the gap between the rear spar of the VTP and the leading edge of the rudder.

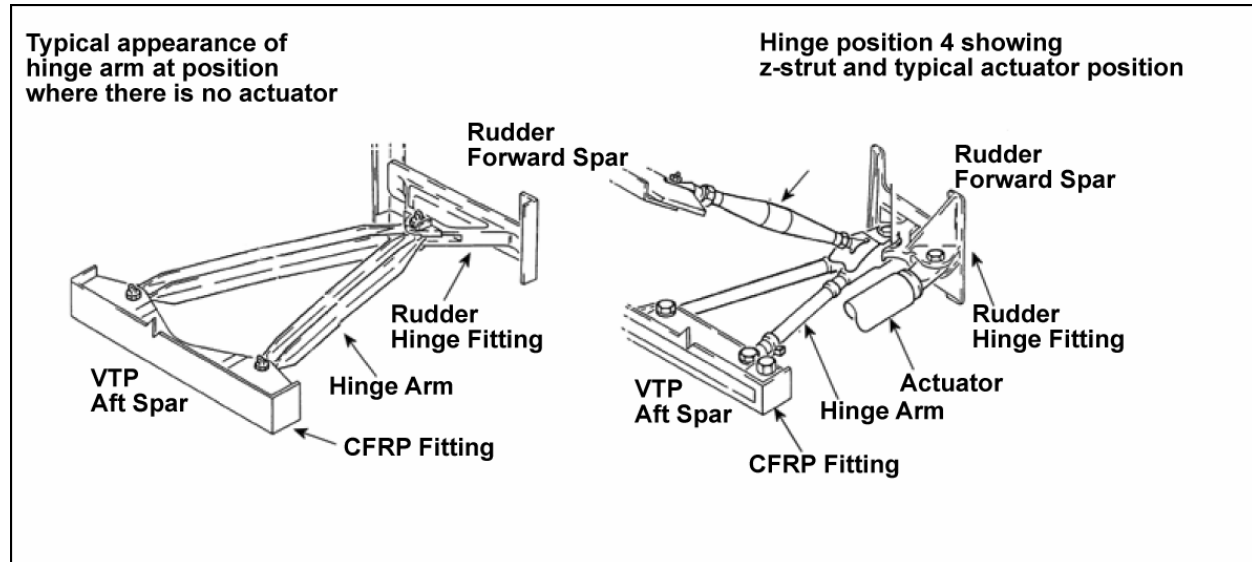
Figure 2. Schematic of hinge arm details

There are seven hinge positions along the VTP rear spar for the attachment of the rudder. These are numbered 1 through 7, from bottom to top. Figure 2 shows the design details at these hinge points. At each hinge position, there is a CFRP fitting attached to the rear spar. Each CFRP fitting has two lugs, one on the left and one on the right. The two front arms of each V-shaped metal hinge arm fit into these lugs on the rear of the VTP spar.

The hinge arms are attached to the CFRP fittings with spherical bearings, so they are free to pivot up and down. The rear of each hinge arm contains a hinge point for the attachment of the rudder. The hinge arm at hinge position 4 is supported in the vertical direction by a metal structural tube referred to as the z-strut. All the vertical loads from the rudder are transferred to the VTP through the z-strut. Rudder movement is controlled by three hydraulic actuators located inside the VTP at hinge positions 2, 3, and 4. The forward ends of the actuators are attached to CFRP fittings on the rear spar of the VTP, and the aft ends are attached to aluminum alloy fittings on the front spar of the rudder.

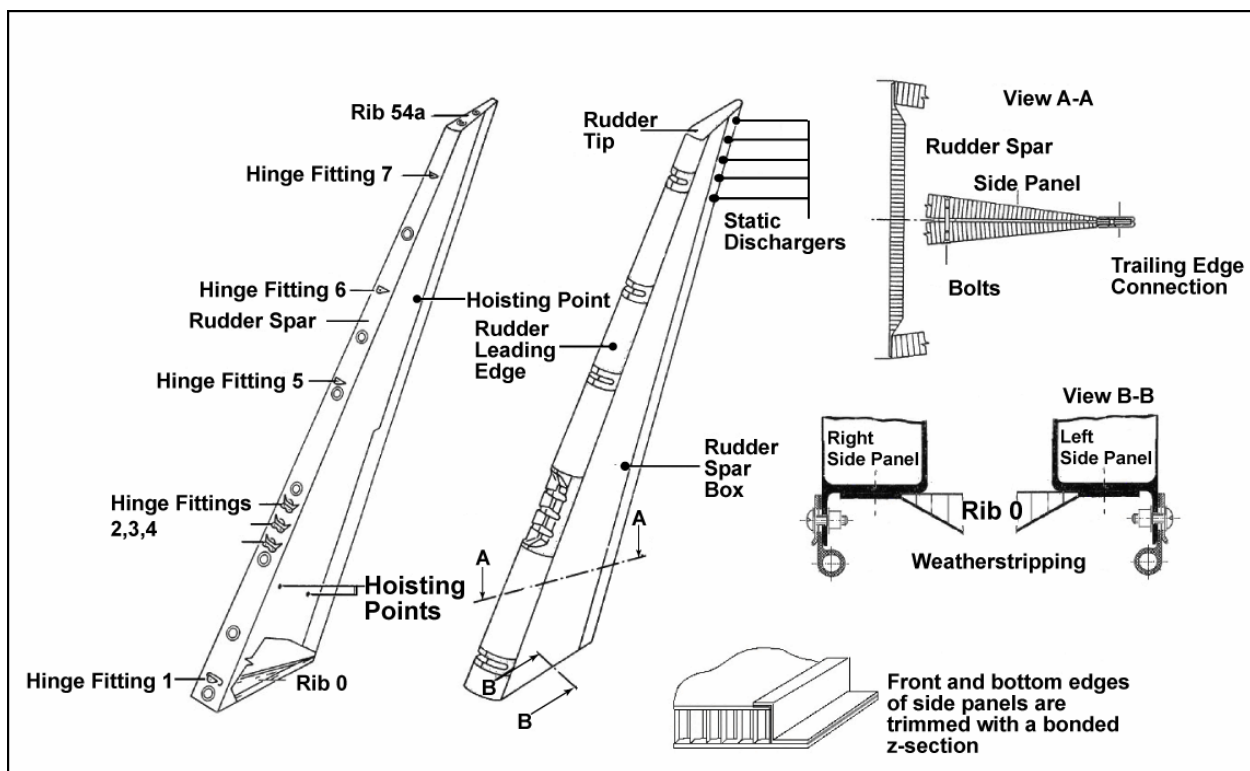
Figure 3. Schematic of the rudder

The rudder consists of a single spar at the front, two side panels that fasten together at the trailing edge, and top and bottom closing ribs (see Figure 3). The side panels are of single-piece construction and do not include any design features to mechanically arrest the growth of disbond damage. Each side panel is a sandwich composite constructed of a non-metallic Nomex® aramid-based honeycomb core, with CFRP face sheets, and a glass fibre-reinforced plastic (GFRP) intermediate layer between the CFRP and the honeycomb as shown in Figure 4. The GFRP intermediate layer does not have a structural purpose. It is simply a carrier for the resin that bonds the CFRP to the honeycomb. There is a layer of Tedlar® on the interior face to provide a moisture barrier, and a layer of film adhesive (AF 126) on the exterior face to provide aerodynamic smoothness. The density and thickness of the honeycomb and the number of face sheets vary with location because they are designed to react to applicable loads.

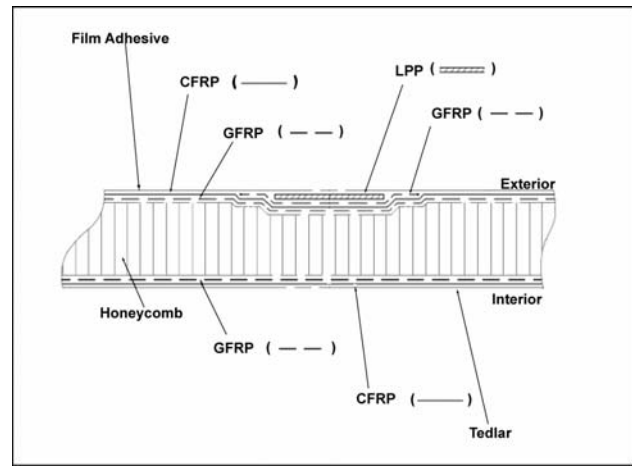
Figure 4. Rudder side panel construction

There are only two ribs within the rudder. Rib 0 is the closing rib at the bottom of the rudder and is a sandwich composite constructed of a Nomex® honeycomb core with CFRP face sheets. Rib 54a, constructed of aluminum, is the closing rib at the top of the rudder. The leading edge fairing of the rudder is divided into multiple sections along its length, each constructed of sandwich composite (see Figure 4). The leading edge fairing sections are fastened to the side panel z-sections with threaded fasteners. There is an aluminum alloy strip along this row of fasteners as part of the lightning-protection system. Attached to the z-section at the bottom of each side panel is a rubber weatherstrip that covers the gap between the bottom of the rudder and the top of the tail cone. The weatherstrip is attached with threaded fasteners, and a metal strip is used as a washer plate along this row of fasteners. The side panels attach together at the rear of the rudder by a row of mechanical fasteners running parallel to the trailing edge, roughly 30 cm ahead of the trailing edge. A metal protective strip runs down the entire length of the rudder trailing edge, which is also attached using mechanical fasteners. There are three hoisting points on each side panel.

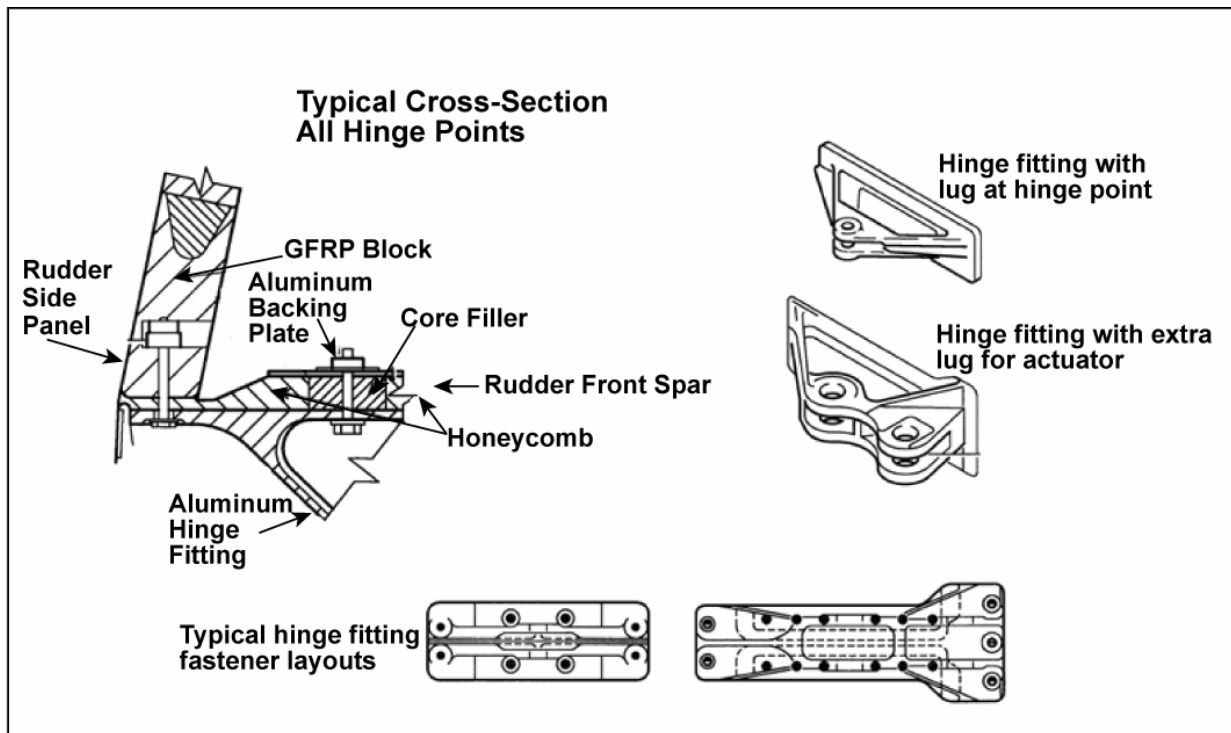
Figure 5. Schematic of rudder hinge fitting details

There are seven hinge positions, numbered 1 through 7, from bottom to top. Figure 5 shows the design details at these hinge points. At each hinge position, aluminum alloy fittings are attached to solid GFRP blocks integrated locally into the side panels and to the spar web by mechanical fasteners. The core of the spar web, where the fasteners pass through, is filled by core filler and reinforced by an aluminum backing plate. The three control actuators attach to the rudder at hinge positions 2, 3, and 4. The metal hinge fittings at these locations have two lugs, one to act as the hinge point, and one to attach to a hydraulic actuator.
