feed**back**

Canadian Aviation Service Difficulty Reports

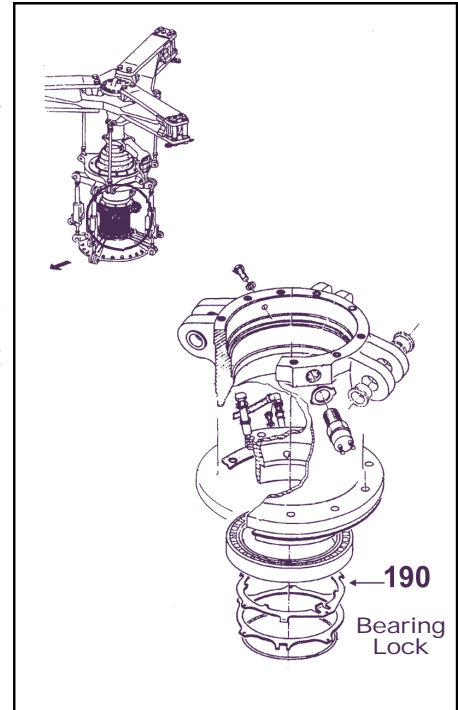
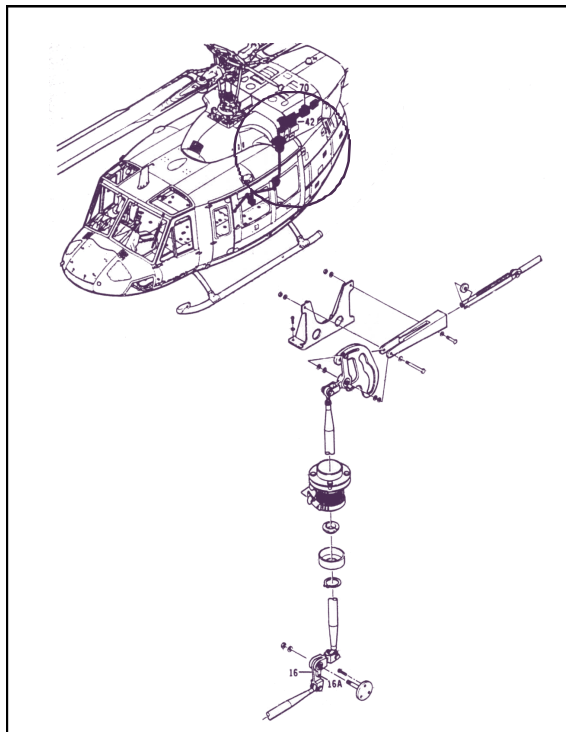
BELL 212

Main Rotor Mast, Bearing Lock Broken

A service history review of past failures of the subject lock indicates that cracks may be a result of inadequate torque pre-load on the mast bearing lock. When replacing any one of the two mast bearings, the thickness of the shims must be adequate to obtain specified pre-load. If not, looseness and unwanted vibrations may result causing damage.

Transport Canada reminds maintainers to verify the bearing shim stack-up and to carefully check the subject lock for wear whenever mast seals require replacement.
