Transport
Canada

TP 6980E

Issue 2/2005

Canadian Aviation Service Difficulty Reports

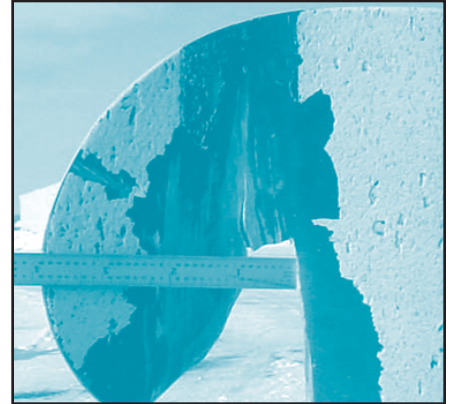
Subsequent inspection revealed that a section of the propeller tip penetrated the fuselage just behind and below the airstair door. Additionally, a 3-inch hole was found on the opposite right propeller spinner. Smaller sized stones (aggregates) were found within the spinner.

During winter operations, it is suspected that this damage was caused by the larger sized (1.5 inch) aggregates that were spread on the runway rather than the much smaller and finer aggregates.
