Transport  
Canada

TP 6980E

# feedback

Canadian Aviation Service Difficulty Reports

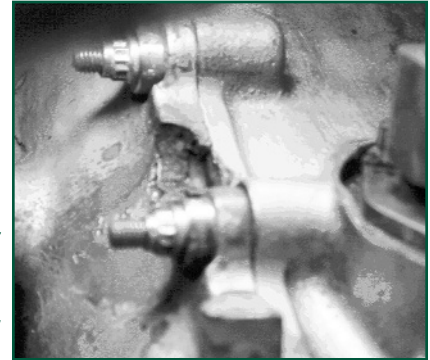
Shortly after aircraft departure, the No.2 AC generator went off-line. The aircraft returned to its point of departure for verification by maintenance personnel. Technicians replaced the generator control unit (GCU), which did not rectify the problem. Further investigation revealed that arcing had occurred between the AC electrical harnesses at the "D" flange location of the engine case.

*The arcing caused a noticeable portion of the engine case at the D flange location to be damaged. Short circuits in electrical systems constitute a serious fire hazard and also may cause the destruction of electrical wiring and damage to units of electrical equipment. Visual inspection of proper routing and clearances for electrical wiring harnesses are not always given the same attention as other system installations. This service difficulty is an example of the significance of wiring harness routing and clearance. ✖*

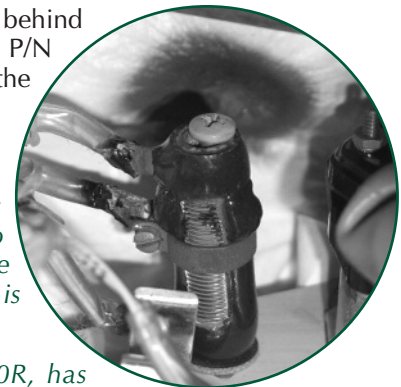
BEECH C90A

An overheated resistor, R145, was discovered at the top of the forward bulkhead behind the instrument panel during a routine inspection. The fluorescent light resistor, P/N 2K40D10, was scorched and had slightly burned the insulation located behind the glare shield.

A company fleet-wide campaign produced three (3) similar defects.

*Transport Canada (TC) recommends maintainers to carry out a detailed inspection of this area to ensure that adequate clearance between the secured resistor assembly and aircraft insulation is maintained.*

*The operator noted that resistor, P/N D25K10R, has been superseded by P/N 2K40D10. ✖*

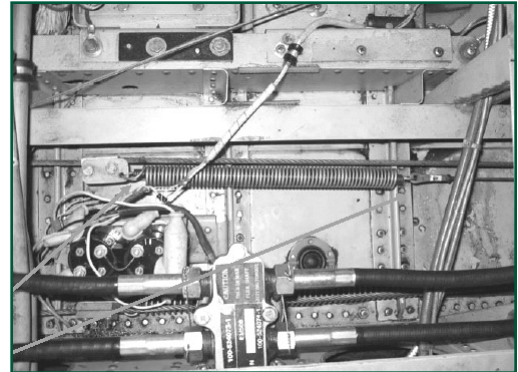
While taxiing the aircraft, the flight crew noticed a full left bias deflection in the aileron system. Maintenance discovered that one of the aileron/rudder interconnect springs had fractured near the end ring that provides connection to the bridle. This defect may have been induced during phase inspection requirements in removal of the springs during tensioning procedures. The tool marks from a set of pliers or other mechanical means during the removal process may have scored the spring, providing areas for stress risers to develop.

*The operator issued a supplemental inspection into their process control to avoid future occurrences of this defect. Maintainers should remain vigilant when inspecting this area and judiciously use the correct tool to prevent damage to aircraft hardware. ✖*
