**MARINE INVESTIGATION REPORT**  
**M07L0158**

**STRIKING**

**PASSENGER VESSEL *NORDIK EXPRESS***  
**ENTRÉE ISLAND, HARRINGTON HARBOUR, QUEBEC**  
**16 AUGUST 2007**

Report Number M07L0158

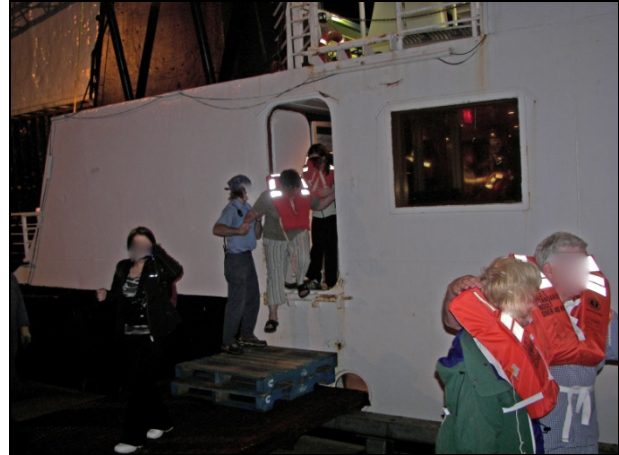
**Photo 3.** Passengers disembarking at Harrington Harbour

People had difficulty moving in the crowded corridors and climbing the stairs with the vessel in its listed condition, and there was a strong smell of smoke or burning. This smell was most likely the result of slippage and overheating in the clutch of the starboard reduction gear after the propeller struck the bedrock.

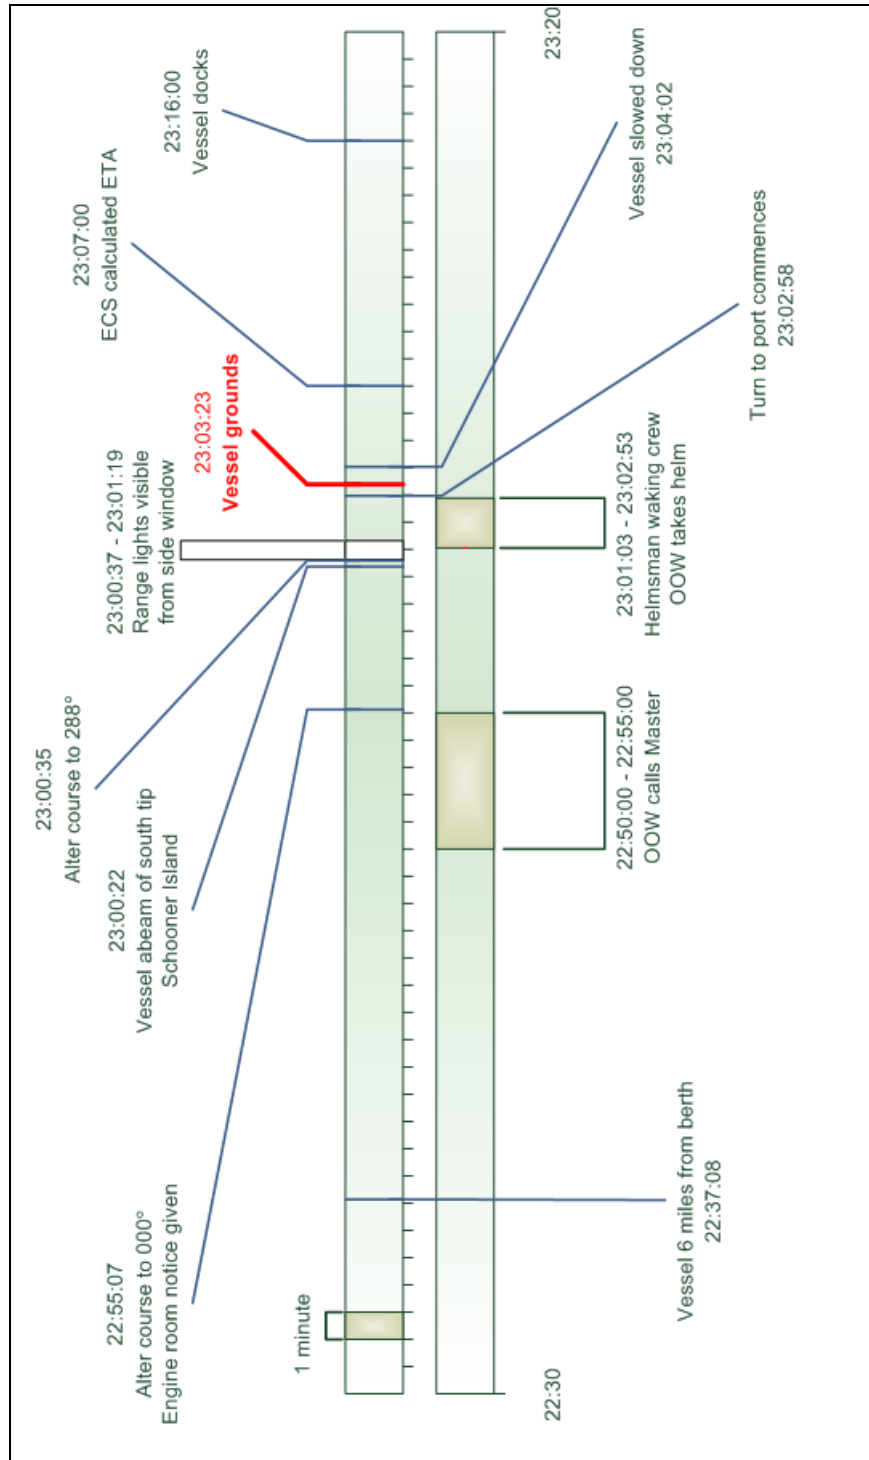
# Appendix E – Occurrence Timeline

Within minutes of the striking and as a result of damage below the waterline, the vessel developed a list of approximately 20° to starboard; however, by the time it reached its berth, this was reportedly less than 10°. For a graphic depiction of the occurrence timeline, refer to Appendix E.
