Corrosion of Domestic Oil Tanks

By: William Moody, P. Eng.
Moody Engineering Consultants
Dartmouth, Nova Scotia

February 2000

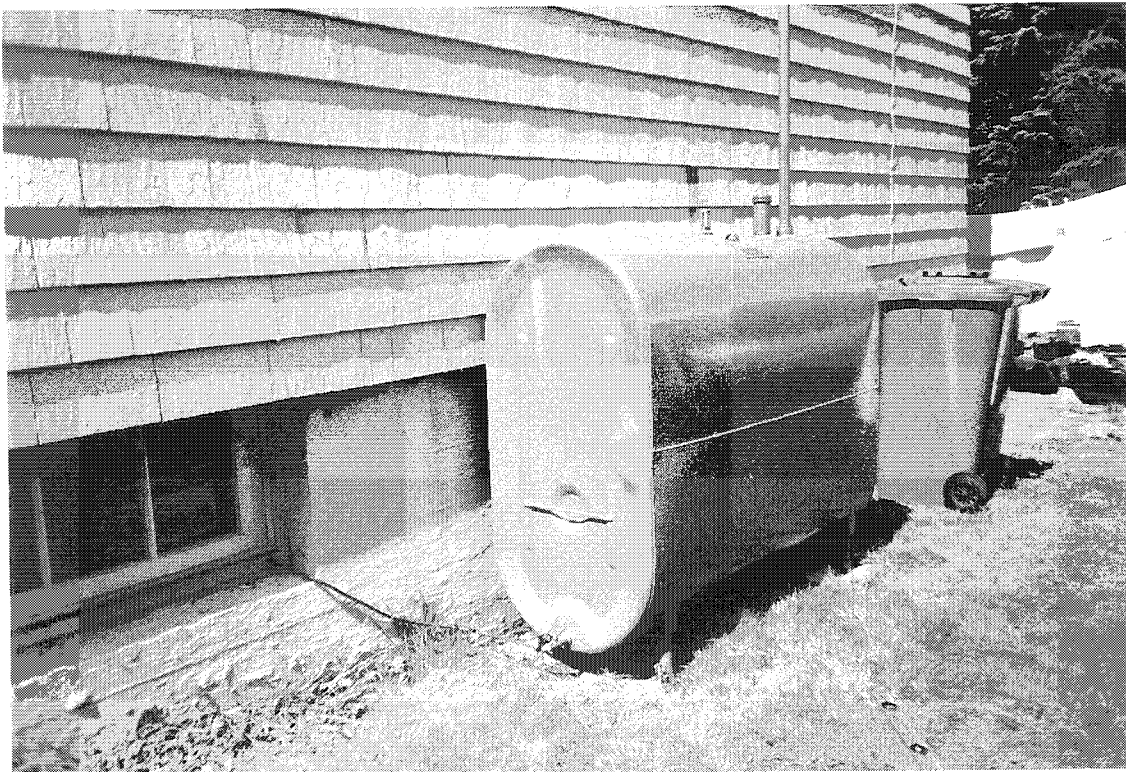
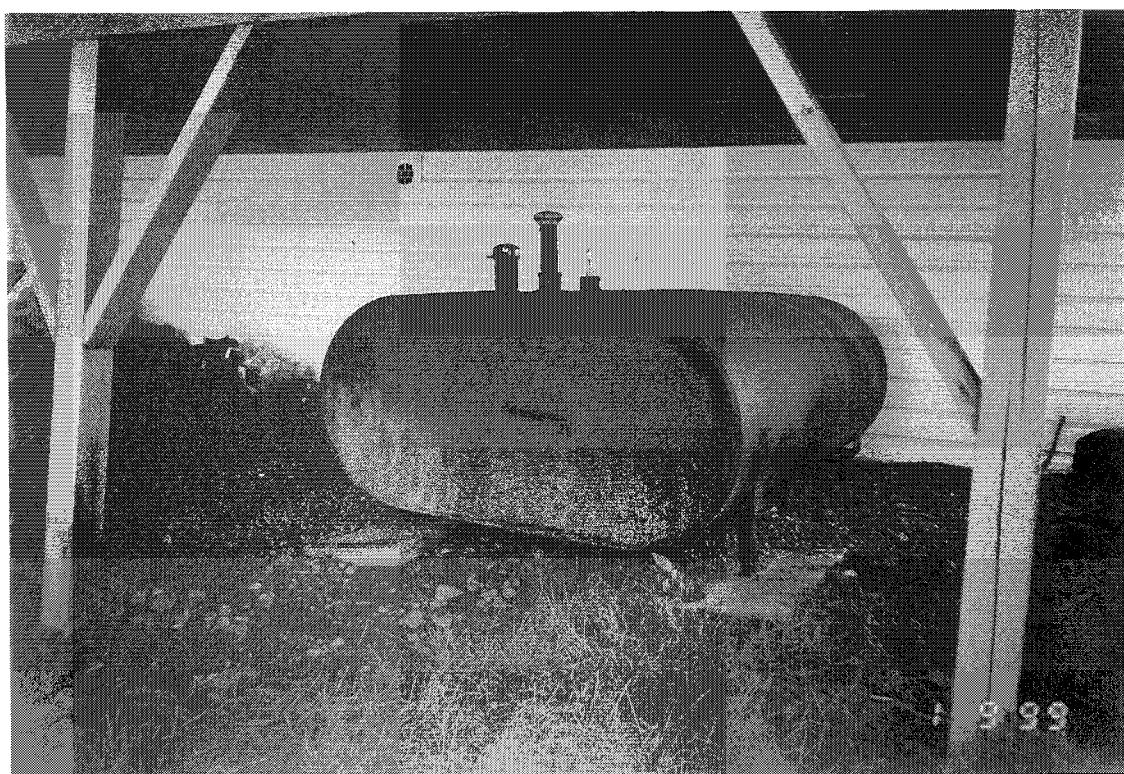
Figure 2 - Typical outdoor tank installations

Typical tank installations, inside and outside the home, are shown in the accompanying photographs (Figures 2 and 3).
