Cost-Effective Indoor Air Quality and Energy Efficiency Recommendations for First Nations Housing

Cost-Effective Indoor Air Quality And Energy Efficiency Recommendations For First Nations Housing

Final Report

January 2001

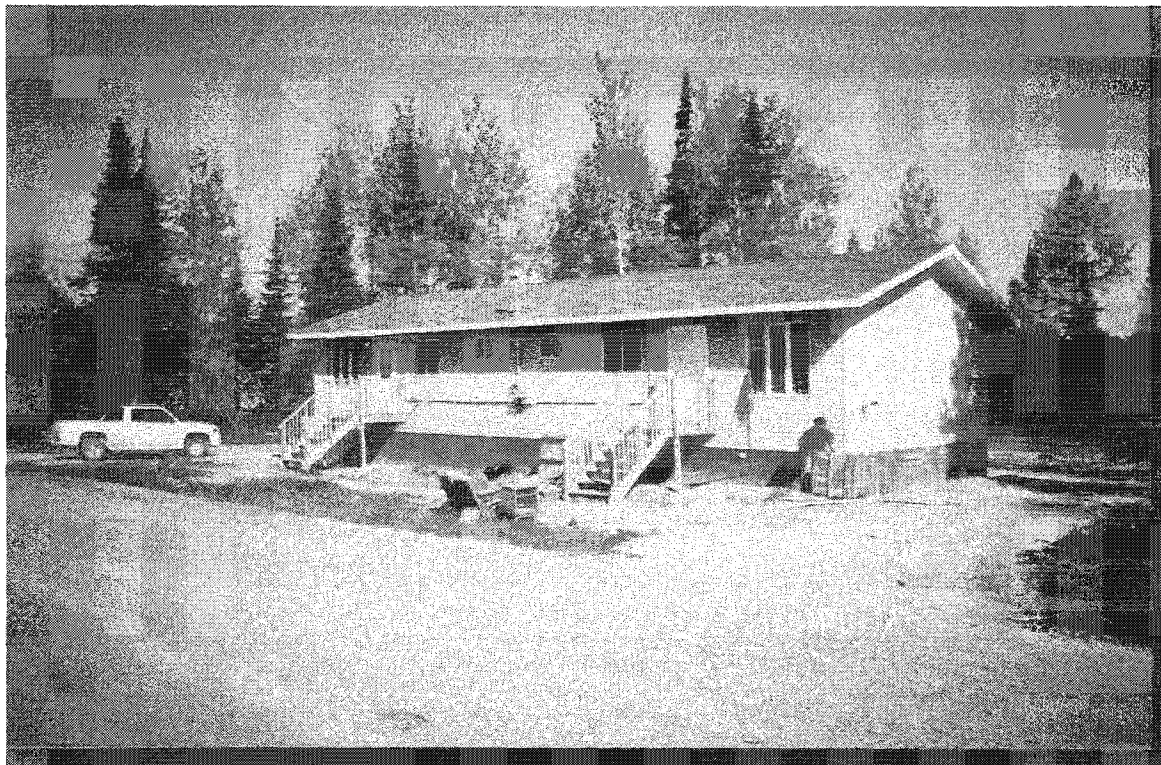
Figure 3: House 2, duplex, left side, southeast view

The band owns this house. The house was built in 1998-99 and the present occupants, a man, woman and girl under 12, moved in upon completion in April 1999. There is recurring mold growth on the edges of windows, in the corners of the bedrooms and in the bathroom beside the tub. The occupants clean it frequently but it always returns. There may also be some growth in the crawl space. A minor water leak above the back door was repaired in April of 1999. The occupants plan only minor improvements, including completing the railing on the deck stairs.

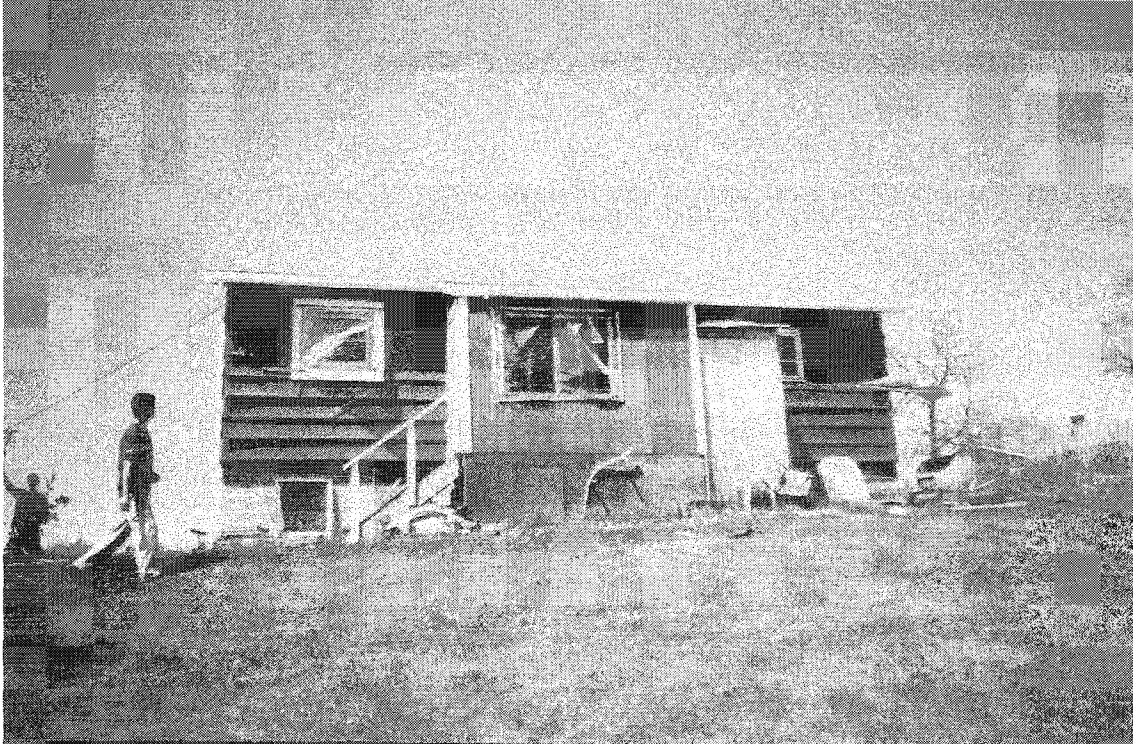
Figure 6: House 3, southeast side

The band owns this house, which was built about 1970. The five present occupants (a man, woman, two teens and a four year old boy) have lived here since 1987. They notice a musty odour when they enter the home. Odours linger in the bathroom. They would like to have new siding, new ceiling finish, a bathroom renovation, insulation of the crawl space and a new bedroom addition to the house.

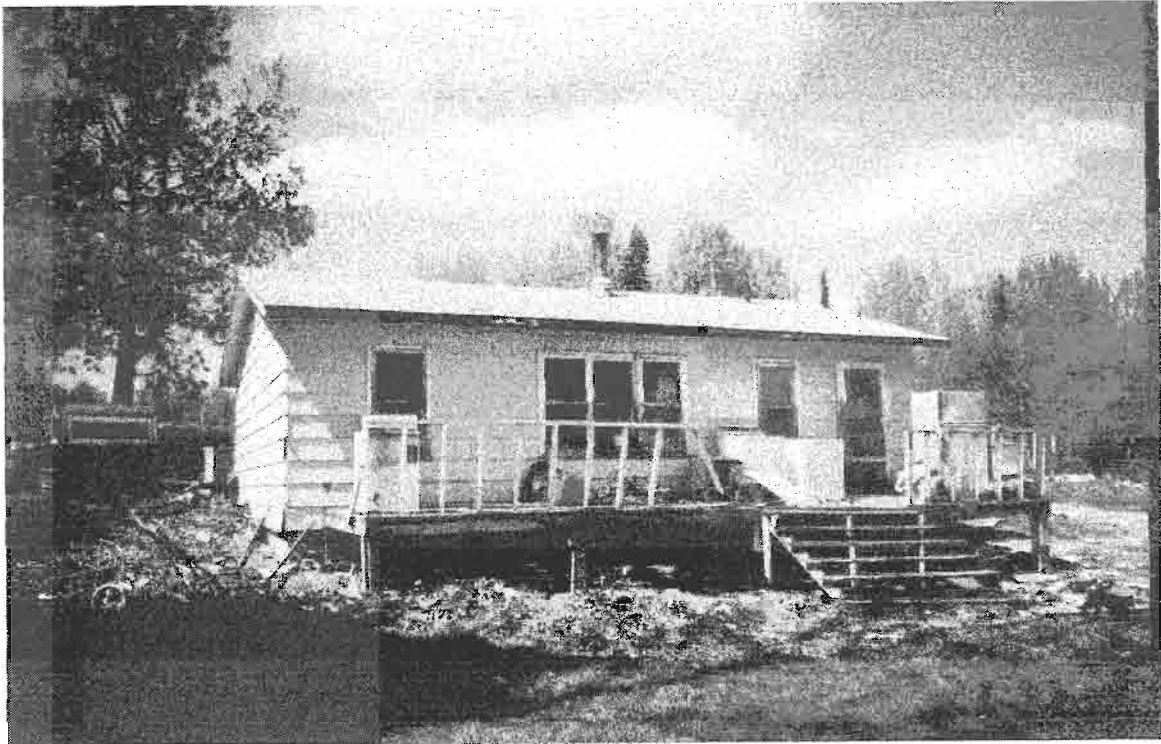
Figure 10: House 5, original part, east side

House 5 is in such poor condition that re-location of the occupant is recommended.
