**TESTING OF
DOMESTIC
OIL TANKS**

By: William Moody, P.Eng.
Moody Engineering Consultants
Dartmouth, Nova Scotia

October 1998

The scope and objective of the research covered by this report is to develop a practical, efficient and economical method of determining the condition and projected remaining life of operational above ground domestic oil tanks.

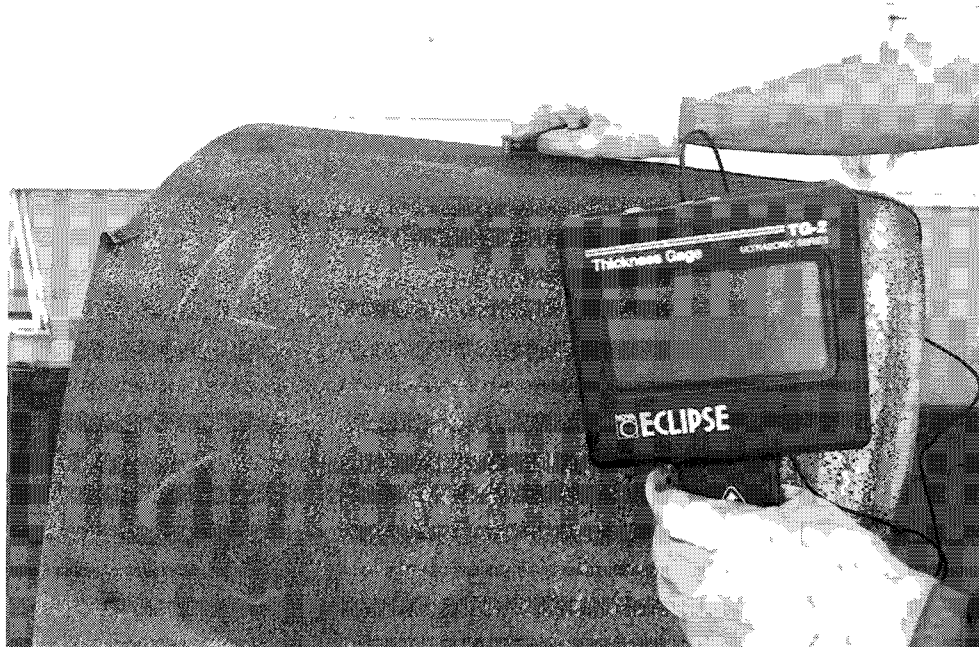
Figure 9 – Leak Areas after Cleaning with Emery Paper

Without cleaning the exterior of the tank in any way the transducer and appropriate couplant were applied to the previously identified leaking areas. No readings could be obtained. The regions were then wire brushed to remove surface rust. Again there was no reading. It was only when emery paper was used to bring the surface down to bare metal that a thickness reading was achieved (Figure 9). The instrument however was not precise enough to identify interior pitting in the area where this reading was taken. As verification of this latter point a portion of the tank that was badly corroded inside (Figure 10) was identified and a grid set up on the exterior. Spot ultrasonic readings were then taken from the outside after the region had been cleaned. No definitive areas of pitting could be detected (Figure 11). As another experiment, tank exterior areas that were uncorroded and painted were ultrasonically tested. Sometimes a thickness reading could be obtained and sometimes not, apparently dependent on the thickness of paint and sensitivity of the instrument.
