Study Of Houses Affected By Hazardous Lands: Appendixes A, B, C, D, E and F

**STUDY OF HOUSES AFFECTED BY
HAZARDOUS LANDS
APPENDIXES A, B, C, D, E, AND F**

**THE RESEARCH DIVISION
CANADA MORTGAGE AND HOUSING CORPORATION**

**CH2M HILL ENGINEERING LTD.
in association with
SHELTAIR SCIENTIFIC
APPIN ASSOCIATES
XCG CONSULTANTS LTD.**

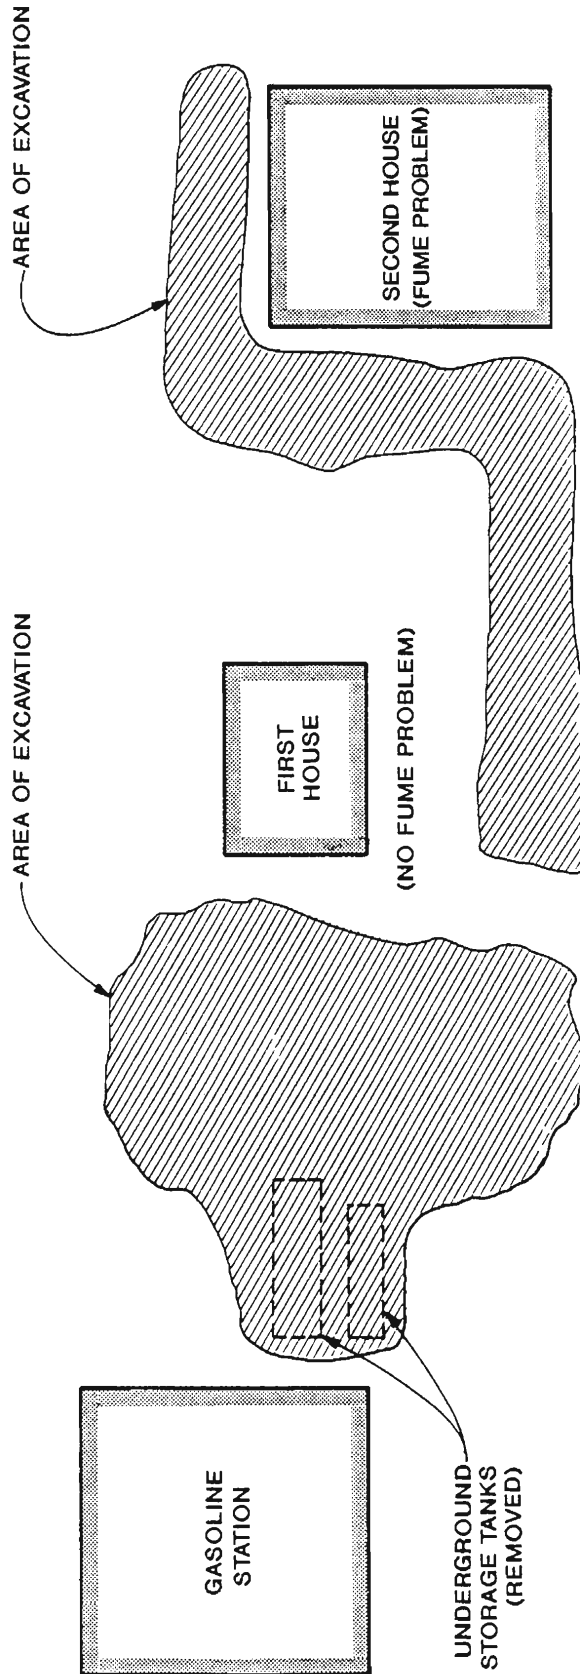
**FIGURE A-1:
LOCATION OF AFFECTED
HOME RELATIVE TO LEAKING
UNDERGROUND STORAGE TANKS**

On October 16, 1986, gas fumes were detected in a basement, two houses away from the gasoline station. The basement of the affected home in places had no foundation which allowed the rapid entry of soil gases. The gas fumes were checked by the local fire chief with the use of a gas sniffer; the readings were not explosive. In an effort to remediate the gas fume problem, a trench was then excavated next to the house for the purpose of soil gas ventilation. During the excavation of the trench, many large boulders were encountered in a sandy soil - good for soil gas migration. The attached figure (Figure A-1) shows the location of the affected house and the various trenches.

Despite the venting trench, by October 24, 1986, gas fumes still persisted in the affected house. By October 27, the owners of the affected house were ordered to vacate. By November 12, gasoline fumes were still noticeable; however, the odours had diminished considerably. The residents had still not moved in.

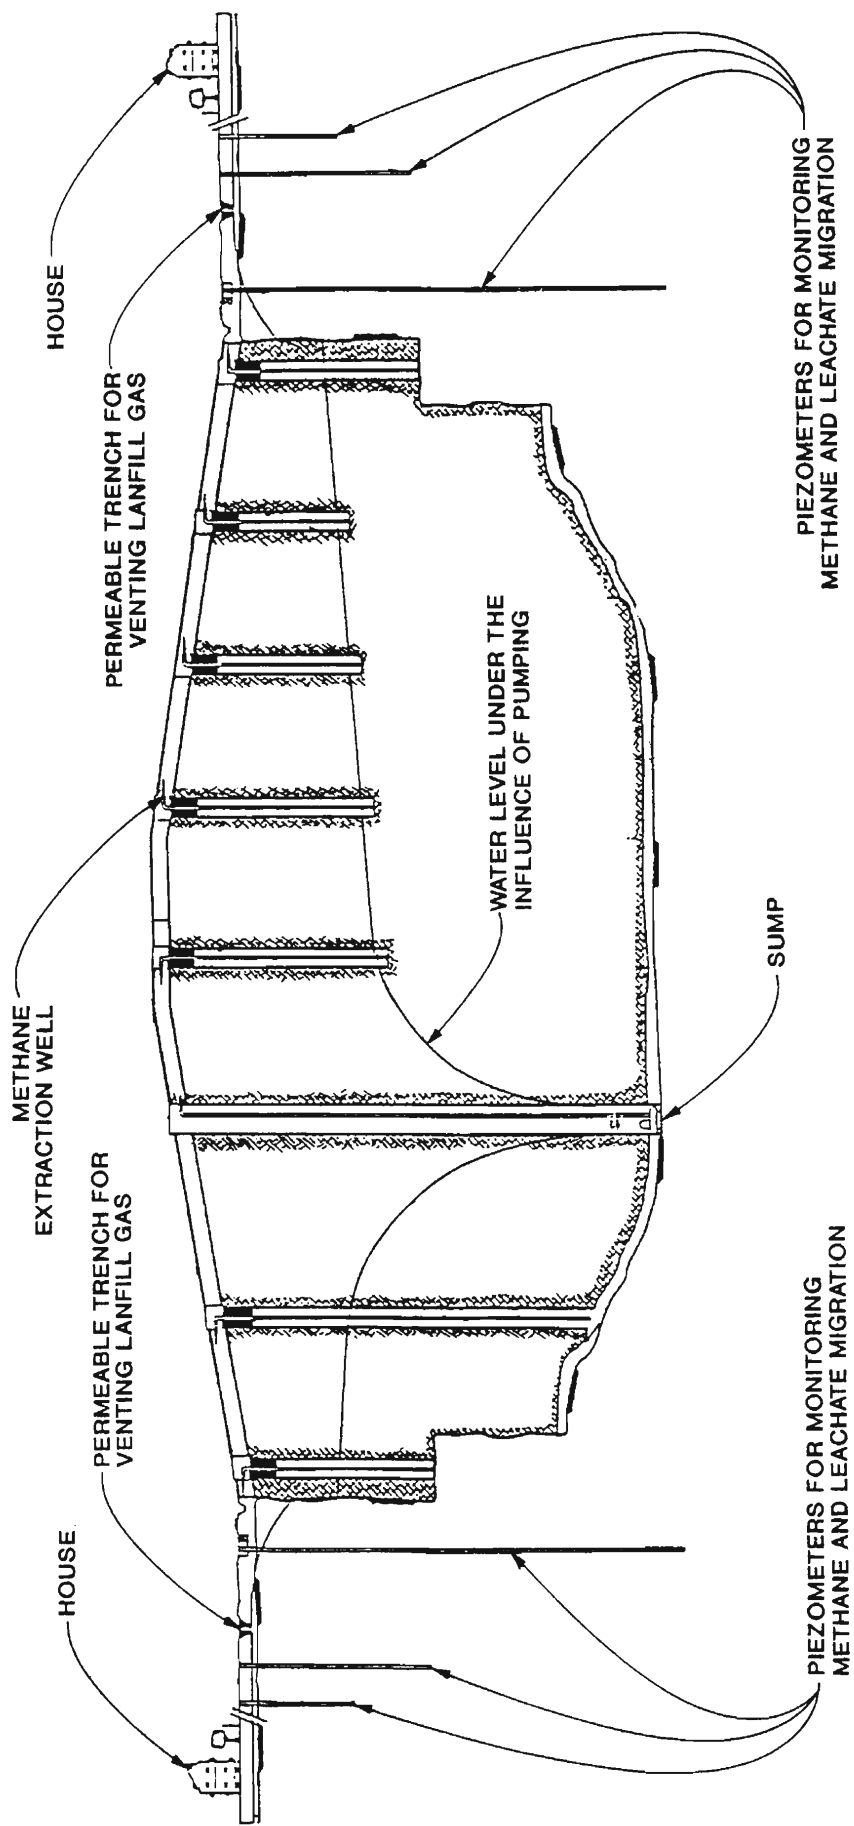
FIGURE A-3:
MIRON QUARRY LANDFILL

It is estimated that by 1994, the landfill will produce an approximate 20,400 cubic metres of gas per day. Some houses are located within 50 metres of the edge of the landfill (Figure A-2). There is concern that gas from the landfill may migrate into the nearby houses through the fractures of the bedrock. The Municipality is presently installing an extensive network of interceptor wells within and around the edge of the landfill (Figure A-3). Monitoring wells (about 40) will also be bored around the quarry to monitor the chemical composition of the leachate and of the migrating gas. An interceptor trench, extending down to the level of the water table, will also be constructed around the site to intercept gases migrating through the overburden. The network of interceptor wells installed at the periphery of the landfill was first operated in January 1991; the wells installed at the core of the landfill will become operational progressively as sections of the landfill are closed.

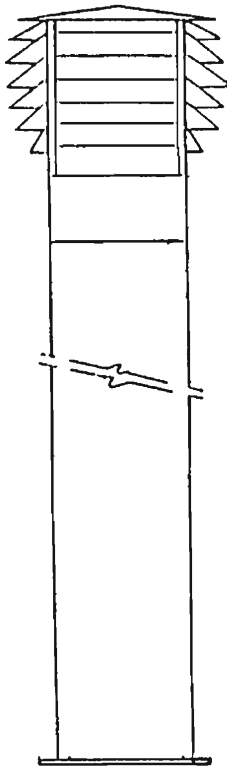
VENT PIPE DETAIL

The Municipality is developing a park on an old quarry that was used as a municipal dump between 1951 and 1975. Multiple housing units are located on the east and west sides of the park. The City is presently installing a passive venting trench around the landfill to avoid migration of gases into nearby houses. The trench extends down to the water table and chimneys are placed along the trench to allow for the evacuation of the gas (Figure A-6). The south-western segment of the interceptor trench is already in place and the remaining segments will be constructed as development of the park progresses.

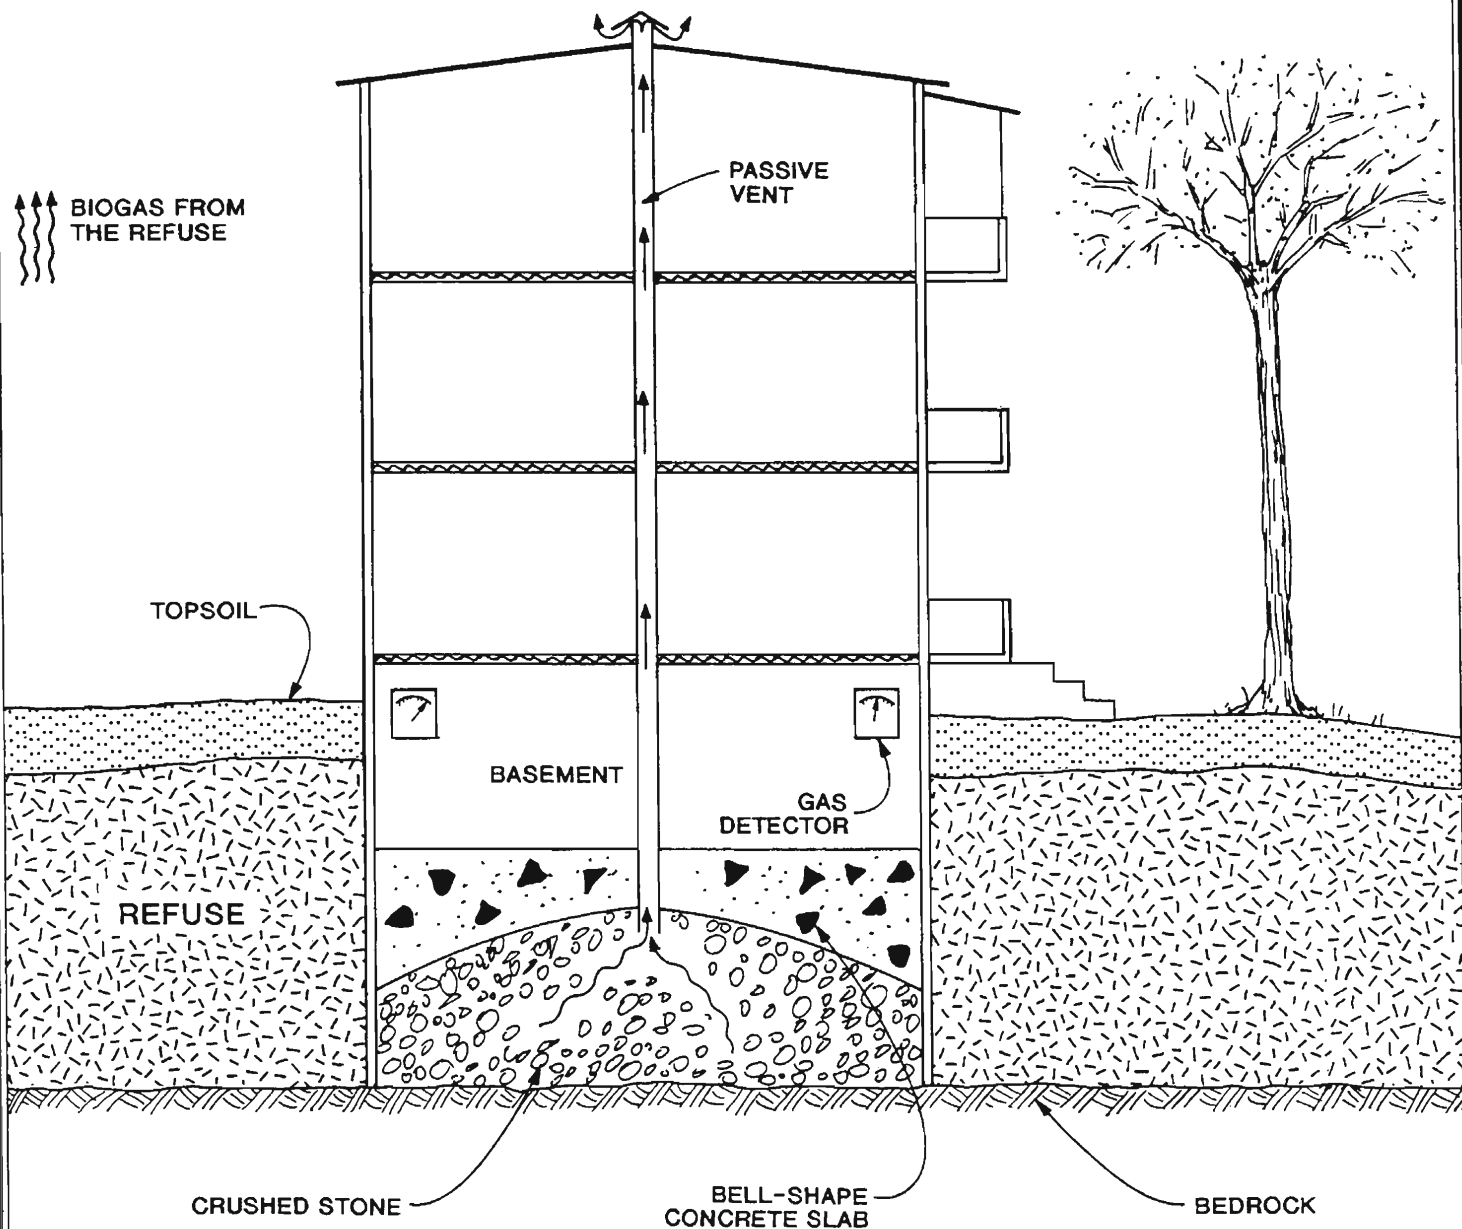
In Montréal, a triplex was built on a small quarry that had been used as a dump site. A passive venting system was installed underneath the basement to intercept gases released by the refuse. The venting system consisted of a bed of clean crushed stone laid in an oval shape overlain by a slab of concrete serving as the floor of the basement and an impermeable layer (Figure A-7). A chimney, penetrating into the crushed stone, was added to the system to allow the release of the gas accumulating in the venting system. Finally, gas detectors were placed into the basement to detect any concentration build-up of methane. The remedial measure has the added advantage of not requiring any moving mechanical part and is reported to be working effectively (Personal conversation; M. S. Barbeau, City of Montréal).

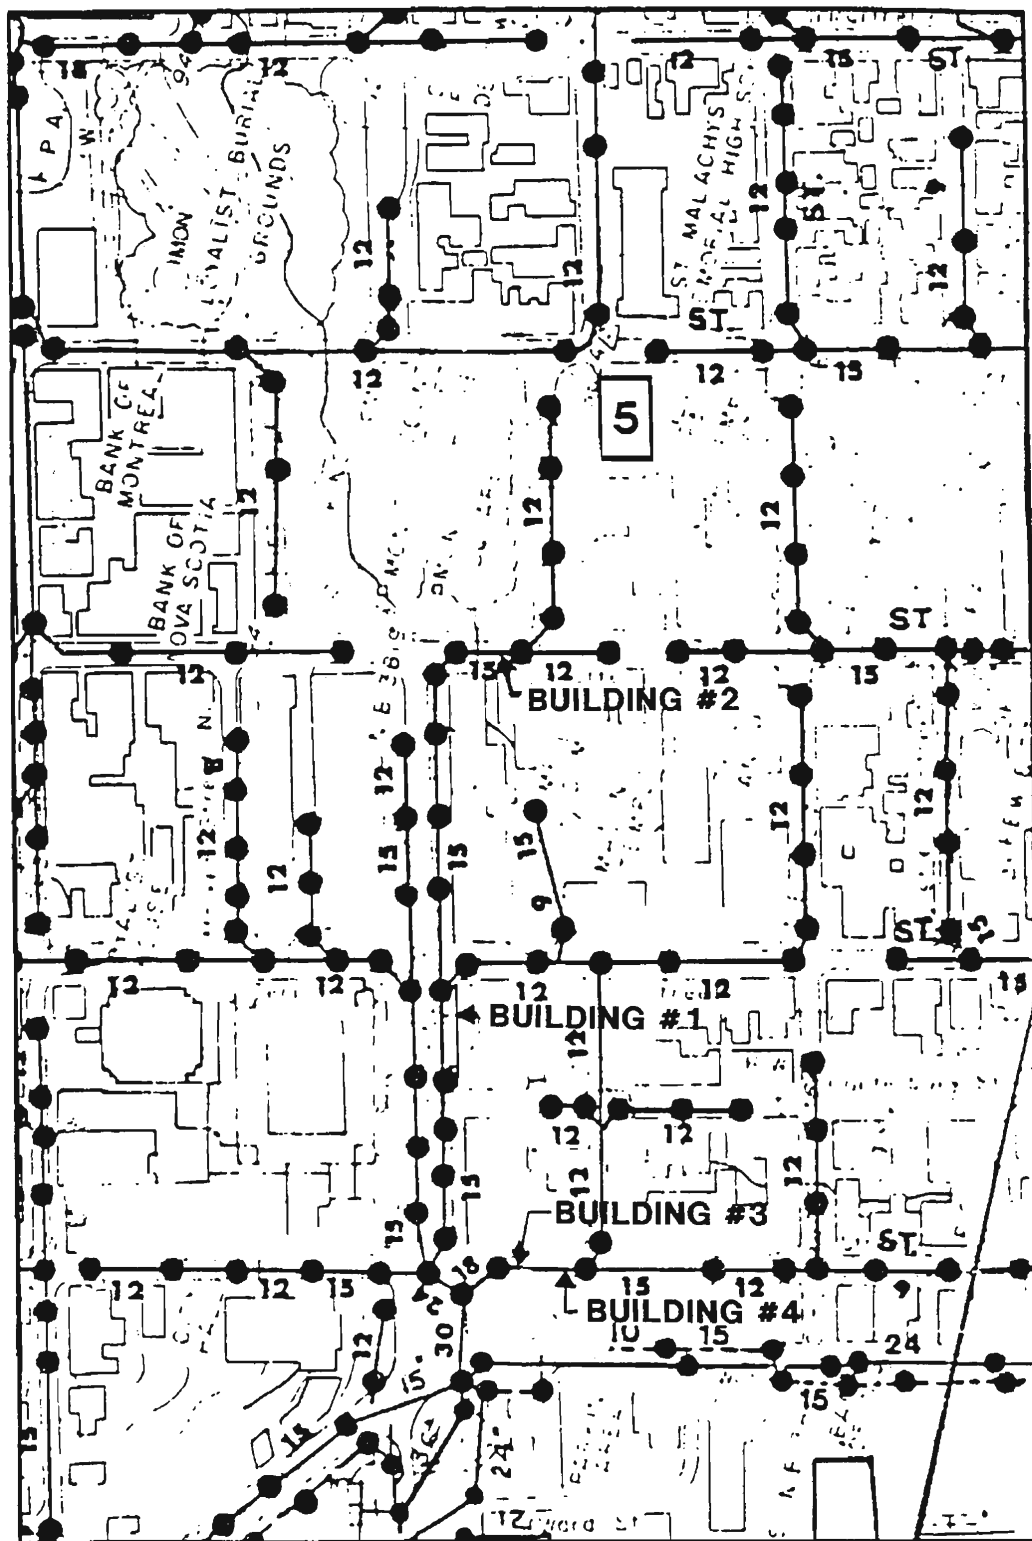
**FIGURE A-10:
PLAN OF SEWER SYSTEM IN
THE VICINITY OF THE SPILL
(Source: Cooke, 1986)**

As part of the accident, gasoline infiltrated into the ground and emerged in the sewer system. Vapours that resulted from this spill backed up into many nearby homes affecting as many as 10 - 20 houses. The fire department used explosimeters and recommended evacuation based on the explosive levels reported. People were allowed to return to their homes once explosive levels were no longer encountered. No further documentation was available.

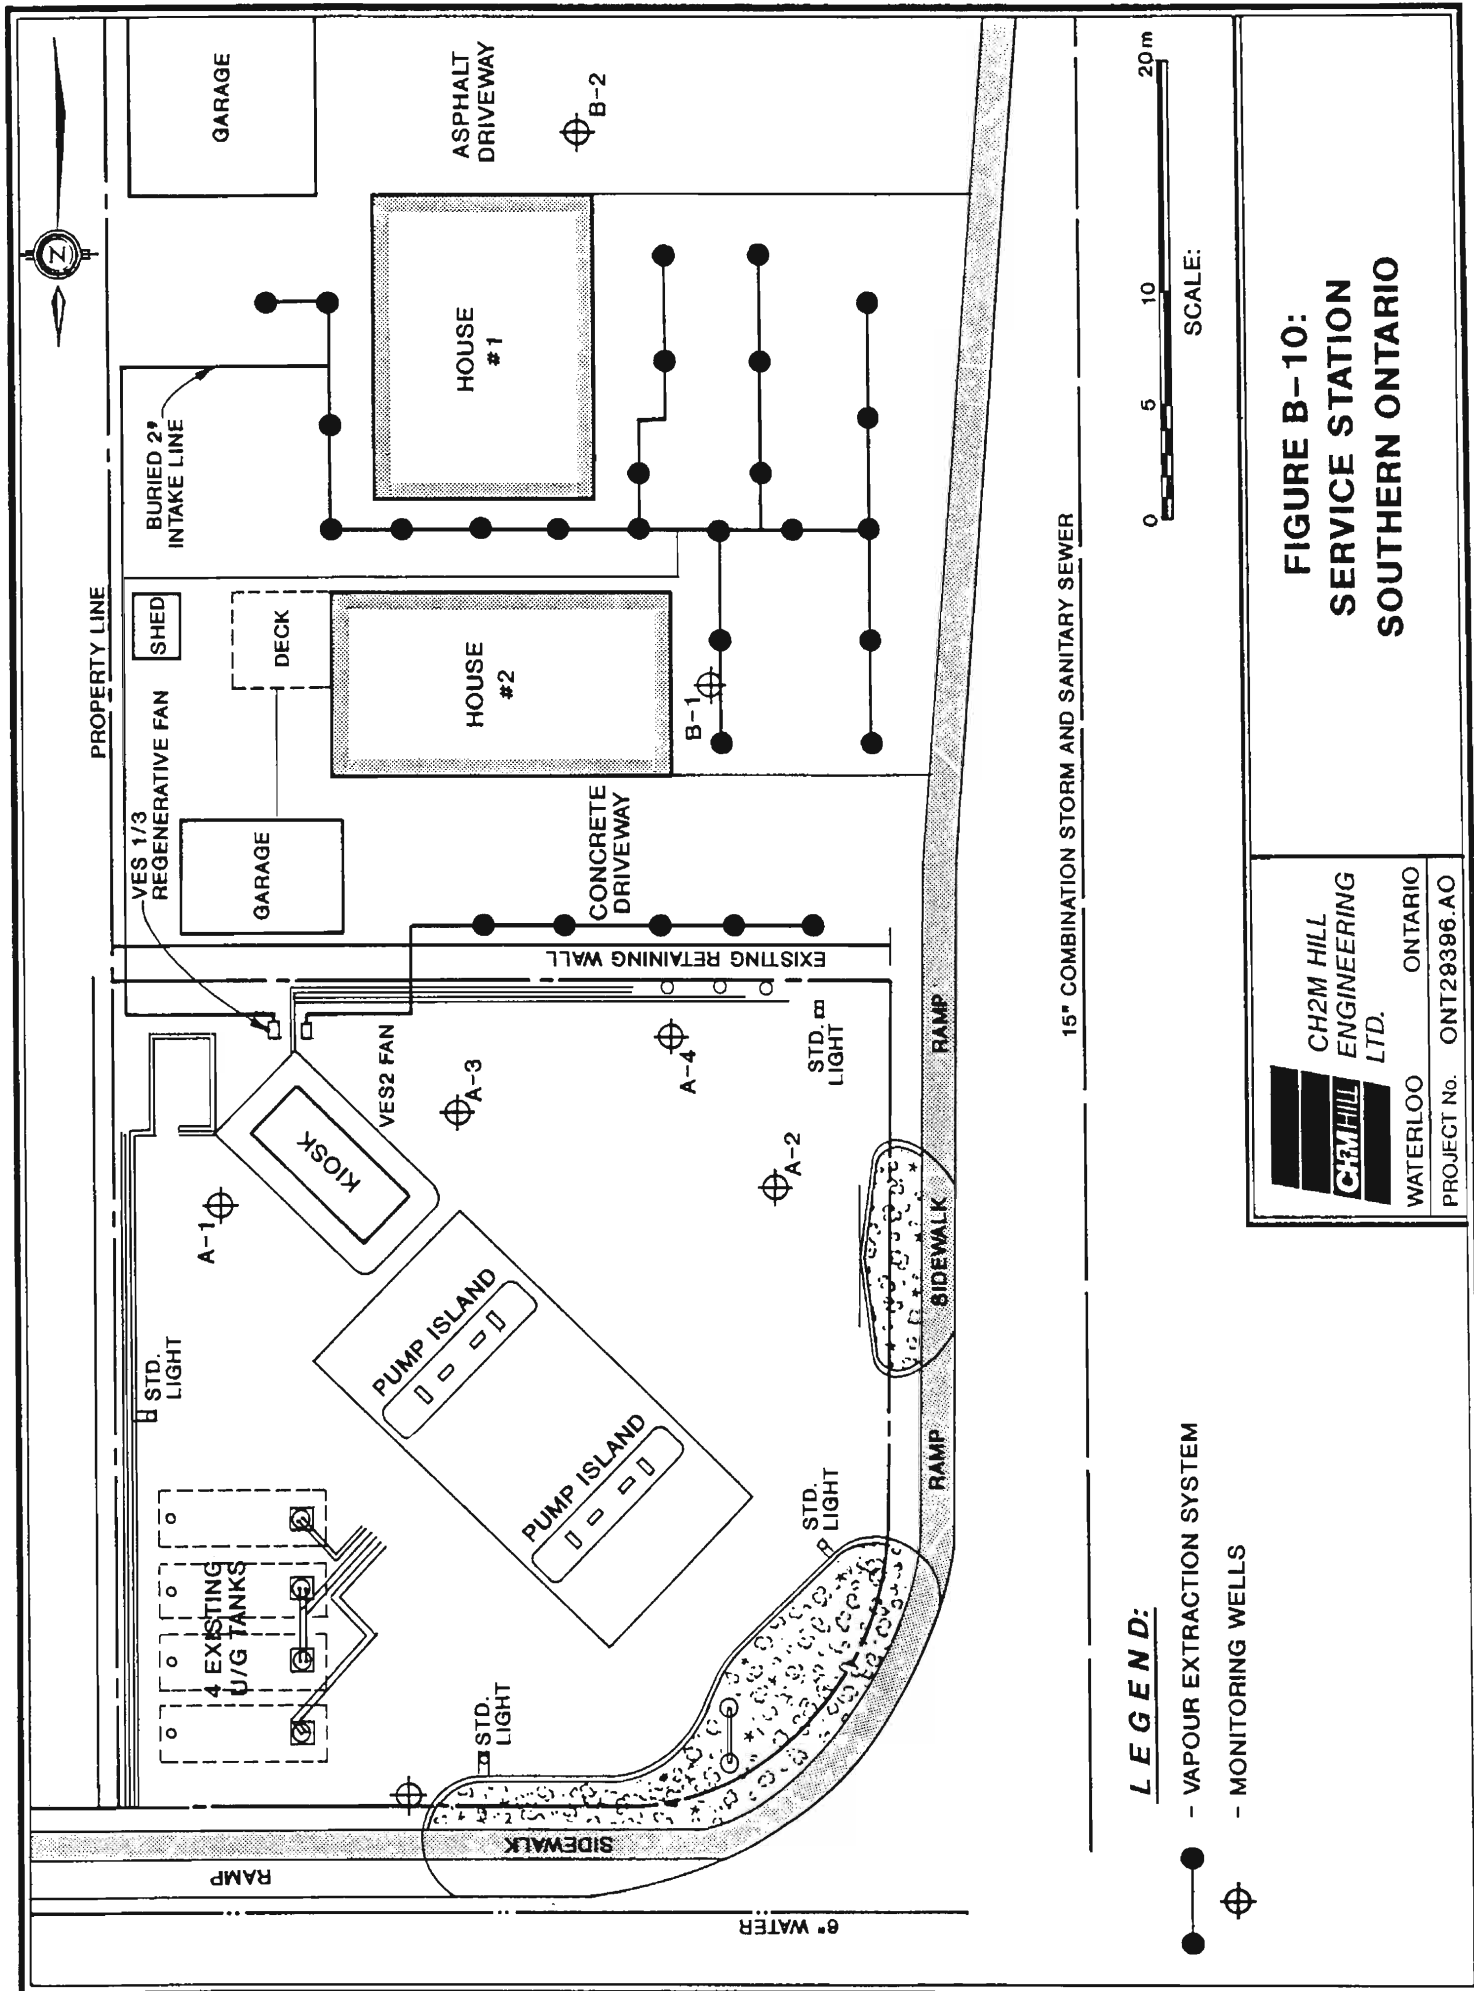
**FIGURE B-10:
SERVICE STATION
SOUTHERN ONTARIO**

In response to these new findings (i.e. the elevated ambient concentrations), the Medical Officer of Health indicated that "these levels are what one would expect from normal household activities in North America and are consistent with published household tests from the U.S.A.". The health officer concluded that the homes were no longer being affected by gasoline seepage from the neighbourhood gas station. The owners could reoccupy their homes.

The cleanup efforts are continuing at this site. The product recovery pumping system was removed January 24, 1989, but the vapour extraction is continuing. The service station has been closed since December 1988 and will remain closed for the foreseeable future. The owners are anticipating to decommission the site in the near future.

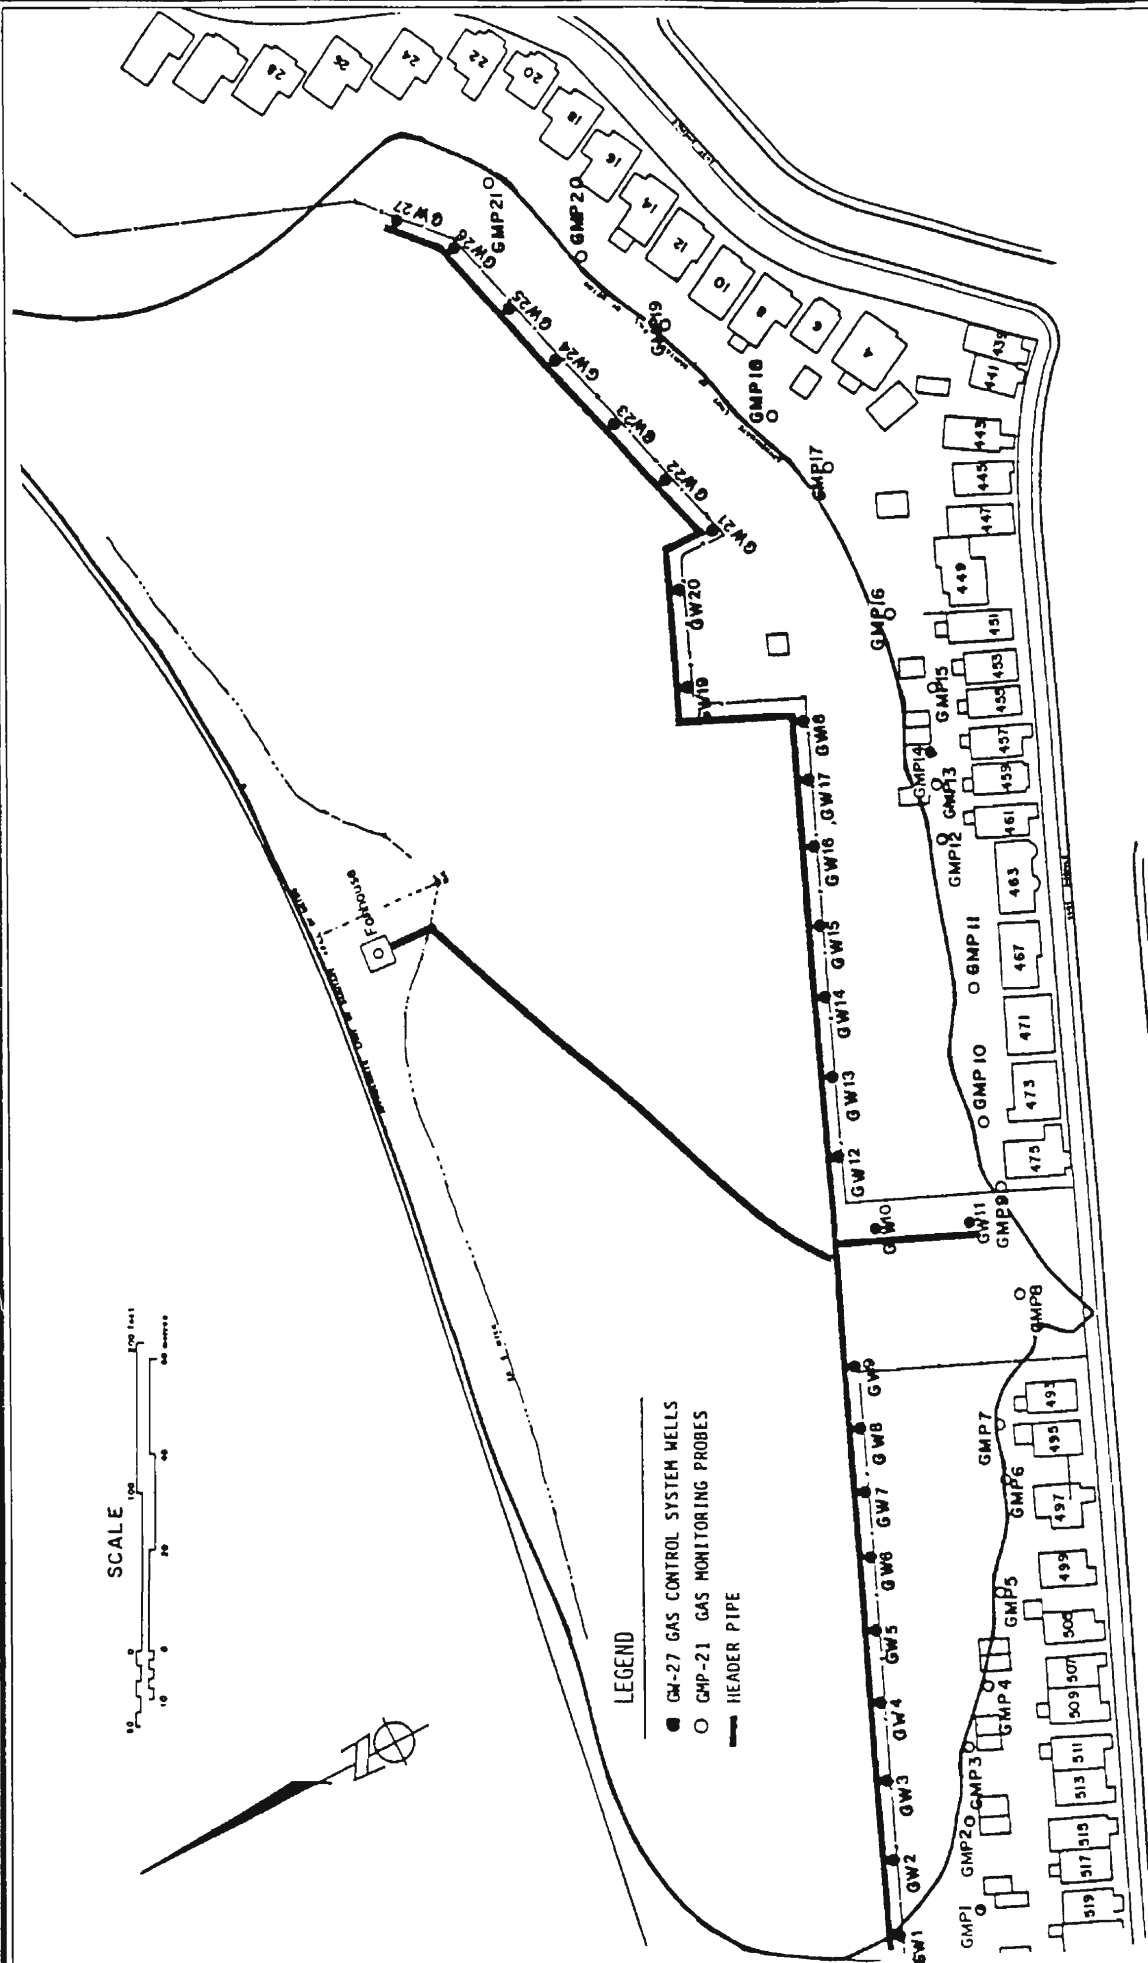
**FIGURE B-29:
SITE PLAN
LANDFILL SITE**

After several years of operation, it was noticed that the flow rates from the gas extraction system were reduced. This fact initiated an investigation to determine the causes for a reduction in venting. Based on the investigation, reduced venting was caused by several factors: plugging of well screens, accumulation of water in the extraction pipes, and settlement of the leader pipe which connected the vertical withdrawal wells.

Many of the problems that were experienced with the extraction system were attributed to the aerobic degradation of the refuse. Aerobic degradation evokes quicker settlement of refuse causing non-uniform settlement of the header pipes which can cause blockages within the vacuum system. The aerobic degradation process also causes higher temperatures to exist within the landfill. Tempera-

tures (~70°C) can cause warping of the PVC pipes which also may reduce flow rates. Aerobic activity was also a contributing factor for slime buildup on the extraction well screens. Several wells were also blocked with water.

As a result of this investigation, header pipes were re-aligned, and several wells were replaced or repaired. Monitoring at the perimeter of the landfill during this entire period showed no signs of methane migration.

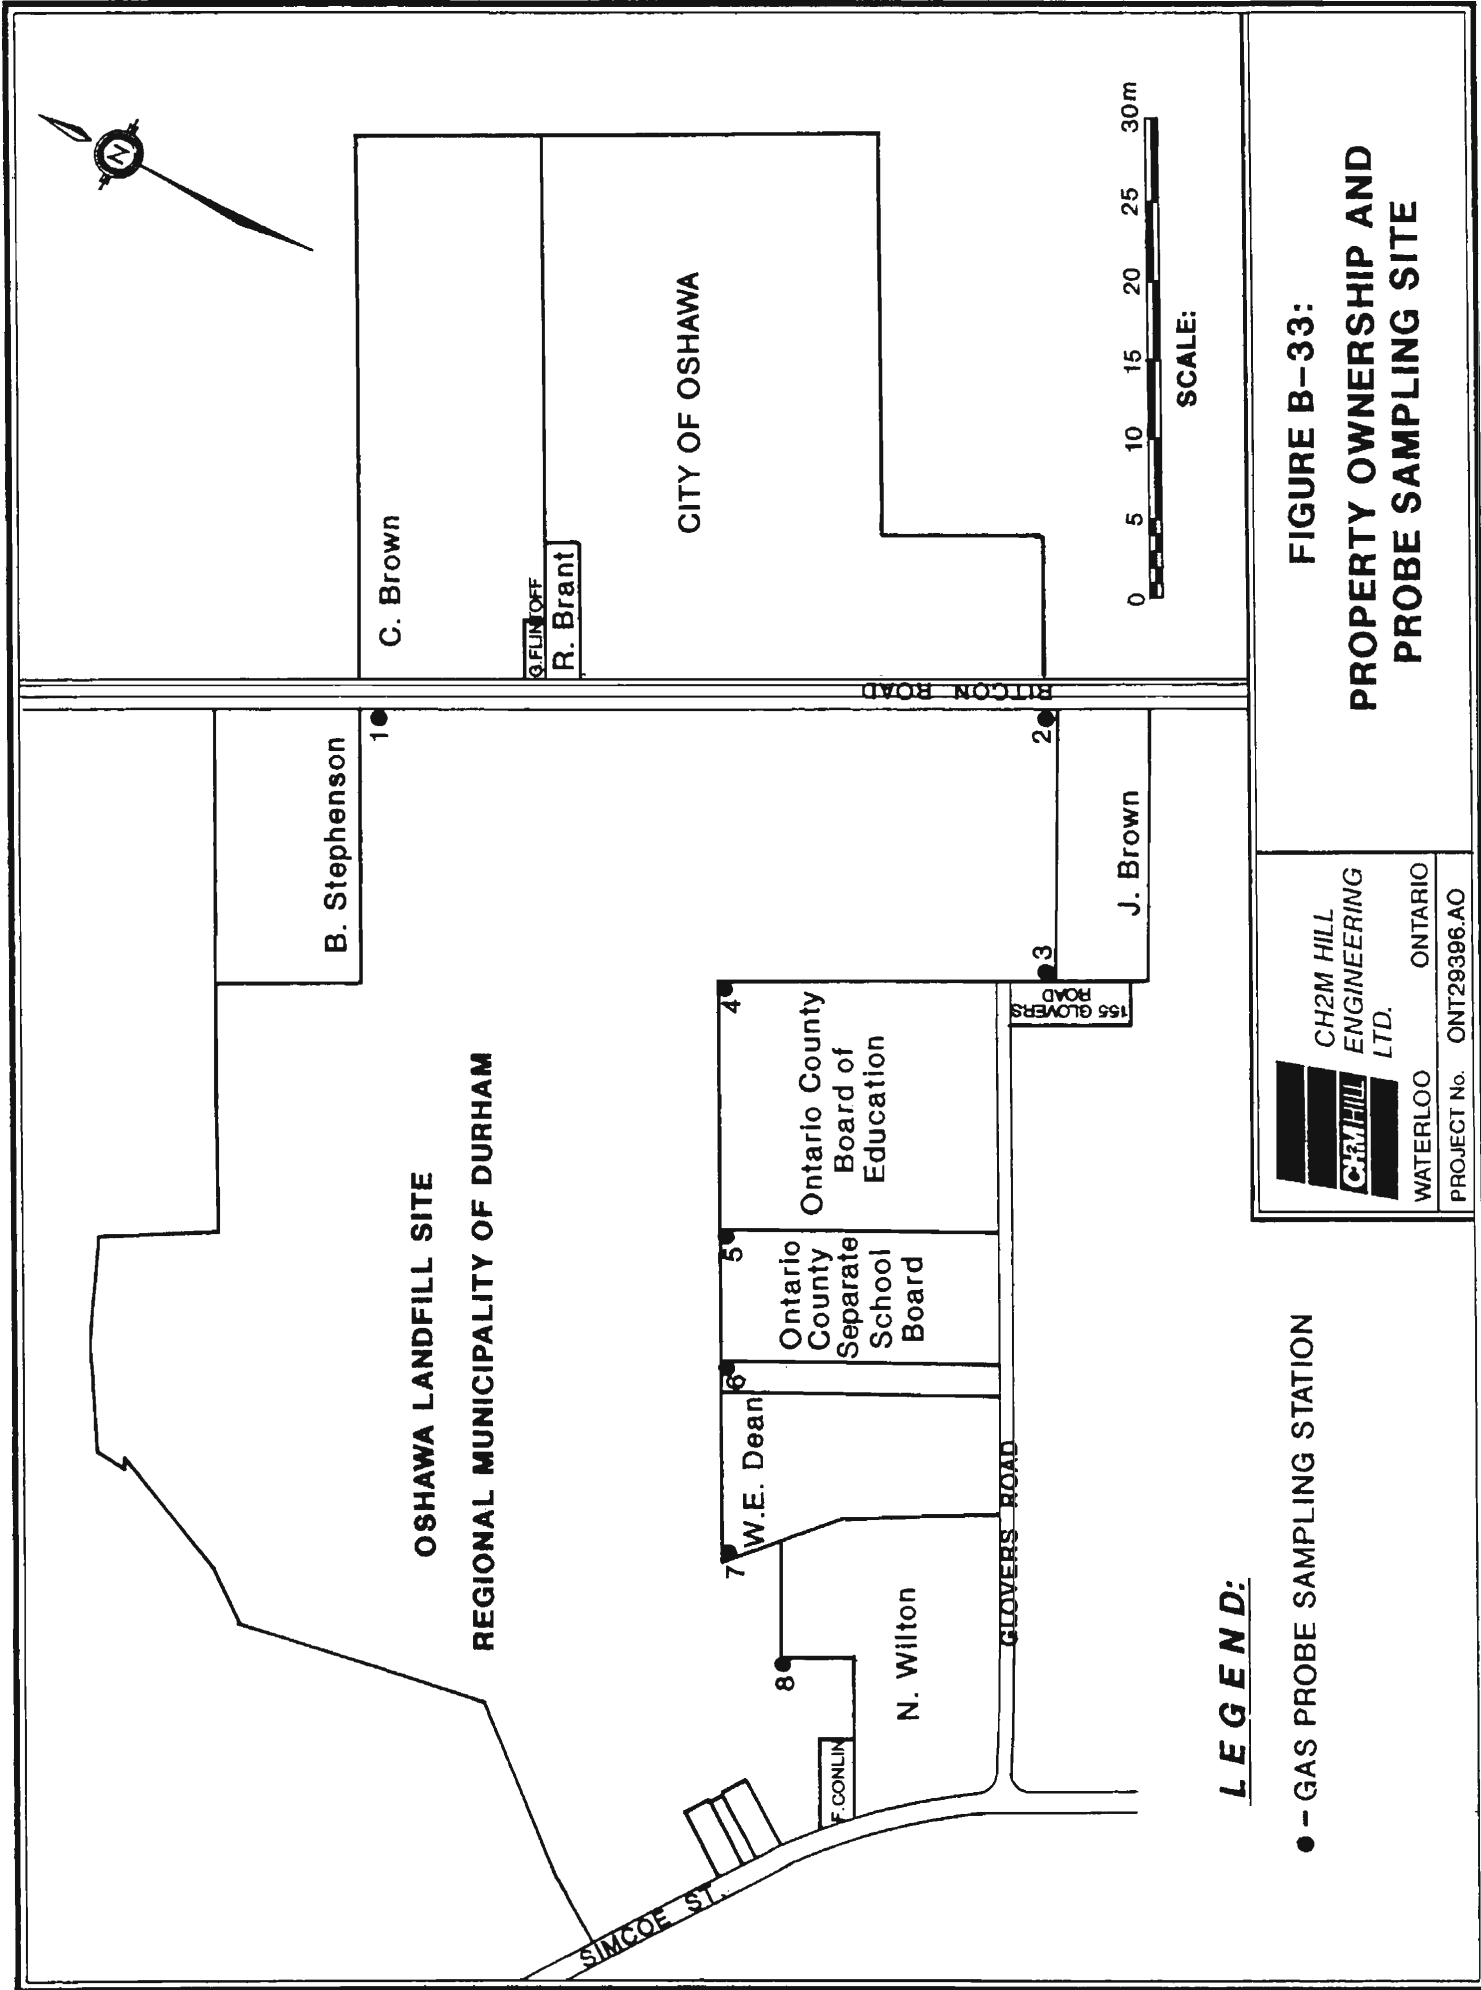
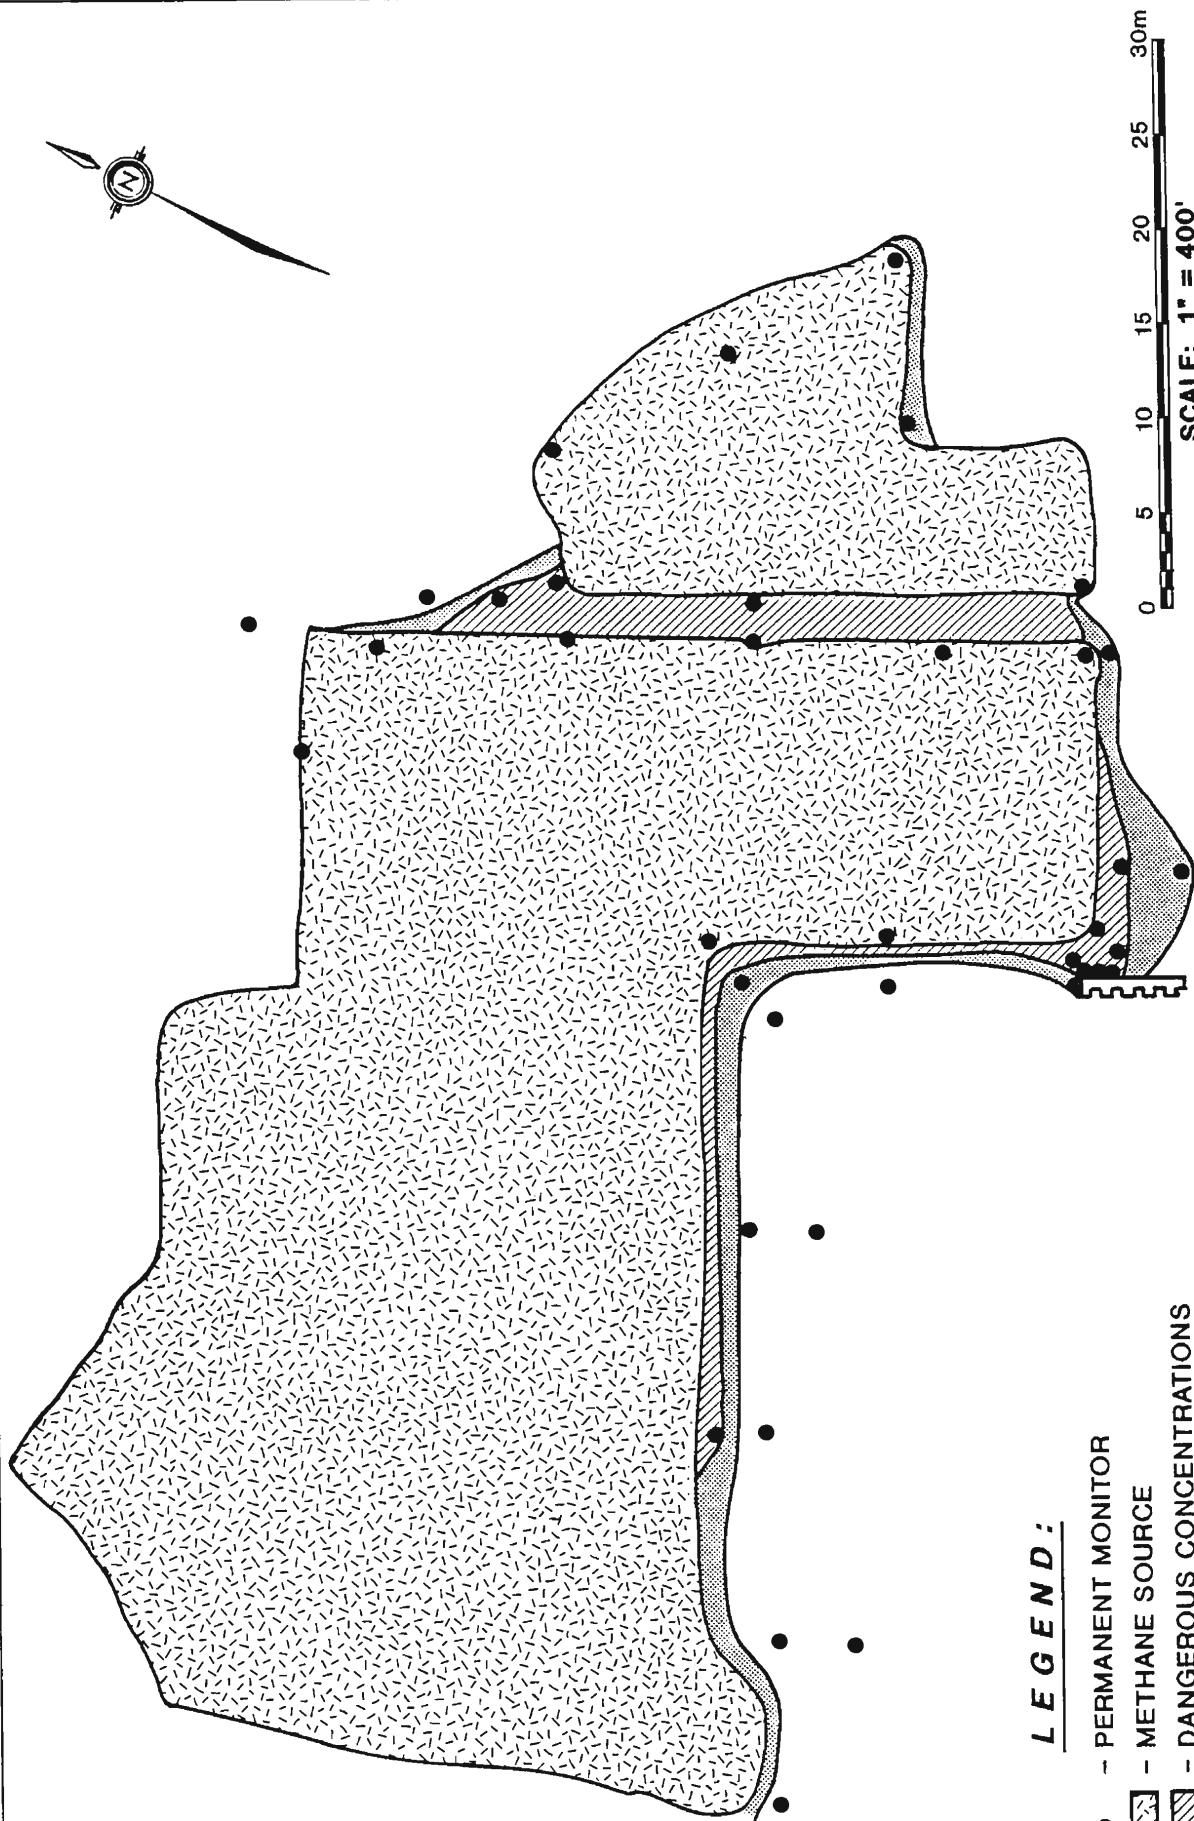
FIGURE B-34:
METHANE DISTRIBUTION
(MARCH 6, 1977)

Methane concentration tests revealed an unusually high level of gas (50 to 60 percent) in the vicinity of the three residential areas and a concentration of CO₂ reaching up to 30 percent. Figure B-34 shows methane distribution. Speculation revealed three possibilities for such high gas concentrations. Firstly, the proximity of the townhouses to the landfill is less than 15 m. Secondly, the affected area is underlain by well-sorted sands and gravel and fill as opposed to the poorly sorted soils found elsewhere. And thirdly, imported topsoil, which is fine-grained has a high moisture retention capacity and is impermeable to gas, is found aplenty. The topsoil has been placed around foundations, thus providing a cap for landfill gases and consequently creating a concentration and pressure gradient towards the building.

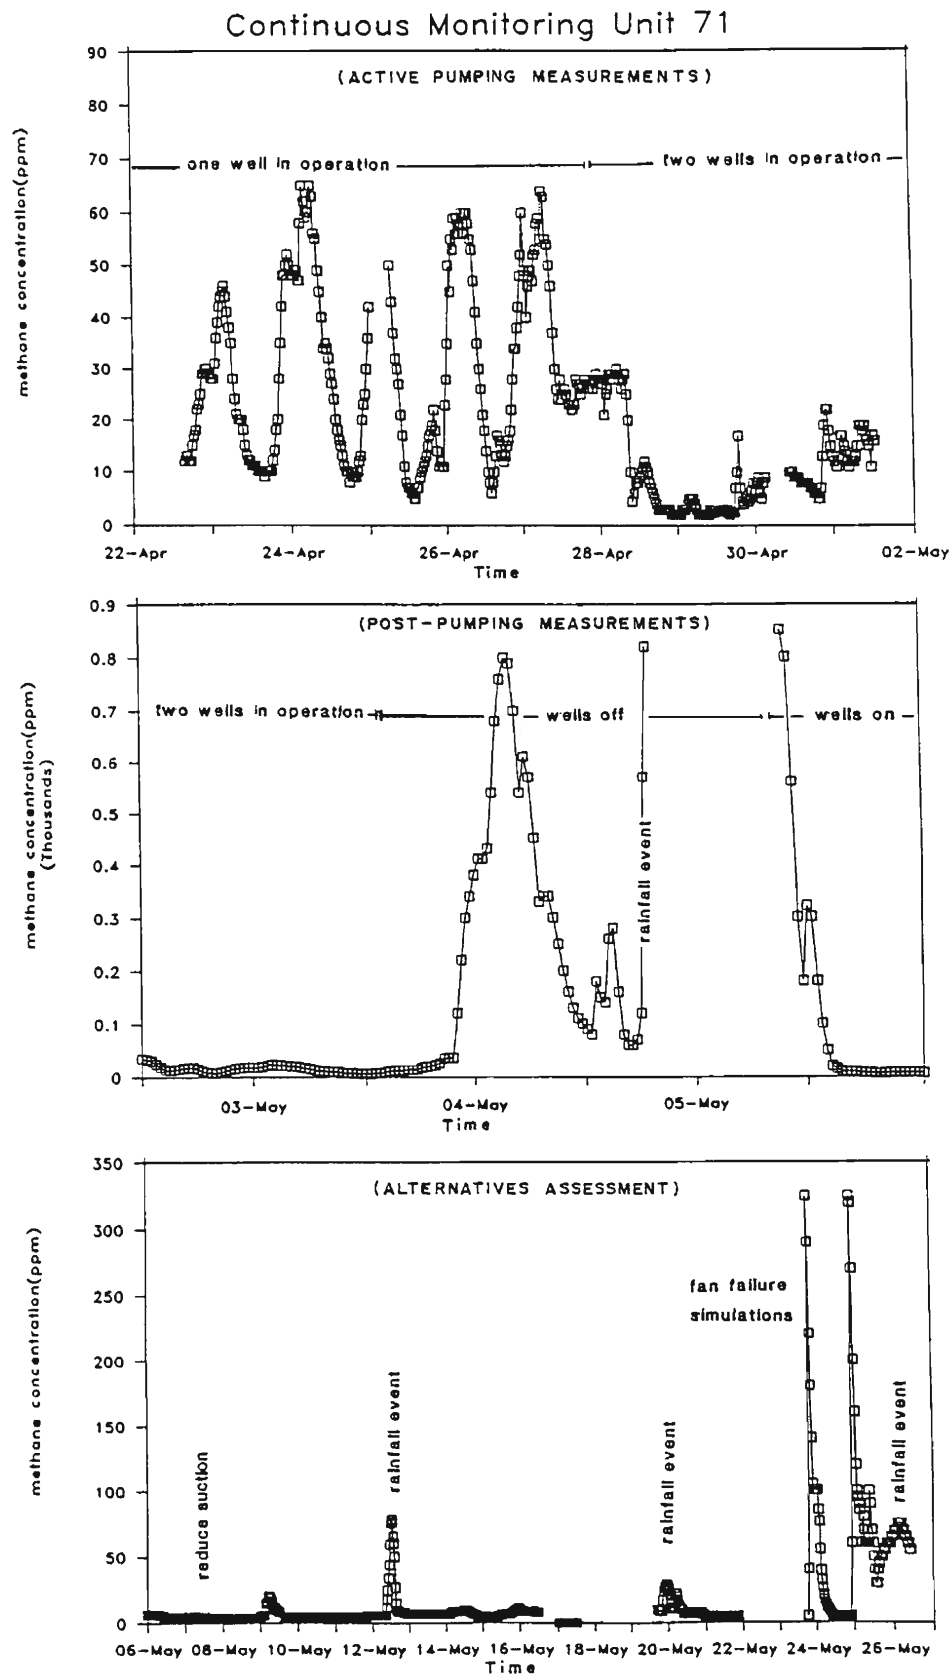
FIGURE B-38:
METHANE CONCENTRATIONS IN UNIT #71
FROM APRIL 22 TO MAY 26

Despite the technical success of this technology, several legal or jurisdictional approvals are still required. Presently, both municipal approval for reoccupation of the homes and Ministry of the Environment Certificate of Approval (Air) have not been given. Negotiations on the extent of necessary monitoring has not been conclusive.

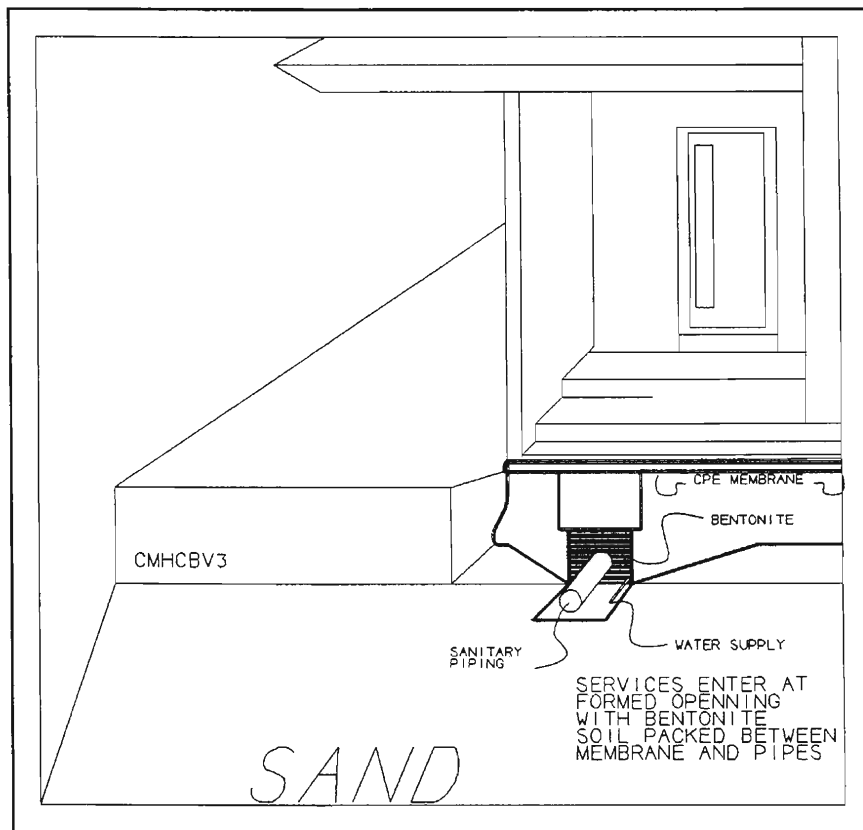
Figure C-3
Detail Showing Installation of Sanitary and Water Services

To date 16 houses and 16 townhouses have been tested; all units tested showed non-detectable levels of methane intrusion. One unit showed methane levels in the 50 PPM range but was determined to be the result of methane generated by lightly contaminated wood waste inside the membrane.
