RESEARCH REPORT

ICE DAMMING FIELD RESEARCH:
ICE DAMMING SOLUTIONS

Ice Damming Field Research Ice Damming Solutions

Ottawa, ON

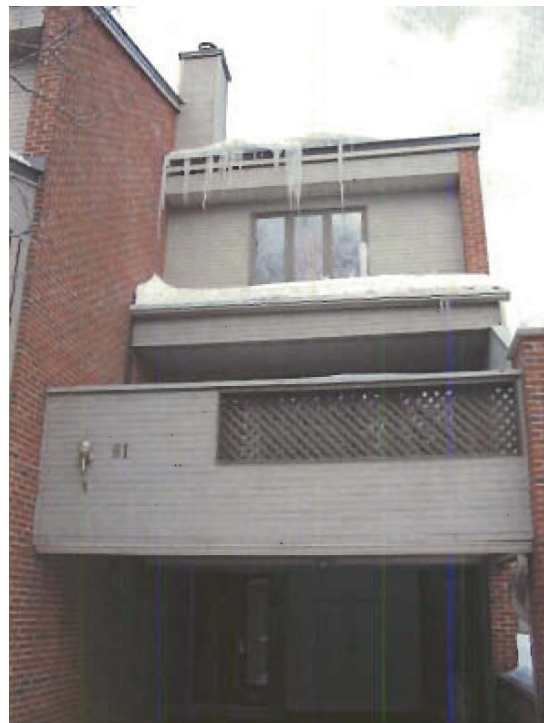
Our visual reviews noted a significant reduction in ice formation during the winter of 2003/04. Photographs 11 through 13 display icicles on typical non-repaired units while Photos 14 through 16 convey similar information on repaired units. These Photos were taken on February 19, 2004, although similar visual results were noted at other times during the winter. It is important to note that the winter of 2004 was not a particularly problematic year for ice damming, as noted in section 4.3, so even small amounts of roof ice could be an indication of a problematic roof from an ice damming perspective.

Photo 12: Site 1, Unrepaired Unit, February 19, 2004

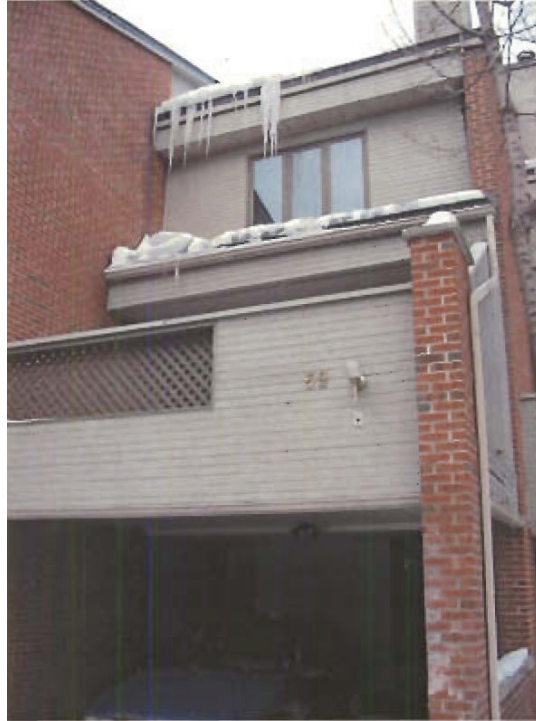
Photo 13: Site 1, Unrepaired Unit, February 19, 2004

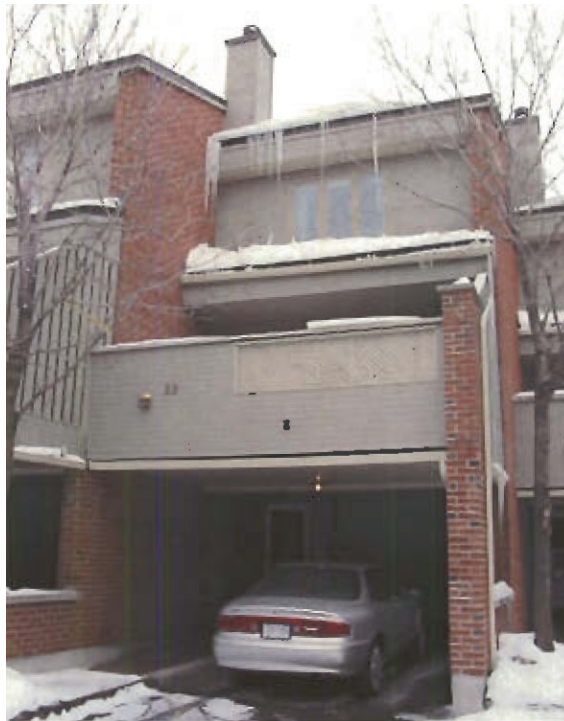
Photo 14: Site 1, Unrepaired Unit, February 19, 2004

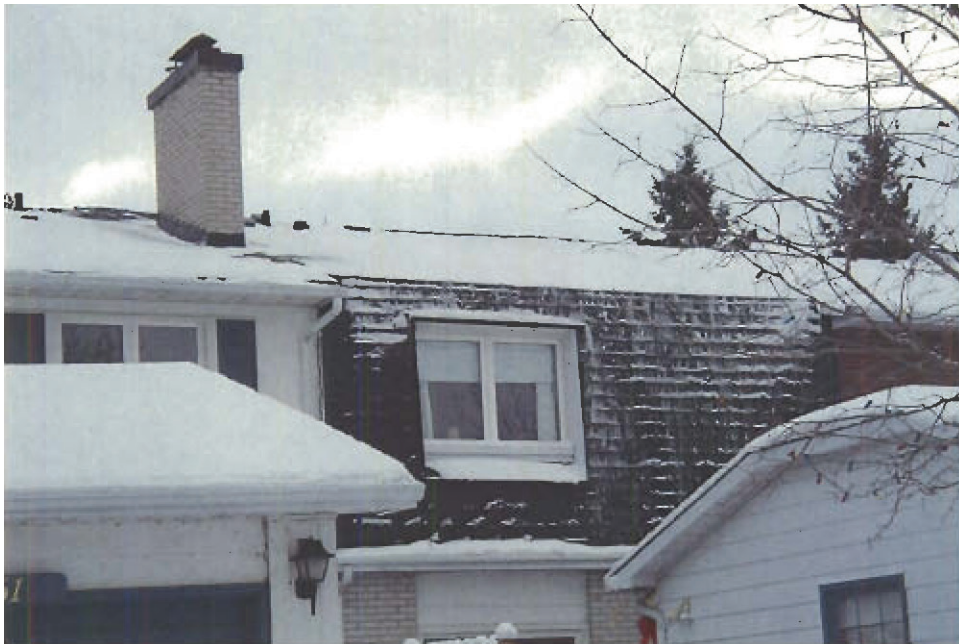
Site 2 is a 62 unit townhouse complex located in Ottawa that the owners reported has been exhibiting moderate to severe ice damming in past years. The complex was constructed in the 1980's and includes units with mansard and conventional style roofs with a 4/12 slope, as shown in Photos 17 and 18. The roofs do not have dormers, but have two chimneys and smaller (vent) penetrations.

Photo 18: Site 2, Ice Formation on Mansard Style Roofs

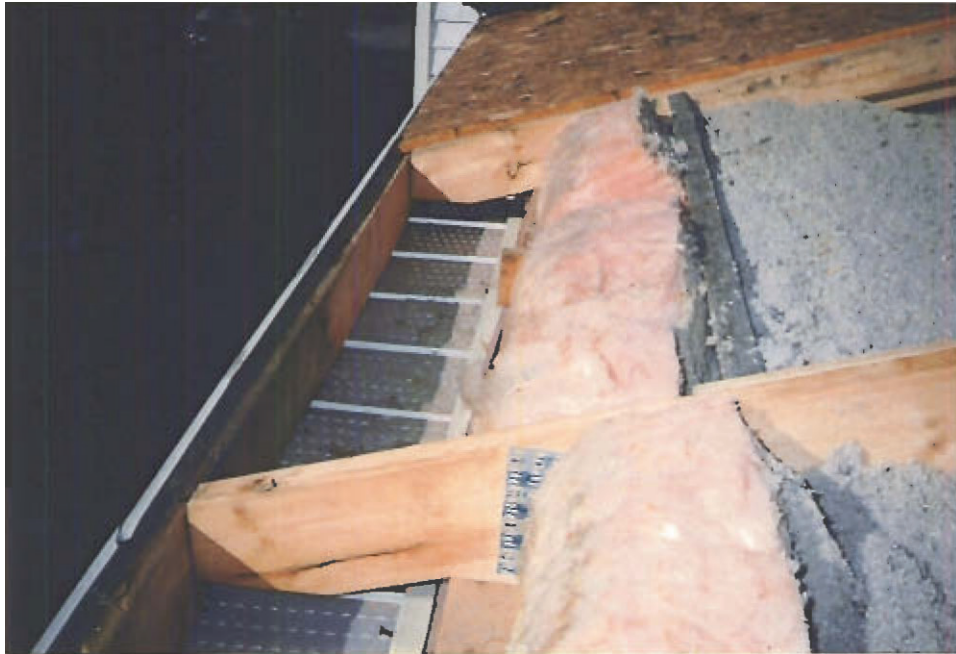
Photo 41: Site 4, Blocked Soffit Ventilation

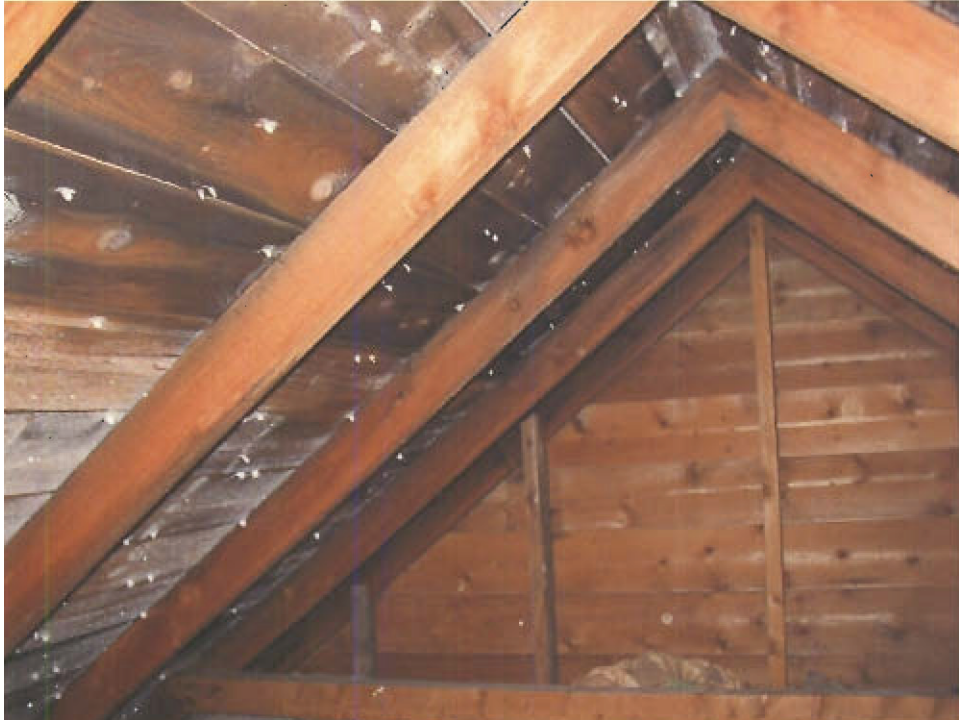
Photo 56: Manotick, Front on Underside of Sheathing
