## Renovation Strategies for Brick Veneer Steel Stud Construction: Task I Brick Ties

**BRICK VENEER/STEEL STUD RENOVATION STRATEGIES FOR  
WALL CONSTRUCTION**

**TASK 1:  
BRICK TIES - OPTIONS FOR REMEDIATION**

M.A. Postma, E.F.P. Burnett  
Building Engineering Group  
University of Waterloo

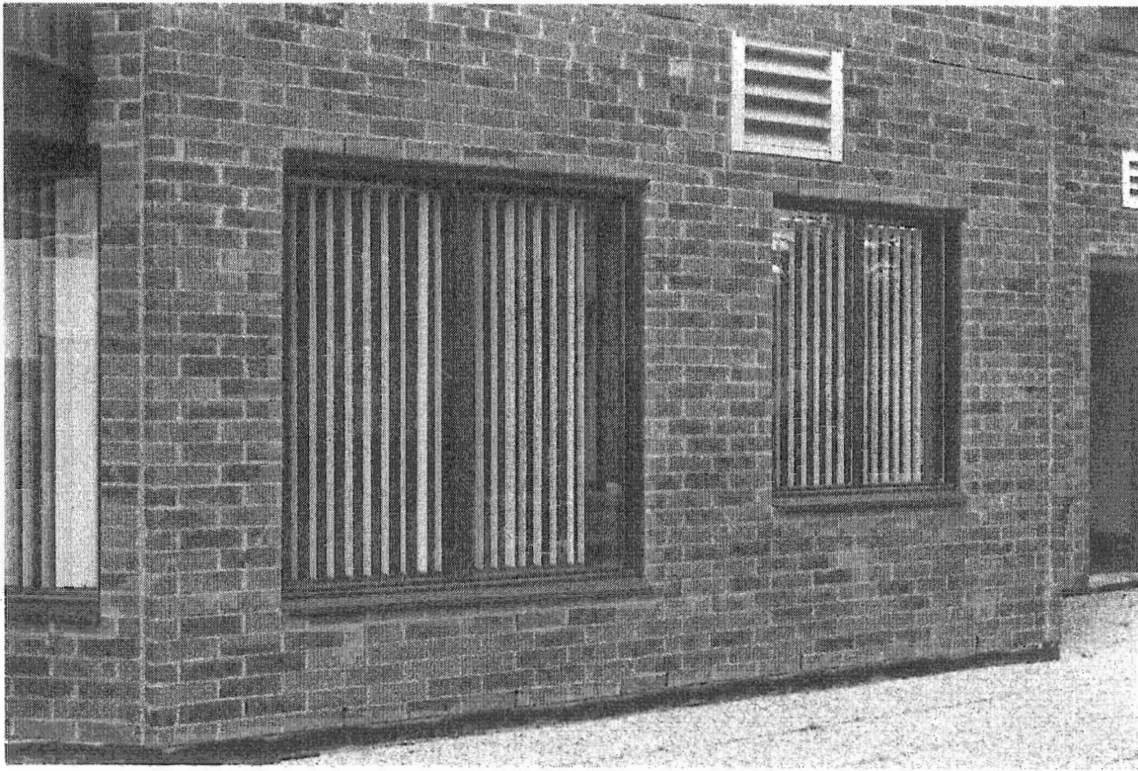
**Photo 1 - Exterior of Wall Used for Demonstrations**

The section of non-structural external wall on which the demonstrations were made is located on the ground floor in a large room containing exercise equipment and a jacuzzi. Photo 1 shows an exterior view of this wall. Photo 2 shows an interior view of this wall.

Because the wrong ties have been used and because of installation problems, some supplementary ties need to be installed. These deficiencies make this building suitable for this project to physically demonstrate various remedial methods for installing supplementary ties.

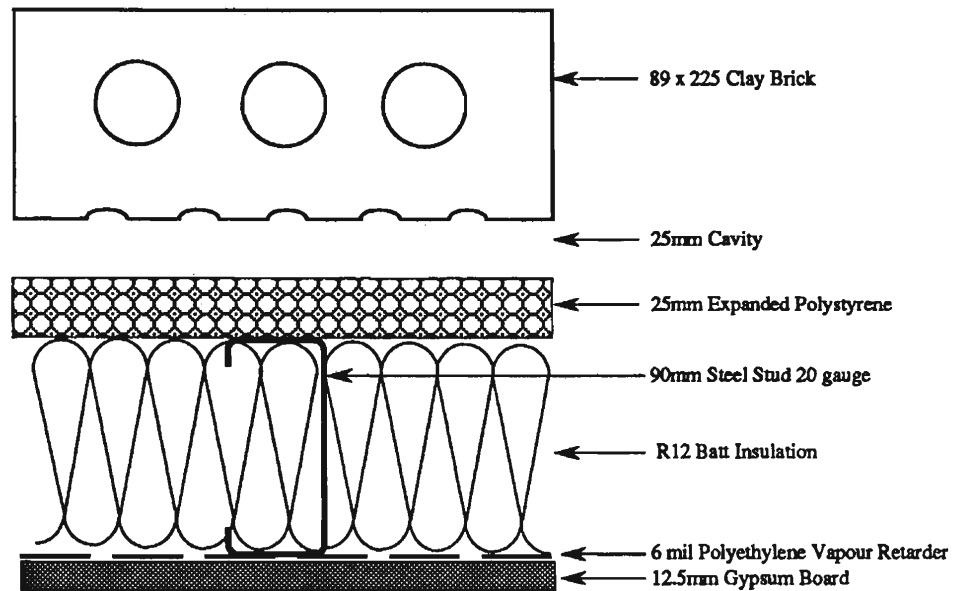
**FIGURE 1 --- Cross Section of Brick Veneer/Steel Stud Wall**

Figure 1, shows the composition of the wall :

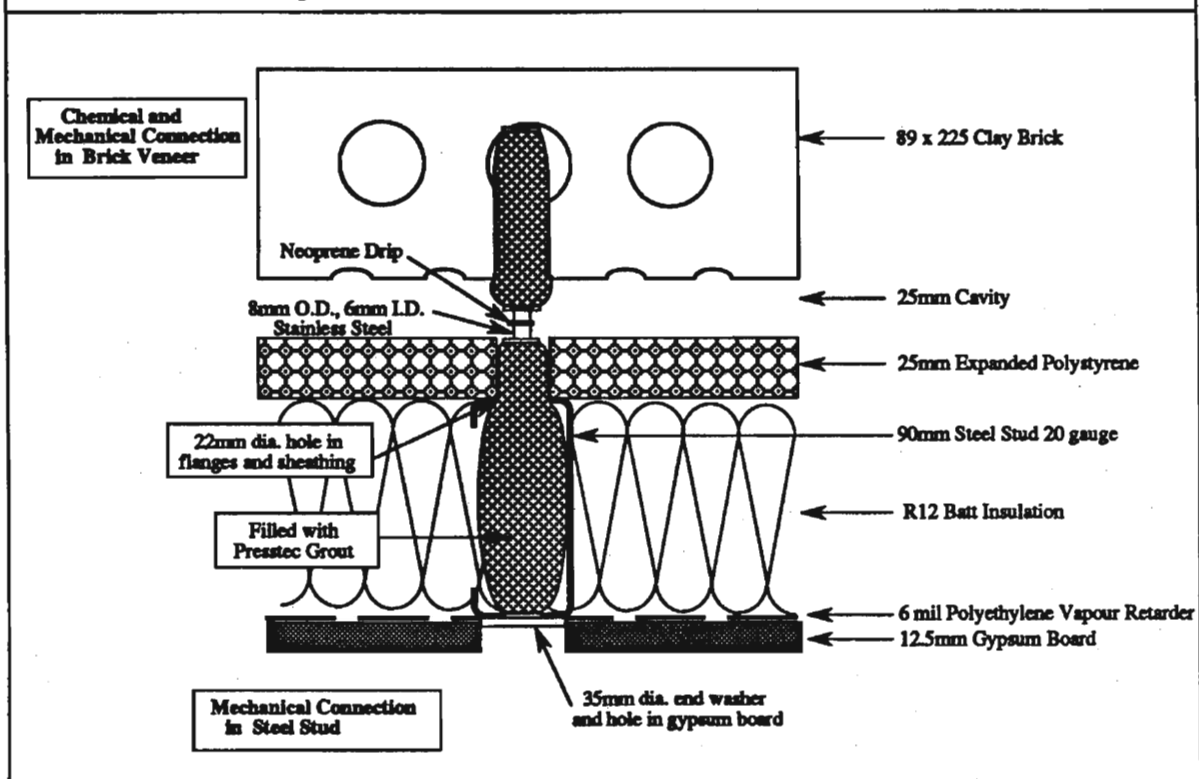
**FIGURE 2 : Repair Method INT1 - Cintec Cementitious Sock with a 22mm Hole**

The Cintec cementitious sock anchor employs both a mechanical attachment and chemical bond. The tie consists of an 8mm O.D. , 6mm I.D. stainless steel cylinder with a polyester sock on each end. The tie is inserted in the pre-drilled holes in the brick veneer and the steel stud. Presstec grout, a one component mix of Portland cement, graded aggregate and additives, is injected under pressure to fill and inflate the sock. Grout passes through the expanded sock mesh to provide chemical bond to the brick and the expansion of the sock in the voids of the brick and within the steel stud develops mechanical attachment. Figure 2 illustrates the Cintec 22mm tie repair.

STEP #	DESCRIPTION	TIME (sec)
1	Locate Stud	
2	Drill Through Steel Stud Flanges - 22 mm dia. core on extension - regular drill	60 seconds
3	Drill Into Brick Veneer - 22 mm dia. masonry drill bit - hammer drill - mark distance on drill bit	120 seconds
4	Measure up sock system	
5	Mark and cut drywall to recess 35 mm dia. end washer	30 seconds
6	Insert tie into hole	
7	Inject Grout	15 seconds
8	Repair Hole	
Total Observed Time for Repair		225 seconds

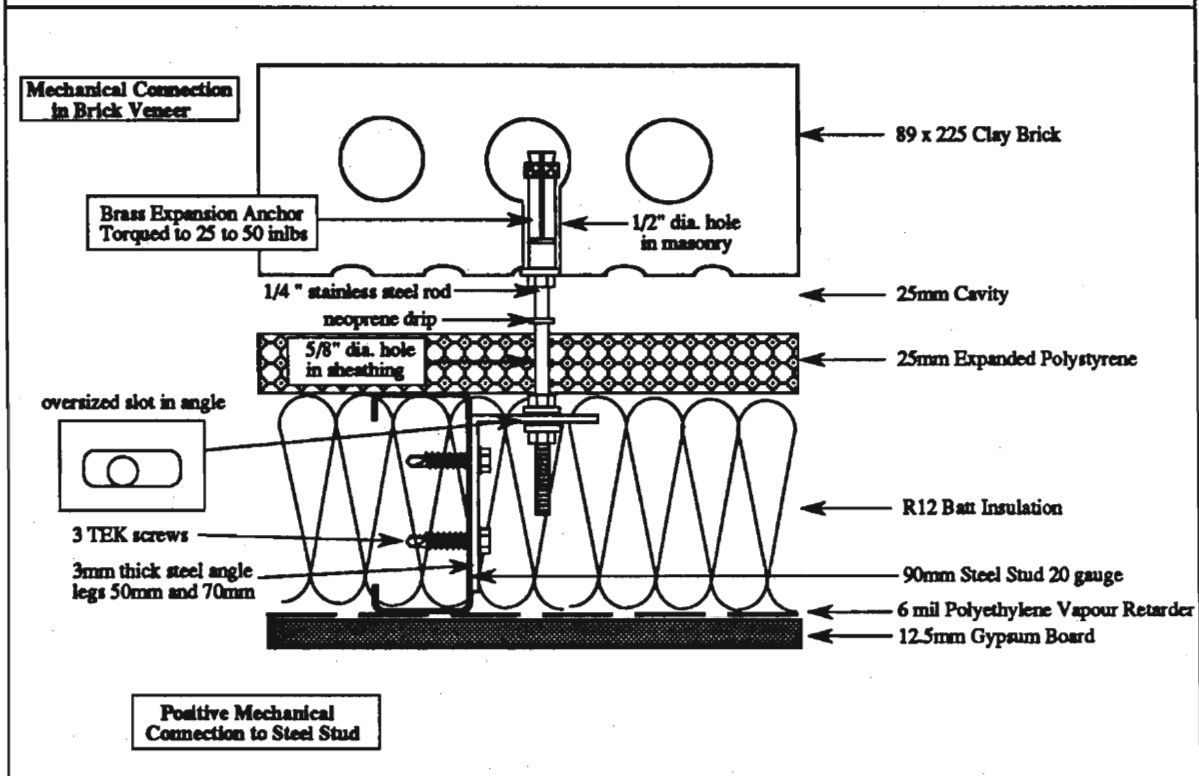
**FIGURE 3 : Repair Method INT2 - Dur-O-Wal Side Bracket and Expansion Anchor**

The tie used in this repair method has components made of brass, steel, and stainless steel. Photo 7 shows these components. This repair method uses a brass expanding shell to provide the attachment in the brick. This brass unit is threaded onto a 1/4" (5.5mm) dia. 304 stainless steel rod. On this rod is a neoprene drip in line with the theoretical centerline of the air cavity to prevent the passage of moisture down the rod. A 3mm thick steel angle with legs of length 50 and 70 mm is attached to the web section of the steel stud with three TEK screws. The leg of this steel angle that is parallel to the brick veneer has an oversized slot which holds the other end of the threaded rod. A nut and washer threaded, but not tightened, on the rod on each side of this leg of the angle to give a tension and compression attachment but to allow both vertical and horizontal movement. Figure 3 illustrates the INT2 - Dur-O-Wal repair system.

STEP #	DESCRIPTION	TIME (sec)
1	Locate Stud and determine orientation of C channel	
2	Cut 300mm x 400mm hole in the gypsum board and 6 mil polyethylene	60 seconds
3	Drill Into Brick Veneer <ul style="list-style-type: none"> <li>- 1/2" dia. masonry drill bit</li> <li>- rotary drill action</li> <li>- mark distance on drill bit</li> </ul>	60 seconds
4	Install Expansion Anchor and torque to 50 to 100 in lbs	20 seconds
5	Position and fasten steel angle to the web of the steel stud with 3 TEK screws	60 seconds
6	Adjust nuts around leg of steel angle	
7	Repair Hole	
Total Observed Time for Repair		200 seconds

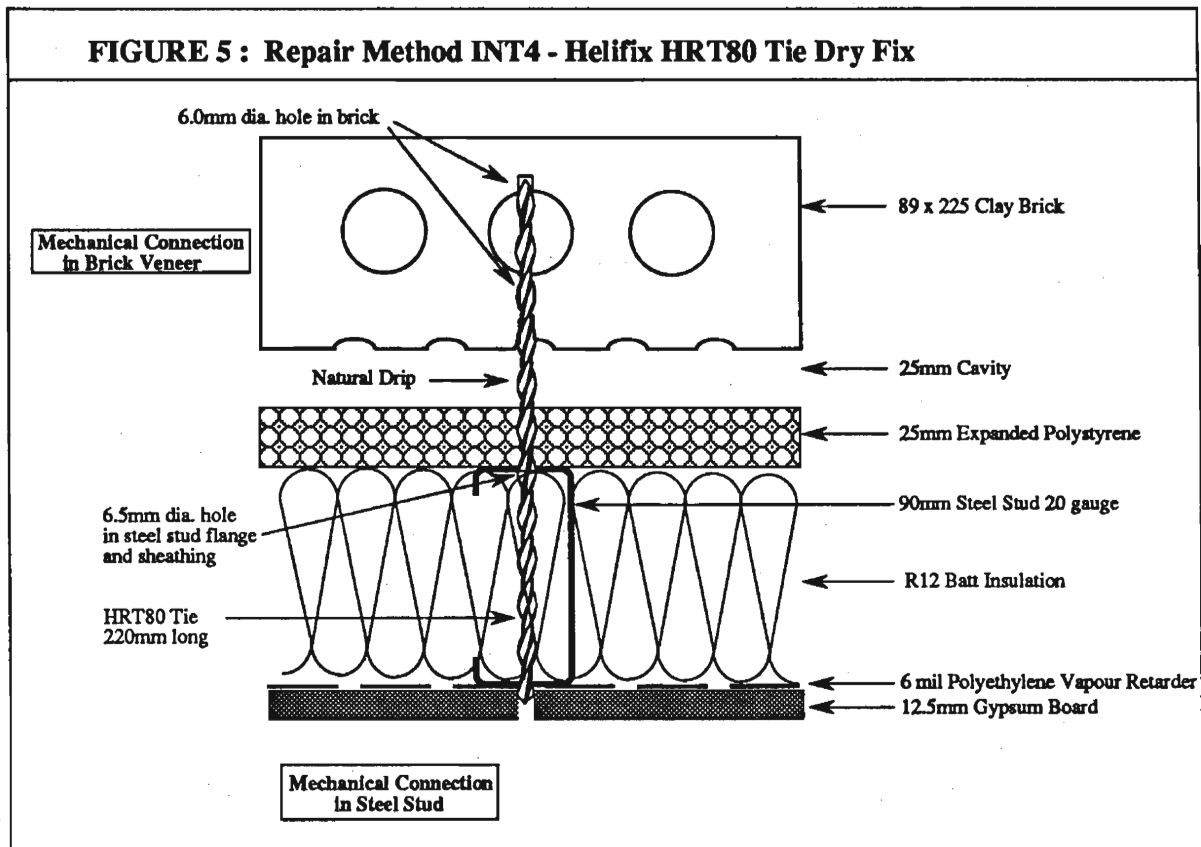
**FIGURE 5 : Repair Method INT4 - Helifix HRT80 Tie Dry Fix**

**Strength of Connection** - The Helifix tie achieves a mechanical fix by threading into the steel stud and the brick veneer. Both flanges of the stud are engaged (see Photos 11 and 12). The effectiveness of this connection needs to be determined. The strength of the HRT80 tie to the brick masonry has been documented while the strength of HRT80 dry installed in mortar has not been tested. The strength of the HRT80 connection to the steel stud also needs to be determined.

STEP #	DESCRIPTION	TIME (sec)
1	Locate Stud	
2	Drill Through Steel Stud Flanges - 6.5mm dia. steel drill bit - rotary drill action only	15 seconds
3	Drill Into Brick Veneer - 6mm dia. masonry drill bit - hammer drill action - mark distance on drill bit	25 seconds
4	Drive HRT80 tie through the steel stud and into the brick	60 seconds
5	Repair Hole	
Total Observed Time for Repair		100 seconds

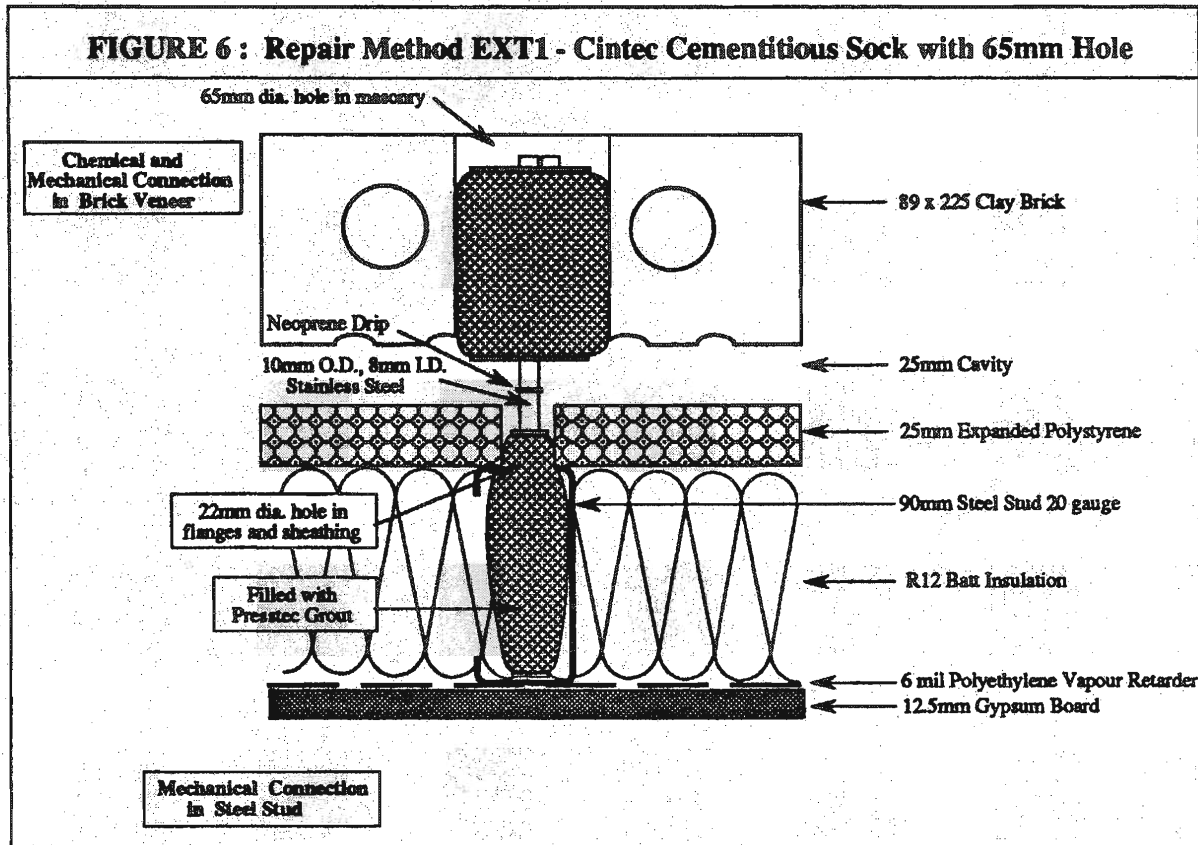
After location of the stud, a 2 5/8" (67mm) dia. diamond tip core was used to drill through the clay brick. The hole was then cut in the sheathing to locate the stud exactly. A 22mm dia. hole was drilled into the outer flange of the steel stud with a steel drill bit. The depth of the hole was measured in order to size the tie and position of the socks. After the tie was inserted into the hole a cementitious grout was pumped into the anchor which inflated both the exterior and interior sock.

STEP #	DESCRIPTION	TIME (sec)
1	Locate Stud	
2	Drill Through Brick Veneer - 2 5/8" (67 mm) dia. diamond tip core - hammer drill	90-180 seconds
3	Cut hole in sheathing to locate stud	10 seconds
4	Drill Into Outer Flange of Steel Stud - 22 mm dia. steel core bit	30 seconds
5	Measure up sock system	
6	Insert tie into hole	
7	Inject Grout	30 seconds
8	Repair Hole	
Total Observed Time for Repair		205 seconds

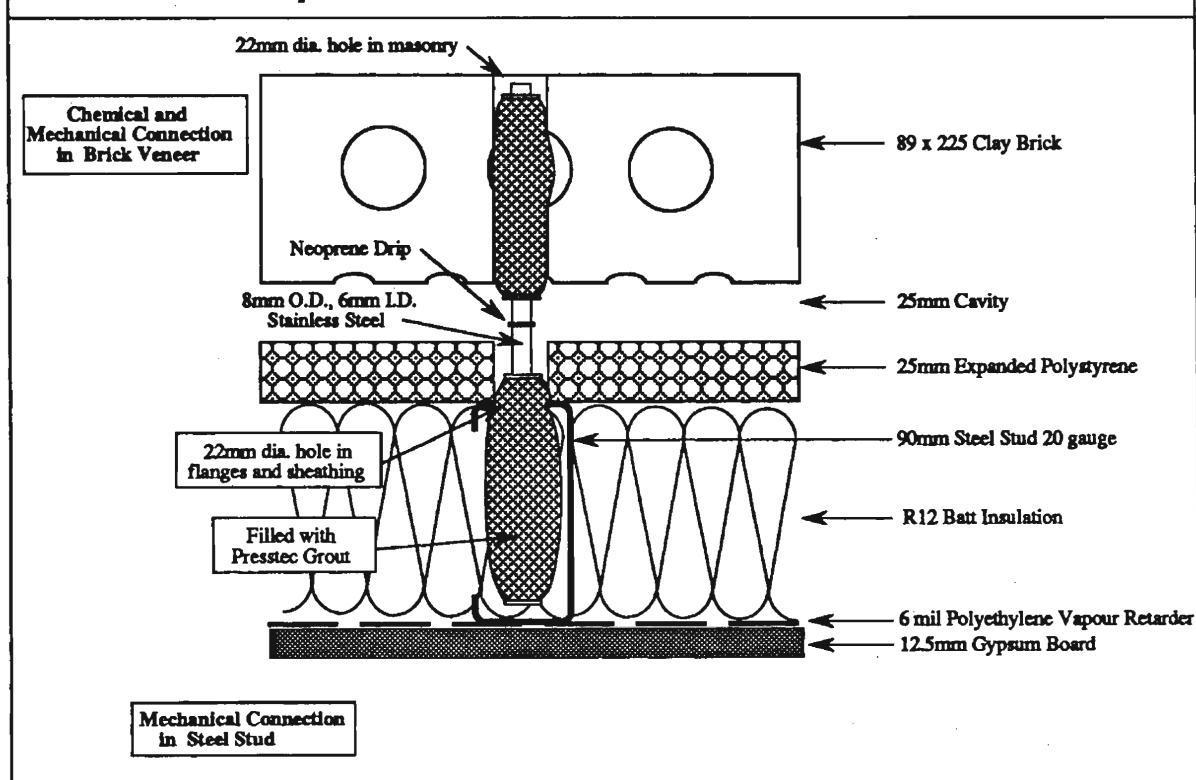
**FIGURE 7 : Repair Method EXT2 - Cintec Cementitious Sock with 22mm Hole**

Like the two previous Cintec anchors, this tie connects in-situ material together using both a mechanical and chemical bond. The tie consists of a 8mm O.D., 6mm I.D. stainless steel section with a polyester based sock on each end. The tie is inserted in the drilled holes in the brick veneer and the steel stud. Presstec grout, a one component mix of Portland cement, graded aggregate and additives, is injected under pressure inflating the sock. Milk grout passes through the expanded sock mesh to provide the chemical bond and the expansion of the sock in the voids of the brick and around the steel stud flange result in a mechanical attachment. Figure 7 illustrates the Cintec 22mm tie repair system.

STEP #	DESCRIPTION	TIME (sec)
1	Locate Stud	
2	Drill Through Brick Veneer - 22 mm dia. diamond tip core - hammer drill	45 seconds
3	Cut hole in sheathing to locate stud	10 seconds
4	Drill Into Outer Flange of Steel Stud - 22 mm dia. steel core bit	30 seconds
5	Measure up sock system	
6	Insert tie into hole	
7	Inject Grout	30 seconds
8	Repair Hole	
Total Observed Time for Repair		115 seconds

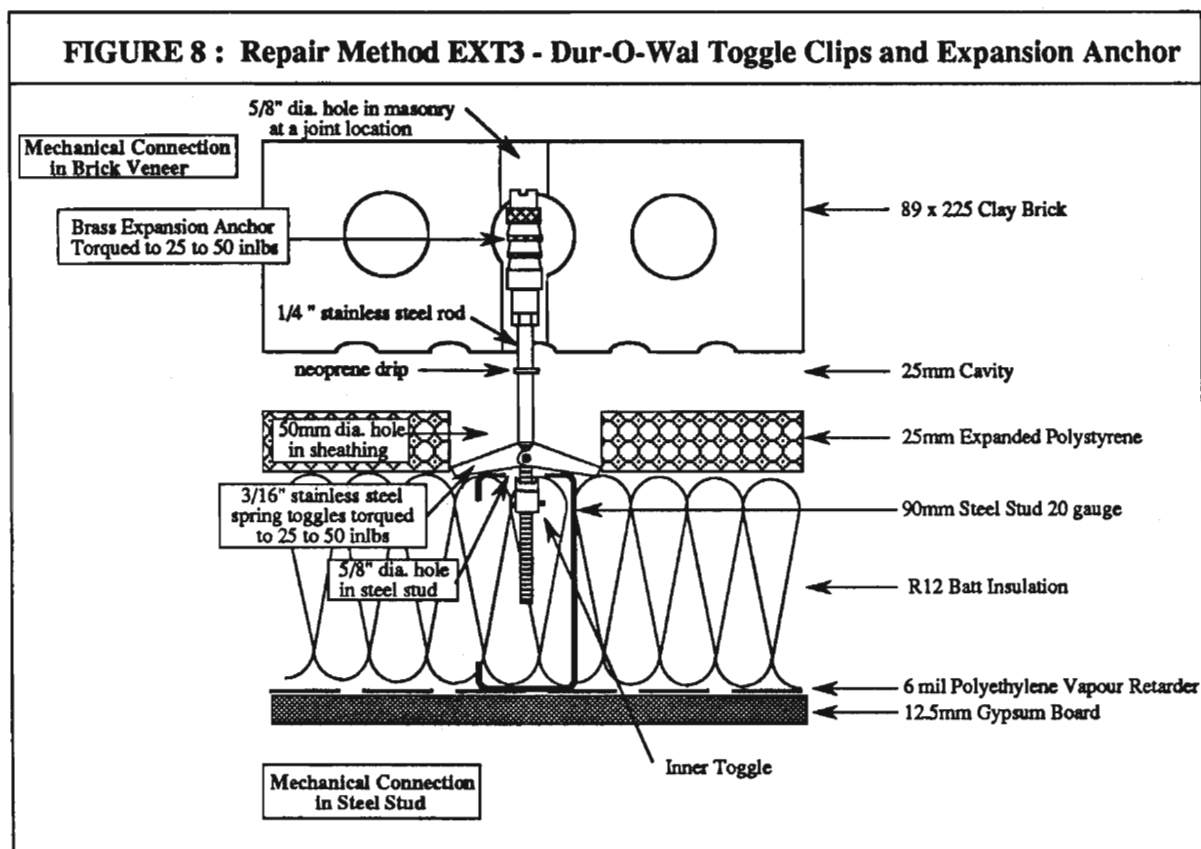
Using a 5/8" dia. masonry drill bit and rotary action, a hole was drilled into the brick veneer at a joint location. A 5/8" dia. hole was also drilled in the outer flange of the steel stud using a metal drill bit and no pre-drilled hole. Any debris in the hole was then blown out. The toggle clips on the end of the 1/4" anchor was then pushed into the hole until the inner toggle was past the flange of the steel stud and the outer toggle was in the cavity. Using the Dur-O-Wal key tool the toggle clips were slowly pulled together. The toggles broke through the expanded polystyrene sheathing and were torqued to 35 in lbs on the steel stud flange. The brass expansion anchor unit was then inserted in the hole and using the Dur-O-Wal key tool the expansion shells were expanded engaging the brick. This expansion anchor was torqued to 25 to 50 in lbs.

STEP #	DESCRIPTION	TIME (sec)
1	Locate Stud	
2	Drill Through Brick Veneer Mortar Joint - 5/8" dia. masonry drill bit - rotary drill action	70 seconds
3	Drill Through Outer Flange of Steel Stud - 5/8" dia. steel bit	15 seconds
4	Blow debris out of hole	10 seconds
5	Insert toggle clips on anchor rod into the hole, tighten the toggle clamps until hitting the steel stud, torque to 35 to 50 in lbs.	90 seconds
6	Install Expansion Anchor and torque to 25 to 50 in lbs	40 seconds
7	Repair Hole	
Total Observed Time for Repair		225 seconds

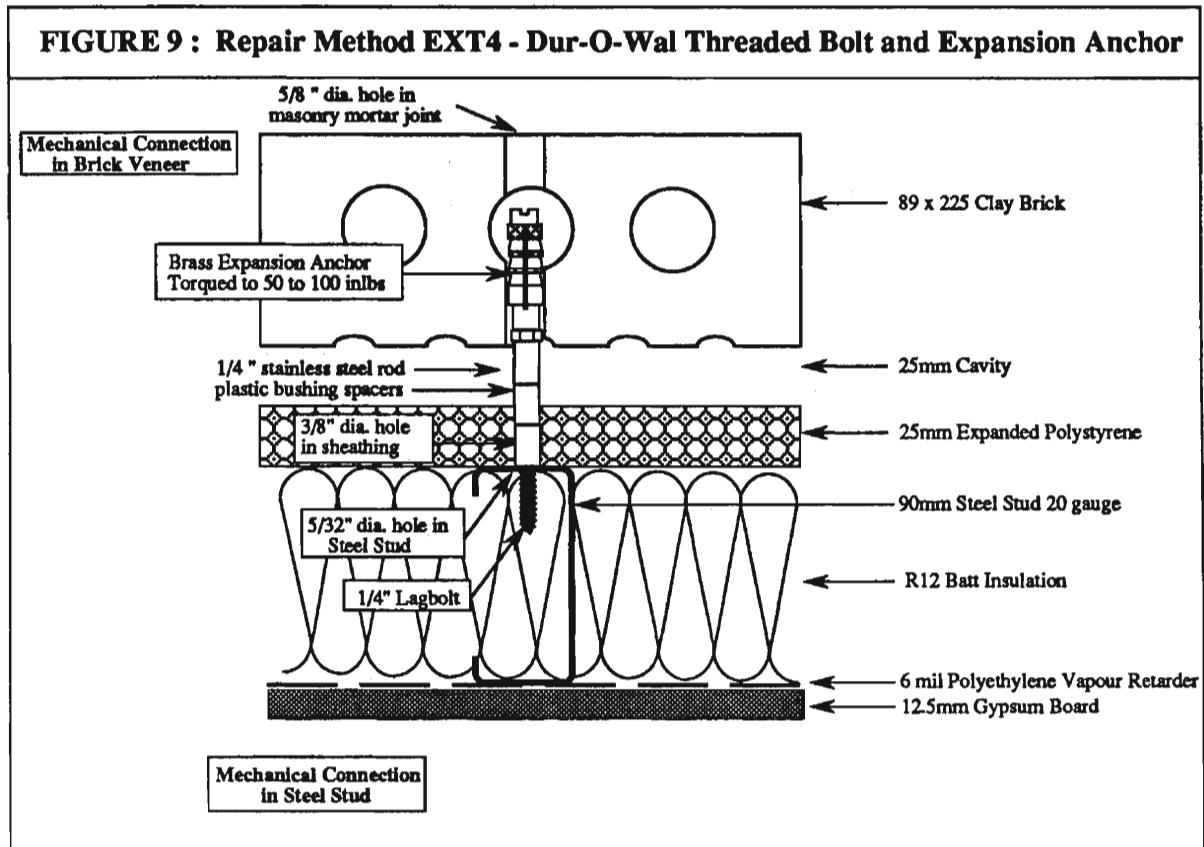
Using a 5/8" dia. masonry drill bit and rotary action, a hole was drilled into the brick veneer at a mortar joint location. A 5/32" dia. hole was also drilled in the outer flange of the steel stud using a metal drill bit. Any debris in the hole was then blown out. Bushings were put on the anchor rod to provide something to torque against when tightening the lag bolt to the steel stud. Silicone was applied to the lag bolt with the idea that this would seal the area around the connection between the lag bolt and the flange. The anchor rod was inserted, and by hand, the pilot hole was located and the tie installed. The lag bolt was torqued to 25 to 50 in lbs. The brass expansion anchor unit was then inserted in the hole and using the Dur-O-Wal key tool the expansion shells were expanded engaging the brick. This expansion anchor was torqued to 50 to 100 in lbs.

STEP #	DESCRIPTION	TIME (sec)
1	Locate Stud	
2	Drill Through Brick Veneer Mortar Joint - 5/8" dia. masonry drill bit - rotary drill action	70 seconds
3	Drill Through Outer Flange of Steel Stud - 5/32" dia. steel bit	15 seconds
4	Blow debris out of hole	10 seconds
5	Bushings were put on the anchor rod	5 seconds
6	Silicone was applied to the threads on the lag bolt	5 seconds
7	By hand the lag bolt was screwed in and then torqued to 25 to 50 in lbs	75 seconds
8	Install Expansion Anchor and torque to 50 to 100 in lbs	30 seconds
9	Repair Hole	
Total Observed Time for Repair		210 seconds

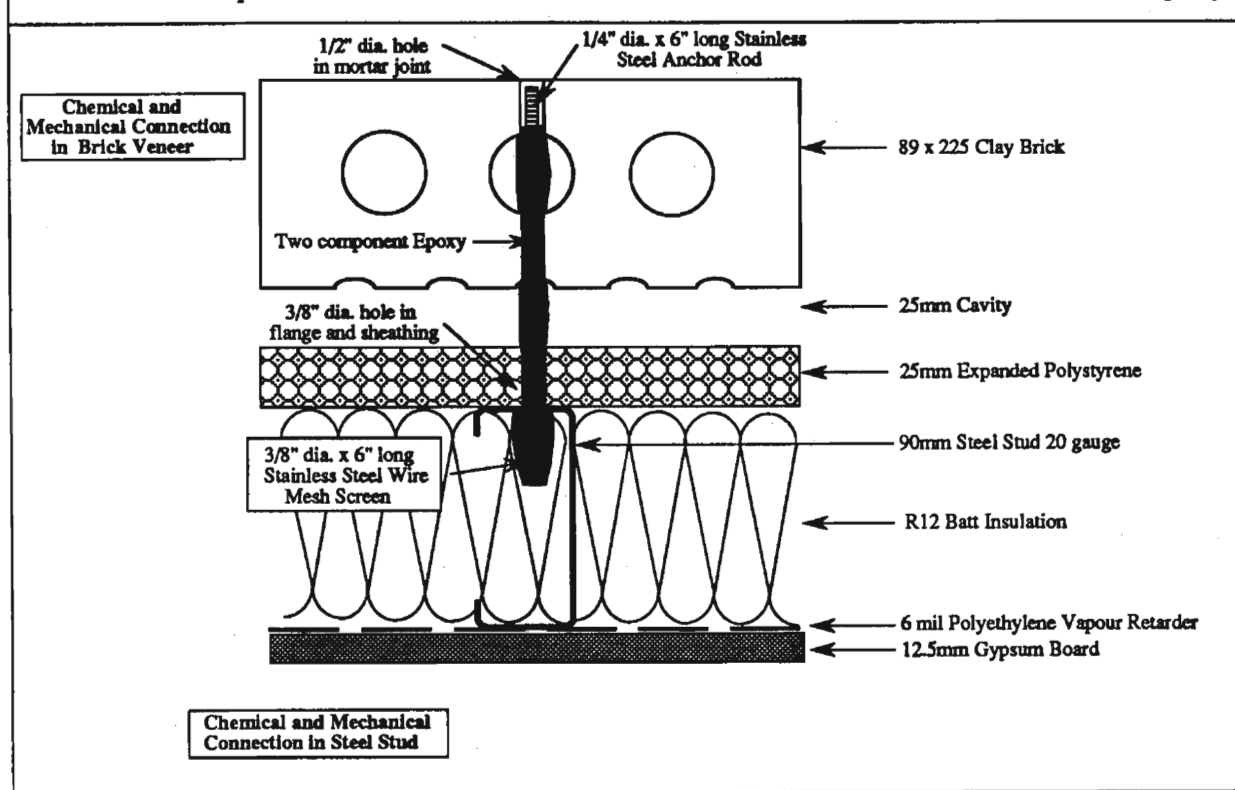
**FIGURE 11 : Repair Method EXT6 - Dur-O-Wal Stainless Steel Rod and Sleeve With Epoxy**

The components of this tie are made from stainless steel and an epoxy. A 1/4" dia. stainless steel anchor rod of 6 inch length is inserted in a 3/8" dia. stainless steel wire mesh screen of 6 inch length that is filled with a high thixotropic, two component epoxy. The anchor rod is threaded 50 mm on each end. Figure 11 illustrates the EXT6 - Dur-O-Wal repair system.

STEP #	DESCRIPTION	TIME (sec)
1	Locate Stud	
2	Drill Into Brick Veneer Mortar Joint - 1/2" dia. masonry drill bit - rotary drill action	45 seconds
3	Drill Through Outer Steel Stud Flange - 3/8" dia. steel drill bit - rotary drill action only	10 seconds
4	Blow debris out of hole	10 seconds
5	Fill wire mesh with epoxy outside of the wall	50 seconds
6	Position filled wire mesh in the wall	10 seconds
7	Insert anchor rod into wire mesh by rotating slowly	15 seconds
8	Repair Hole	
Total Observed Time for Repair		140 seconds

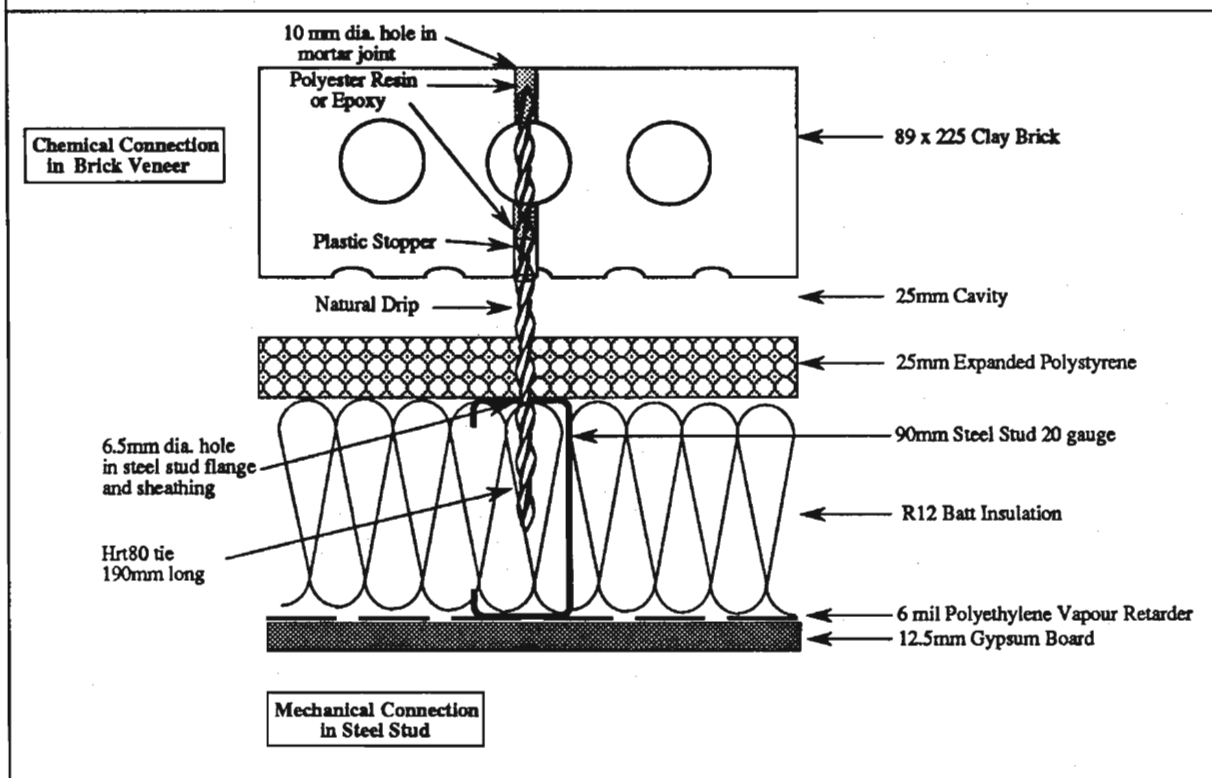
**FIGURE 12 : Repair Method EXT7 - Helifix HRT80 Dry Fix in SS, Polyester Resin in BV**

The Helifix HRT80 tie is a 8.0 mm dia. helical device manufactured from Grade 304 stainless steel. When installed, the HRT80 tie threads itself in the smaller pre-drilled hole in the steel stud which gives it a mechanical fix to the flange. The volume around the HRT80 tie in the brick veneer was filled with a polyester resin. Figure 12 illustrates the EXT7 - Helifix HRT80 repair.

STEP #	DESCRIPTION	TIME (sec)
1	Locate Stud	
	Drill Through Brick Veneer at Mortar Joint <ul style="list-style-type: none"> <li>- 10mm dia. masonry drill bit</li> <li>- hammer drill action</li> </ul>	10 seconds
2	Drill Through Outer Steel Stud Flange <ul style="list-style-type: none"> <li>- 6.5mm dia. steel drill bit</li> <li>- rotary drill action only</li> </ul>	10 seconds
3	Drive HRT80 tie into the outer flange of the steel stud	30 seconds
4	Inject Polyester Resin around the HRT80 tie	20 seconds
5	Repair Hole	
Total Observed Time for Repair		70 seconds
