## Moisture in Straw Bale Housing Nova Scotia

## Final Report, November 1998

Submitted by: S.H.E. Consultants  
RR #3, Comp. 308 Wolfville, NS B0P 1X0  
phone/fax: 902.542.3518  
email: sheconsl@istar.ca  
Shawna Henderson, Principal Investigator

Submitted to: Don Fugler, Research Division  
Canada Mortgage & Housing Corporation  
National Office  
700 Montreal Road Ottawa, ON K1A 0P7

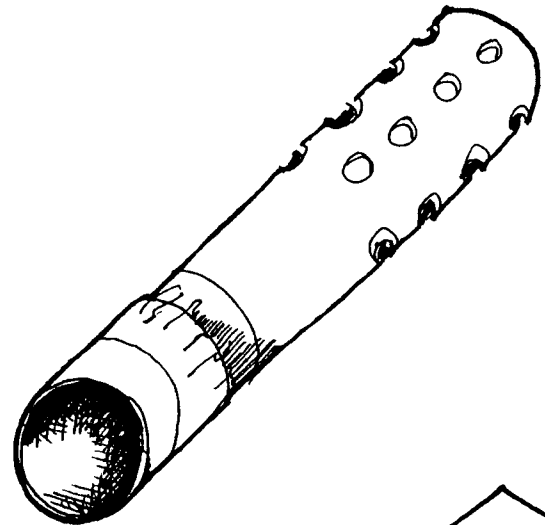
### 2.0a The sensor housing

Salvaged 36mm (1.5") diameter ABS piping were cut to 230mm (9") lengths. These lengths of pipe had a series of four 6 mm (0.25") diameter holes drilled through each quadrant of the first 100mm (4") from one end. Discarded film canisters were obtained from the local 1-hour photofinisher to be used to seal the other end of the sensor housing. The bottoms of each canister were cut and a prepared length of drilled ABS pipe was pushed into the bottom, extending into the canister by about 20 mm (0.75"). Red contractor's tape was used to seal these two pieces together.

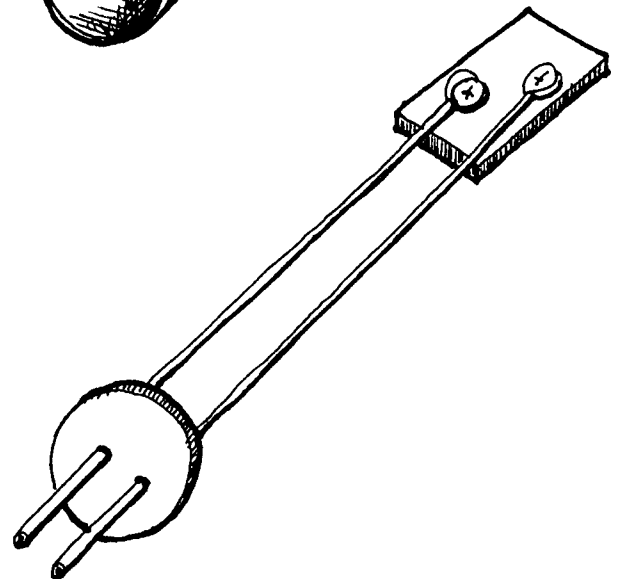
### 2.0b The sensor

A 38 x 32 x 3mm (1.5 x 1.25 x 0.125 inch) block of white pine was drilled through and two 6 mm (0.25") stainless steel screws with nuts were inserted in the drilled holes. Cast-off electrical wiring from building sites was cut into 300mm (12") lengths and had the ends stripped of their plastic coating to hook over the stainless steel screws. Two leads were attached to each block and each pair of leads was pushed through the pre-drilled holes in the soft lids of the film canister. (It was found that the type of canister with a softer plastic lid and uniform surface offered a better seal. The soft top of each canister was drilled through twice using a bit slightly smaller than the diameter of the salvaged wire leads.)

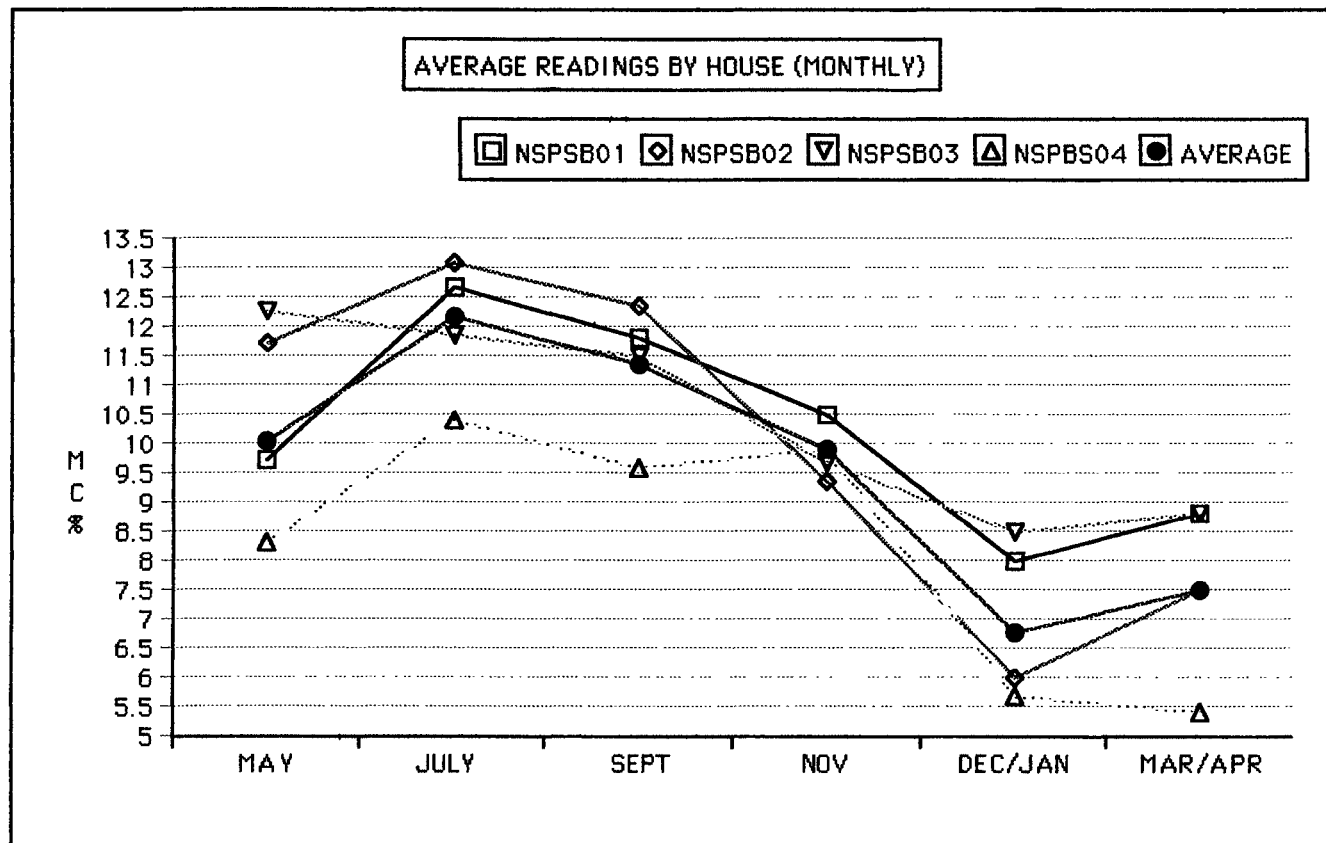
Chart of average monthly readings by house follows.

Moisture content readings in NSPSB01 varied slightly higher than the average except in May, increasing in variation from average (to + 1%) over the period of December through March. However, the trend in this house reflects the overall trend of the bale walls increasing in MC over the warm weather months, and decreasing over the heating season. On average, the walls to the W were driest (9.6%) while walls to the E were wetter (10.9%). One anomalous reading was taken in the E (17%) in July.

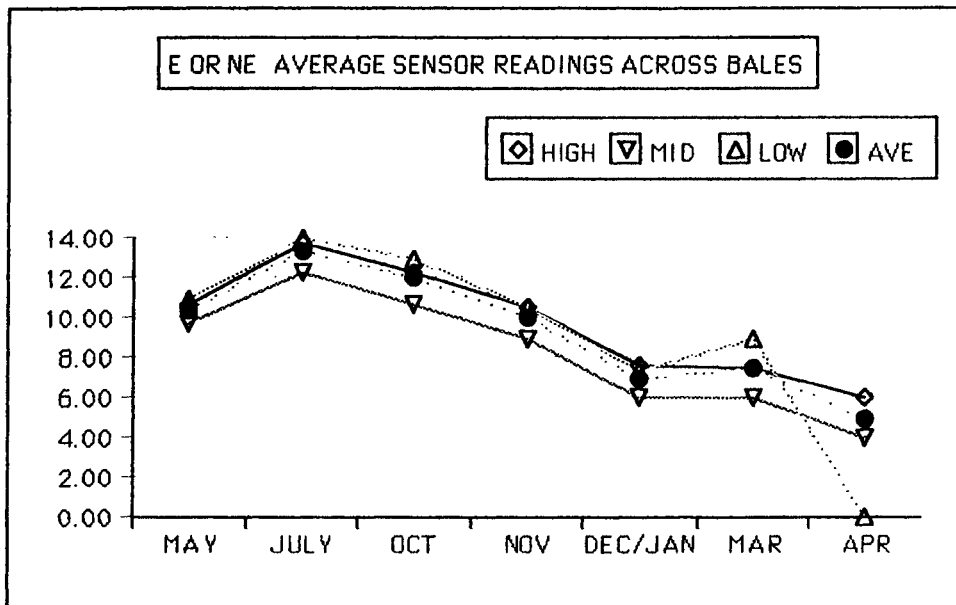
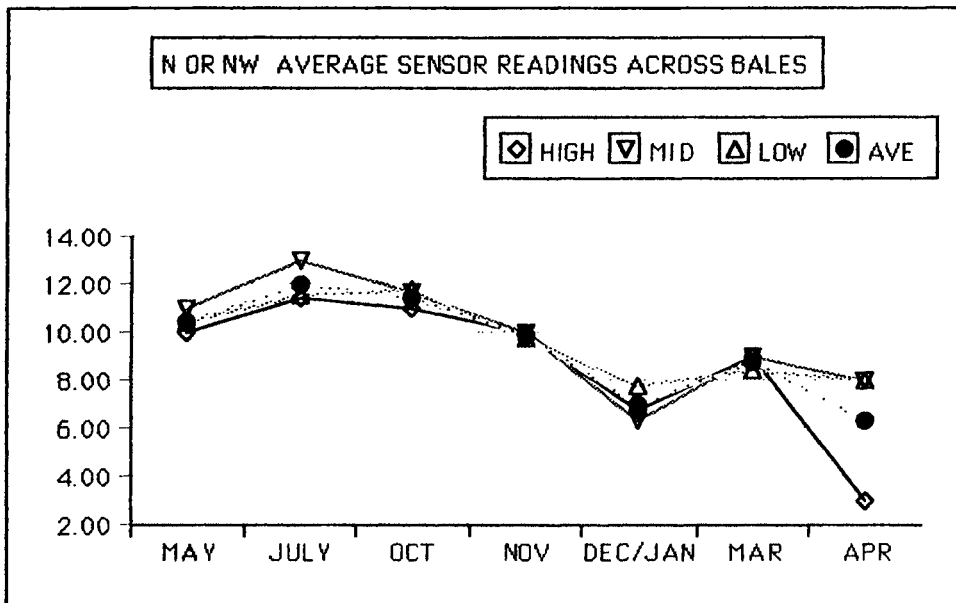
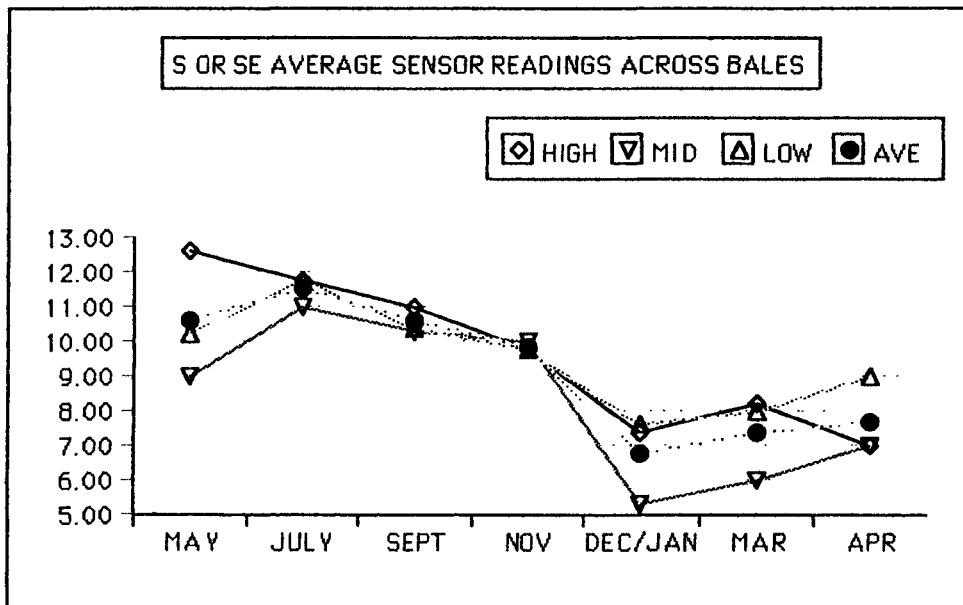
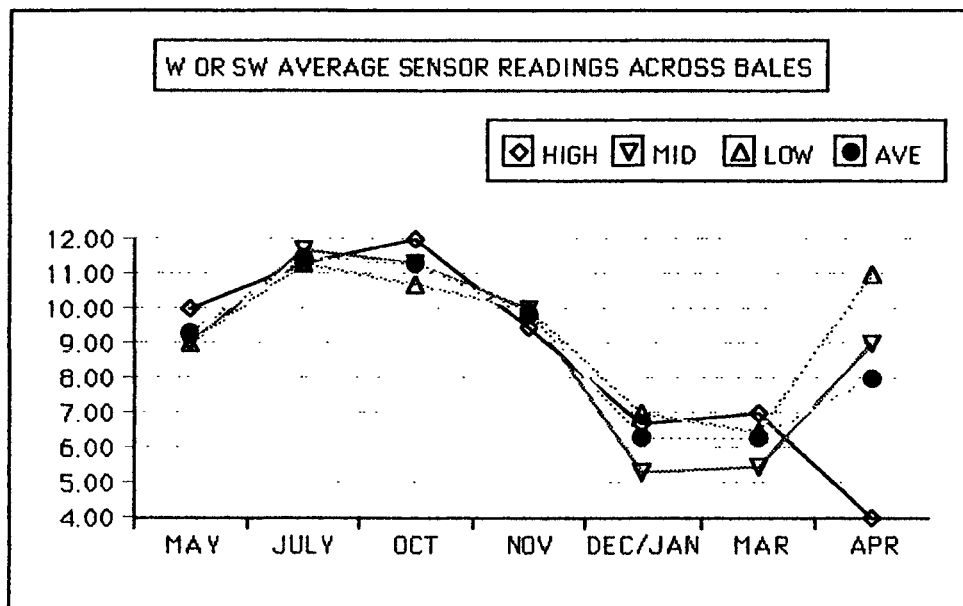
Charts of results follow.
