Performance Monitoring of a Brick Veneer/Steel Stud Wall System Phase 4 Results - Revision 1

**OTTAWA, ONTARIO
JANUARY 23, 1998
REVISED DECEMBER 2, 1999**

**SUBMITTED BY: KELLER ENGINEERING ASSOCIATES INC.
1390 PRINCE OF WALES DRIVE, SUITE 107
OTTAWA, ONTARIO
K2C 3N6**

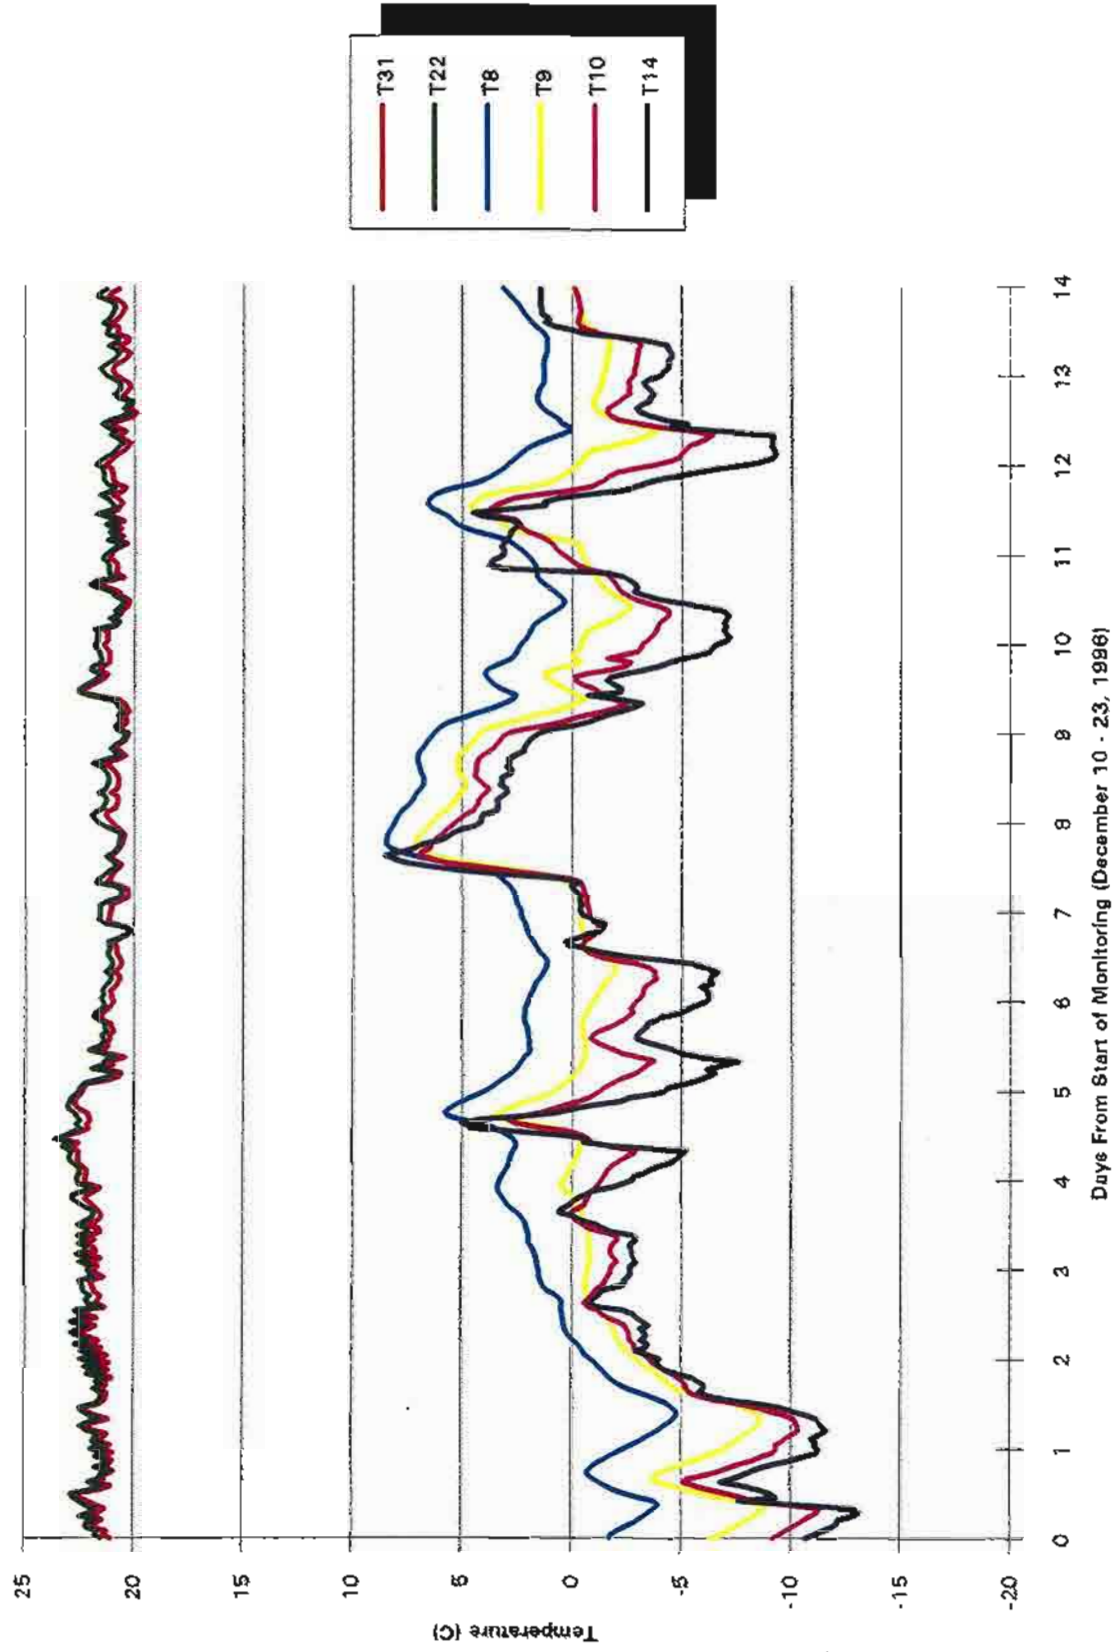
Fig. 5 Temperature Profile Across Test Wall - at Insulation

The temperature profiles of the test wall at the insulation and at the steel stud are shown in Figs. 5 and 6, respectively. The main findings regarding the temperature profiles of the test walls are:

1. Good thermal performance can be expected from a typical brick veneer/steel stud wall; as expected, the vast majority of the thermal resistance of the wall occurs through the insulation.
2. Significant thermal bridging occurs through the steel stud when no exterior insulation is used.
3. The percentage of thermal resistance that occurs within the insulation varies. In cold weather, sometimes the insulation accounts for nearly all of the thermal resistance of the wall, but at other times, it appears that the cavity is a significant factor. To review this finding further, plots such as that of Fig. 7 were made to compare actual and theoretical temperatures on both sides of the cavity, at the insulation. (The

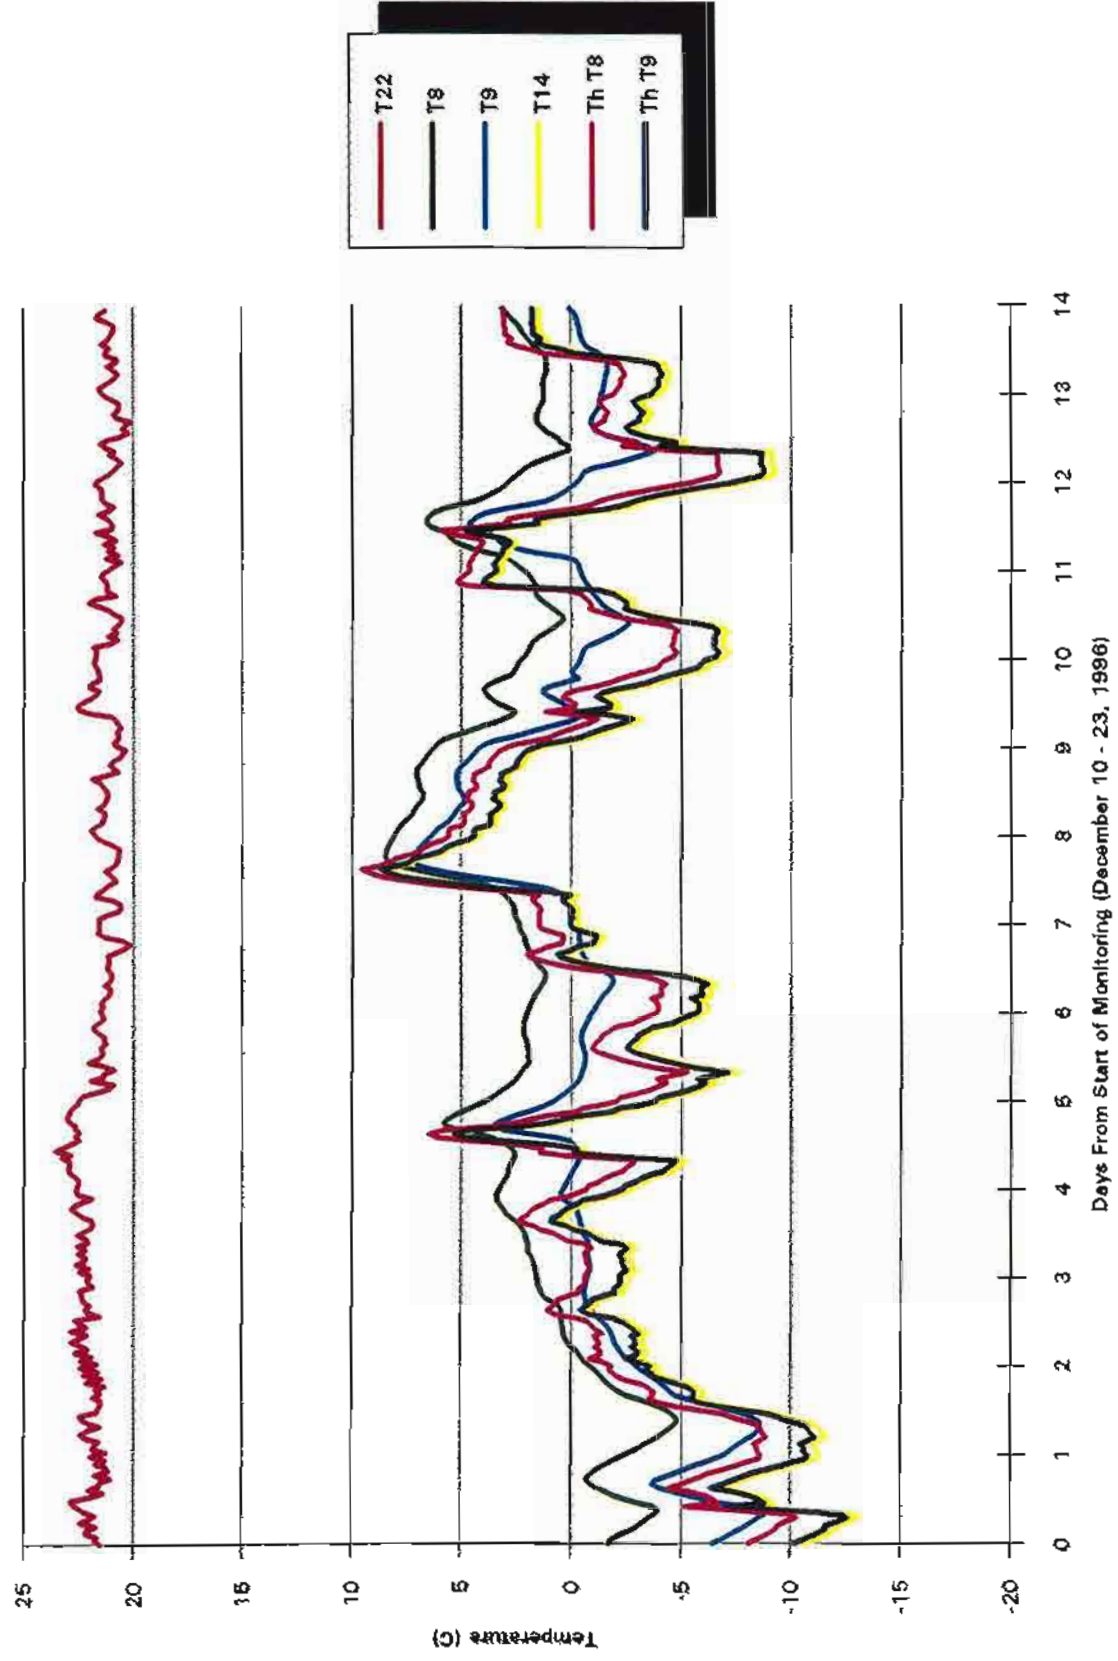
Fig. 7 Comparison of Actual and Theoretical Temperatures in Cavity

theoretical temperatures were calculated by making a "steady state" thermal analysis of the wall and combining the results of this analysis with hourly interior and exterior air temperatures, to obtain "steady state" thermal profiles for each hour of data.) Analysis of data such as that shown in Fig. 7 revealed that the actual and theoretical values of T8 and T9 generally differed by 4°C and 3°C, respectively, with differences of up to about 13°C and 11°C, respectively.

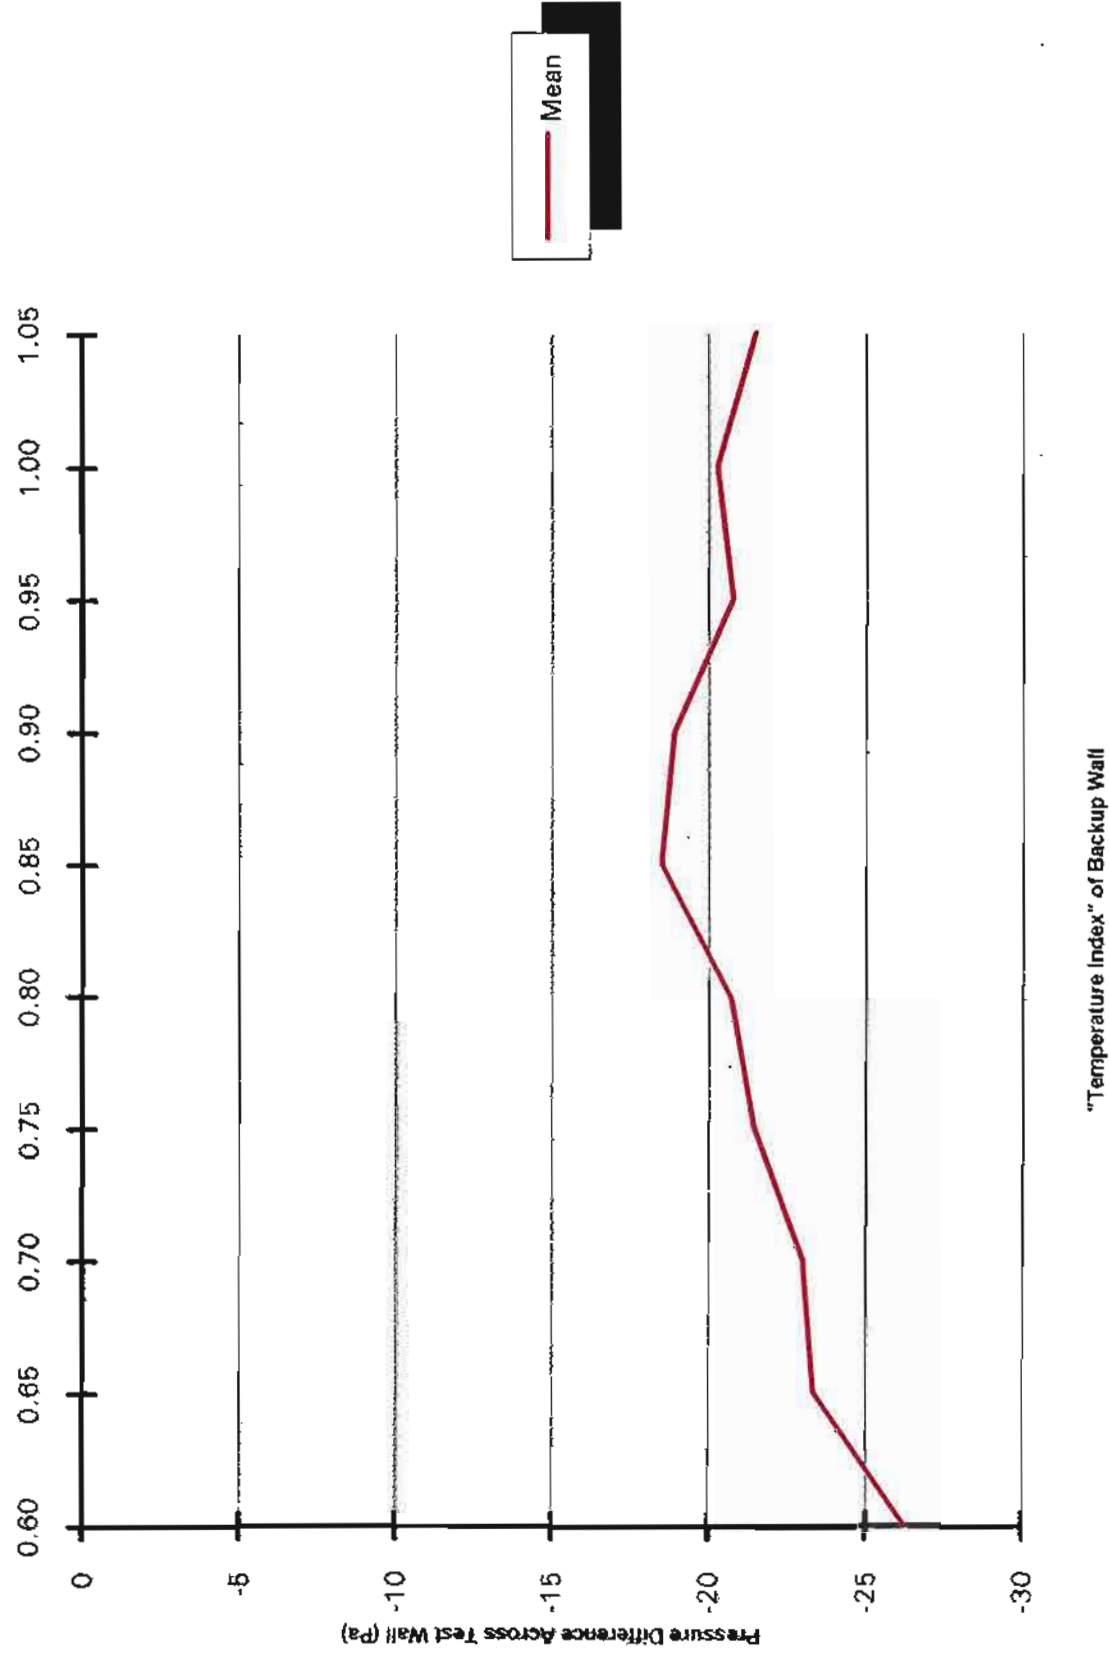
Fig. 8 Relationship Between the Pressure Difference Across the Test Wall and the "Temperature Index" of the Backup Wall

Pertaining to Item 3 in the previous report section, an analysis was done to determine if the thermal performance of the wall is affected by wind forces and stack effect. To make this analysis, average readings for the pressure difference across the test wall, P1-P4, were plotted against the corresponding average values of the "Temperature Index", T_i , of the backup wall. For various cold weather data, the actual Temperature Index of the backup wall was calculated for each hourly set of readings using the actual data and the formula $T_i = (T_{31}-T_8)/(T_{31}-T_{14})$. The plots indicated that there is a relationship between pressure differences across the test wall and the Temperature Index of the test wall. (See example plot of Fig. 8). The data indicates that warm air exfiltration under high pressure differences across the test wall is the key reason that the actual and theoretical temperature profiles differ. It should be noted that the apparent deterioration of the thermal performance of the wall is not due to the brick veneer being "short-circuited" by wind blowing more air into the cavity. Air movement behind the cavity is usually minimal and, in fact, warm interior air that leaks into the cavity is often trapped in the cavity, causing the cavity air to be much warmer than the exterior air.
