Transport  
Canada

TP 185E  
Issue 4/2011

# AVIATION SAFETY LETTER

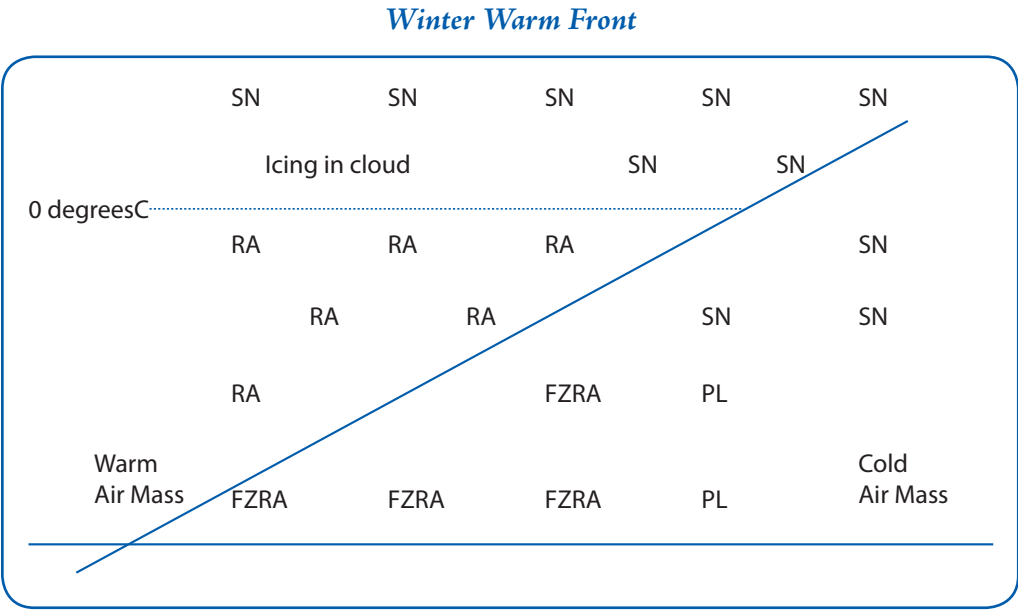
Figure 1

This ice was mixed ice (rime and clear) and added considerable weight to the aircraft as well as considerable drag. Also, our windshield was covered with ice reducing forward visibility to zero.

Airframe icing can occur any time there is an inversion and you are flying in cold air below warmer air aloft and there is cloud above you.

The Cessna Supplement for light Cessna aircraft suggests that if visibility is impaired, perform a forward slip to gain better visibility. It also states that the approach should be flapless at 70 mph. Piper has no recommendations for flight with airframe icing and other light aircraft manufacturers may not have any advice either.

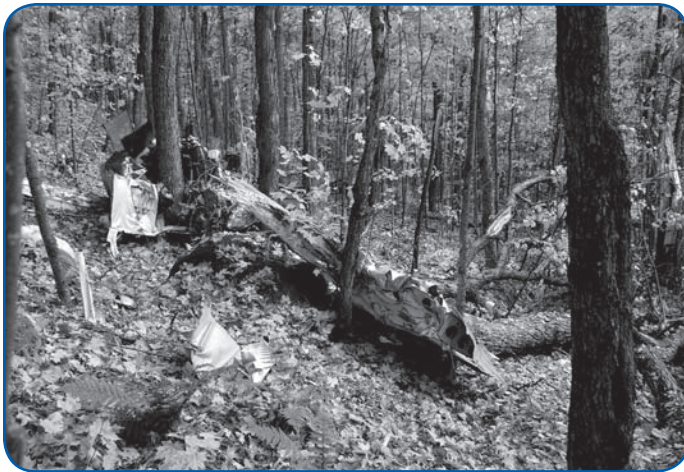
On October 10, 2009, a Piper PA-28R-180 aircraft departed Kingston, Ont., at 18:27 EDT on a night visual flight rules (VFR) flight to Sudbury, Ont. On board the aircraft were the pilot and three passengers. The estimated time of arrival at Sudbury was 20:42. At 20:52, an emergency locator transmitter (ELT) signal was reported by an overflying aircraft. The aircraft was located the following day at 03:02, approximately 22 SM east of South River, Ont. All four occupants were fatally injured.

1. The pilot, with minimal night flying experience, took off at night without fully appreciating the marginal weather that was forecast en route.
2. The pilot planned the flight over inhospitable terrain that afforded few visual cues for VFR navigation and continued flying into deteriorating weather conditions.
3. The pilot likely encountered conditions where ground reference was lost and altitude was not maintained, resulting in the aircraft striking trees in an area of rising terrain.

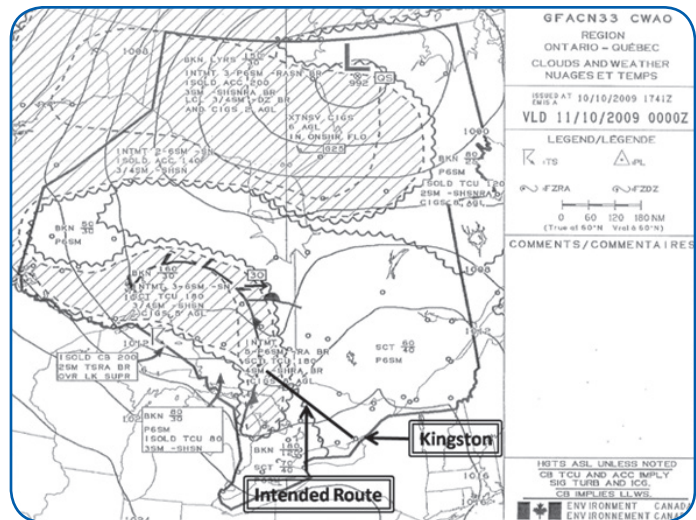
Figure 1. GFA showing intended route and point of departure. Destination is end of line.

At 16:55, the pilot phoned the London FIC to confirm if the forecast weather for Sudbury had improved. The London FIC provided information derived from the Graphical Area Forecast (GFA) for the Ontario/Quebec region at 13:41, which was valid for use from 20:00 onward (see Figure 1).

Immediately east of the cold front, the GFA was forecasting the following:

- ceilings of 800 ft AGL;
- visibility of 4 SM in light rain showers and mist;
- scattered, towering cumulus clouds with tops at 18 000 ft ASL; and
- intermittent visibilities from 5 to more than 6 SM in light rain and mist.

Immediately west of the cold front, the GFA was calling for:

- ceilings of 500 ft AGL;
- visibility of  $\frac{3}{4}$  SM in light snow showers;
- scattered, towering cumulus clouds with tops at 18 000 ft ASL;
- intermittent visibilities from 3 to 6 SM in light snow; and
- layer of broken cloud based at 3 000 ft ASL and topped at 16 000 ft ASL.

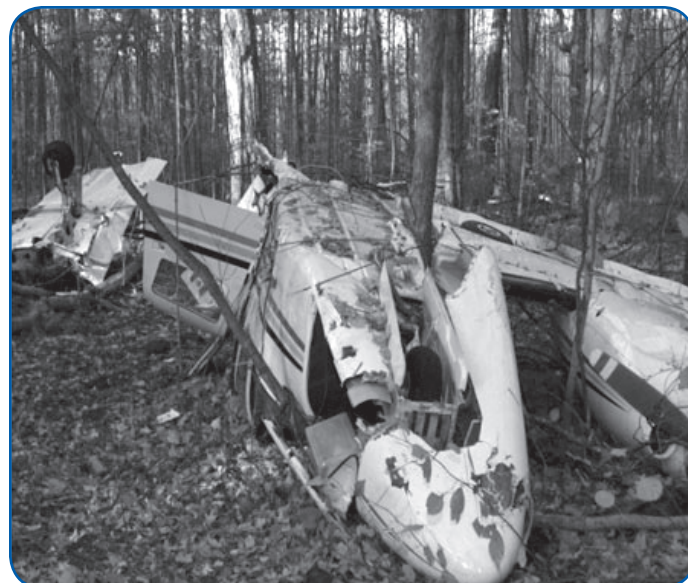
1. The right fuel selector was left in the XFEED position, probably because the pilot was distracted and/or failed to follow the checklist. As a result, both engines were being fuelled by the left tank until it was completely empty, causing both engines to stop simultaneously.
2. The pilot relied on a fuel quantity indicator system that was based on the engine's fuel consumption and not on the quantity of fuel remaining indicated by the gauges.
3. The pilot did not recognize the power loss as being a failure of both engines. The emergency checklist for engine failure was not completed.

1. The aircraft's emergency locator transmitter (ELT) broadcast signals on 121.5 MHz and 406 MHz. The ELT was not damaged on impact, but its antenna was broken, making it difficult to capture signals.
2. The pilot did not declare an emergency and did not clearly indicate the nature of the problem; therefore air traffic control (ATC) could not anticipate his needs.

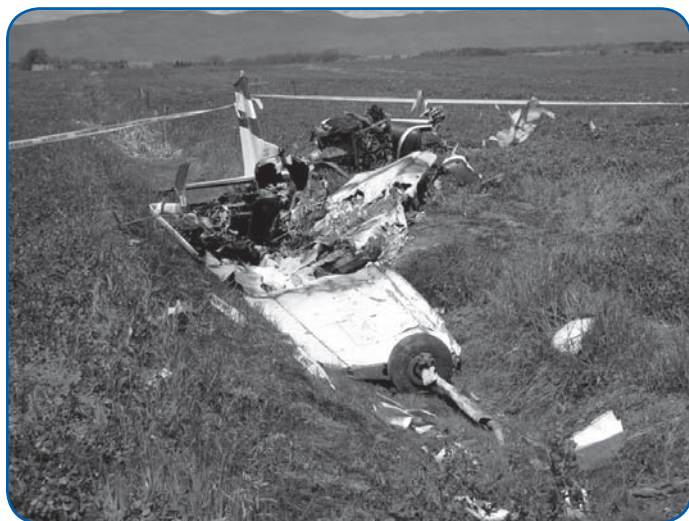
The accident occurred because the aircraft, while flying just above the ground, struck a mound 8 ft in height. Due to a lack of evidence, the investigation was unable to determine why the pilot stopped the climb after the touch-and-go landing and continued flying at low altitude. Nor could it be determined why the aircraft descended to a few feet above terrain, which was unsuitable for landing, just before the initial impact.
