**MARINE INVESTIGATION REPORT
M10M0014**

CAPSIZING AND SINKING

**SMALL FISHING VESSEL
CRAIG AND JUSTIN
OFF MARGAREE HARBOUR, NOVA SCOTIA
01 MAY 2010**

Report Number M10M0014

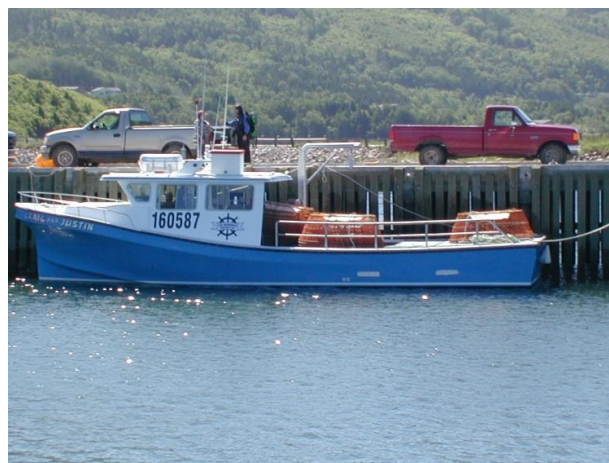
Photo 1. *Craig and Justin* (Courtesy of Briand Marine Surveys)

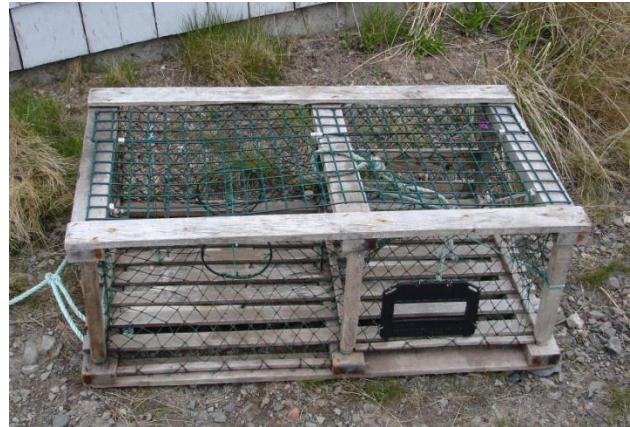
The lobster traps each weighed about 33 kg and the total weight of the traps was approximately 9.08 tonnes. The weight of the ropes for the traps was approximately 0.36 tonnes.

Photo 4. Lobster trap on the *Craig and Justin*
