Transportation Safety Board  
of Canada

## **MARINE OCCURRENCE REPORT**

**DISAPPEARANCE AND PRESUMED SINKING  
OF THE F.V. "LE BOUT DE LIGNE"  
WITH THE LOSS OF THE THREE CREW MEMBERS  
GULF OF ST. LAWRENCE  
13 DECEMBER 1990  
REPORT NUMBER M90L3033**

Report Number M90L3033

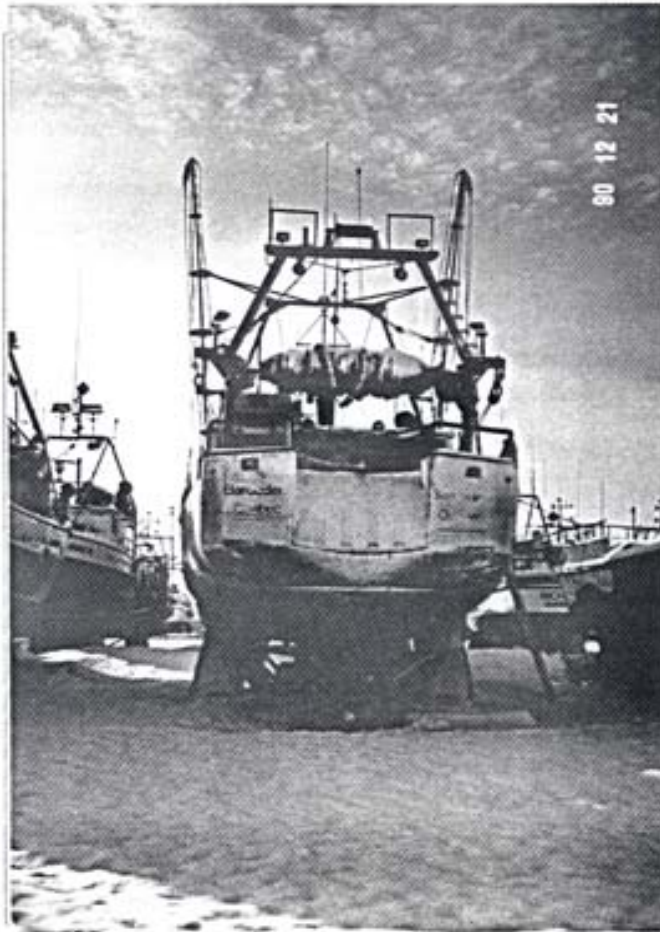
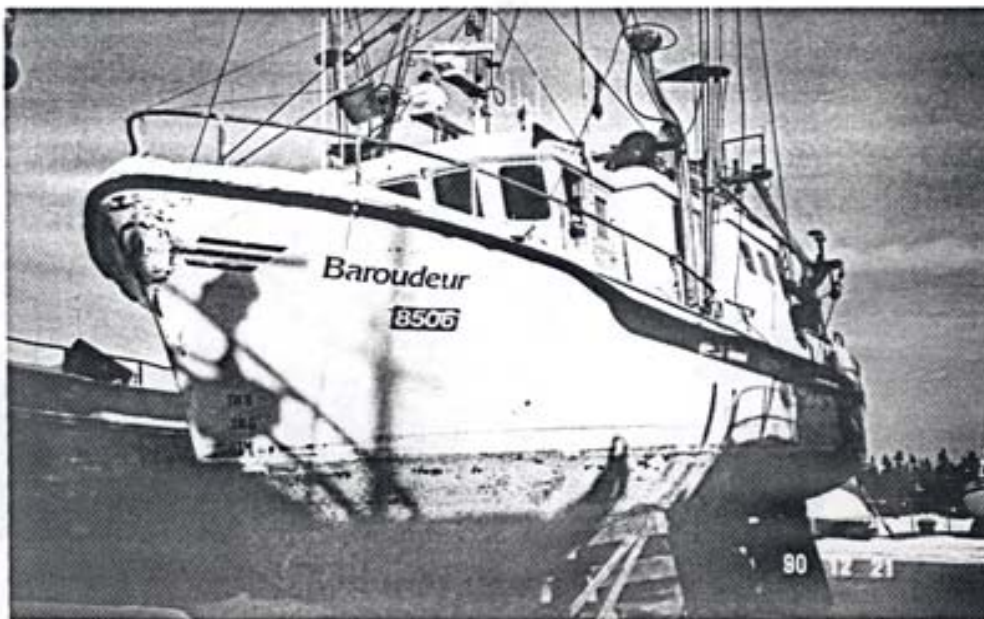
VIEWS OF "BAROUEUR" WHOSE HULL WAS FROM THE SAME MOULD AS "LE BOUT DE LIGNE" AND WHOSE SUPERSTRUCTURE MOST CLOSELY RESEMBLES THAT OF "LE BOUT DE LIGNE".

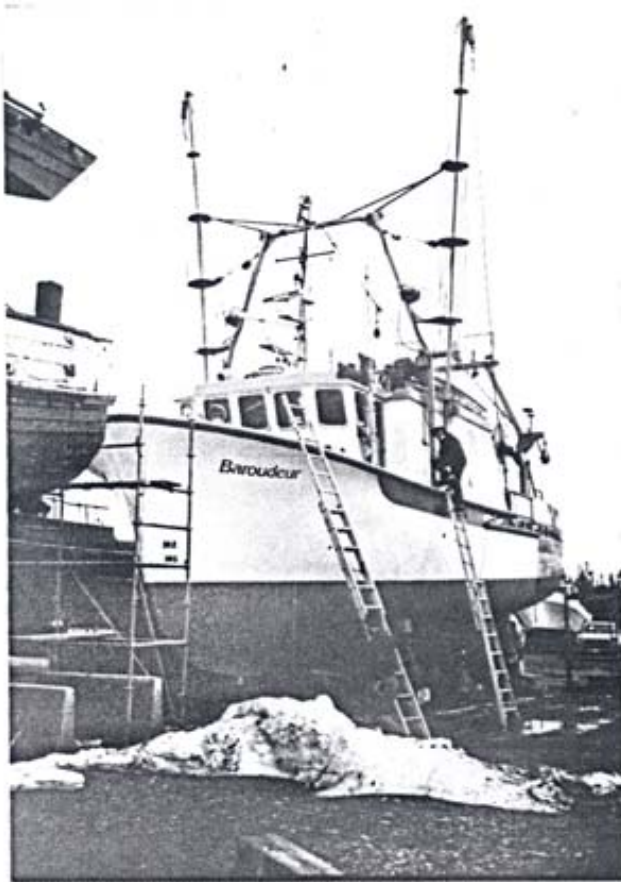
**ANOTHER VIEW OF  
"BAROUEUR", THIS  
TIME UNDERGOING  
MAINTENANCE.**
