National  
Defence

1016-22-1 (DFS 3)  
24 August 2009

# Annual Report on Flight Safety

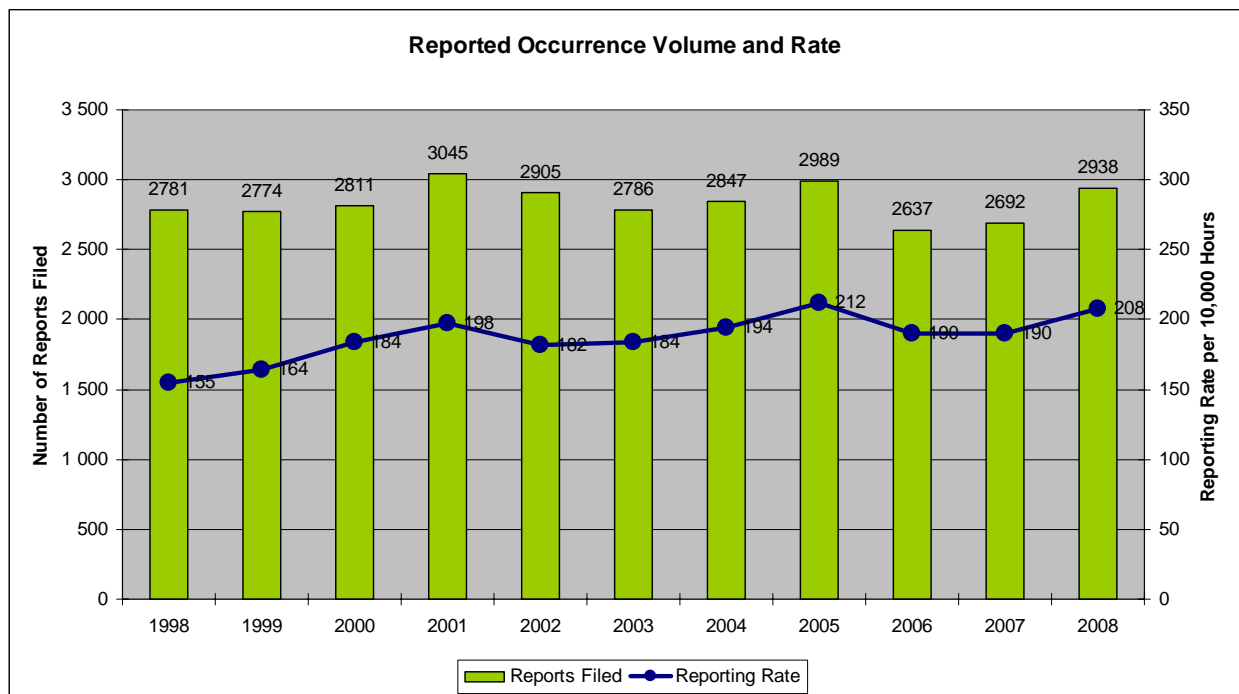
Graph 1 – Reported Occurrence Volume and Rate

As seen in Graph 1, some 2,938 occurrences were reported in the FS Occurrence Management System (FSOMS), which is up from the 10-year mean value of 2,827 per year. The rate of occurrences reported per 10,000 flying hours was 208 which are close to the five year average of 194 which is indicative of a good reporting culture. Approximately 56% of the reported occurrences were classified as air occurrences and the remaining 44% were classified as ground occurrences.

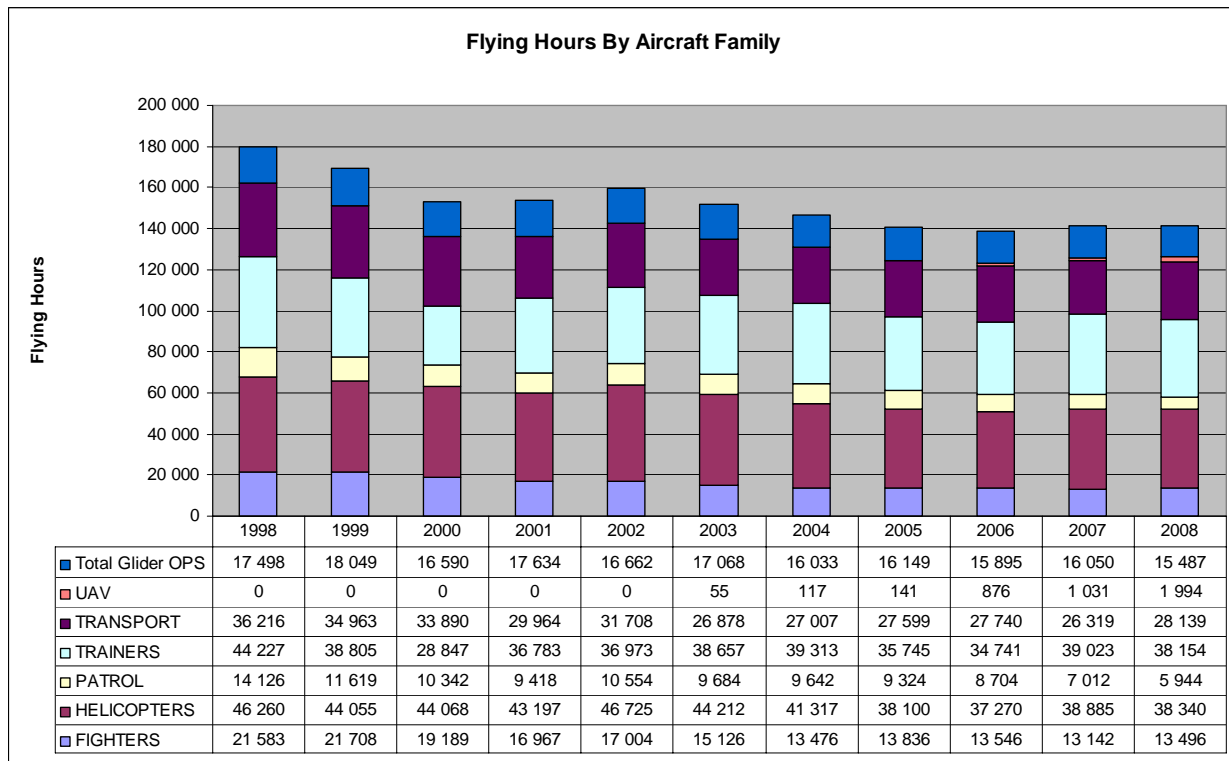
**Graph 2 - Flying Hours by Aircraft Family**

Overall CF flying hours remained relatively stable with no significant changes except for UAV hours which almost doubled (Graph 2). Flying hours reported for both transport and trainer aircraft differ from the ones reported in the 2007 Annual Report because CC142 Dash 8 hours were transferred from transport to trainer aircraft.

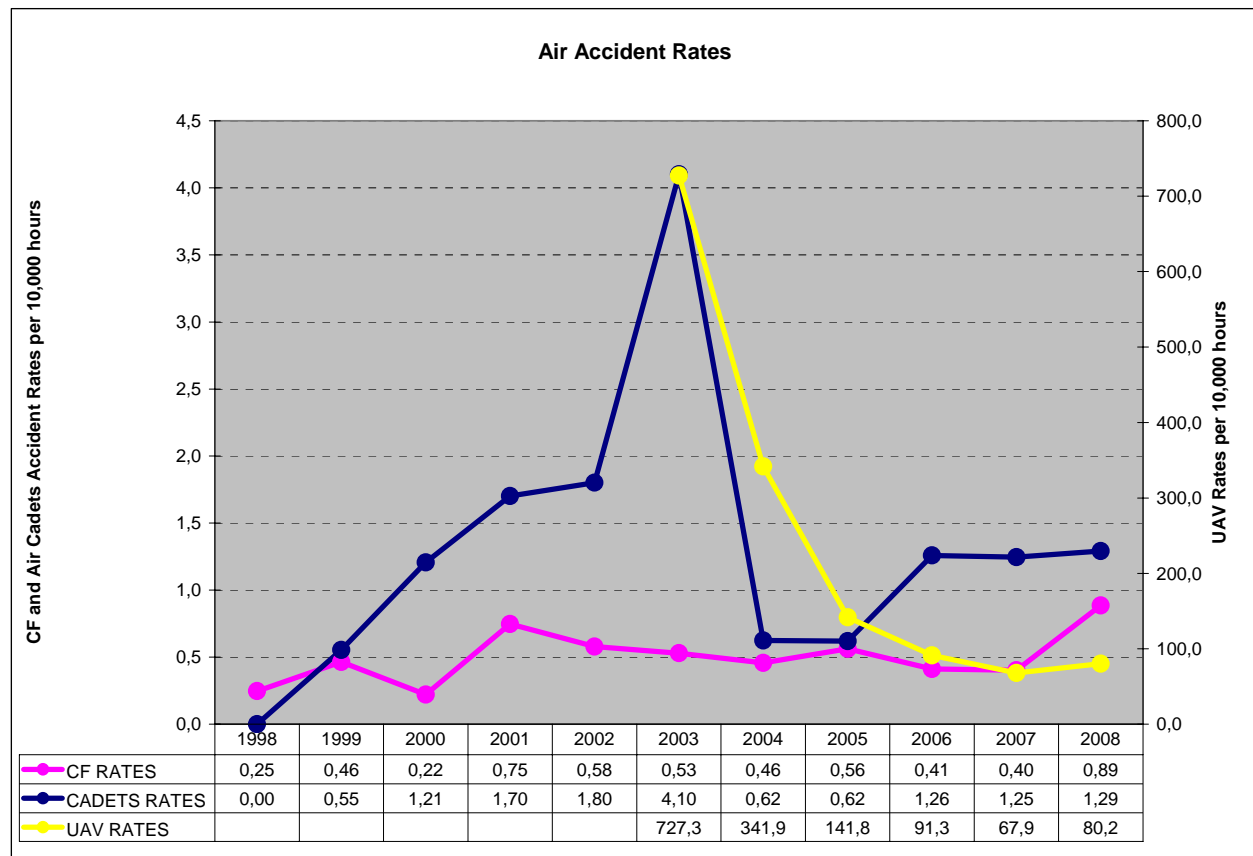
**Graph 3 – Air Accident Rates**

The air accident rate for 2008, exclusive of UAVs and Air Cadets accidents, was 0.89 per 10,000 flying hours (Graph 3). This represents a significant increase from the 10-year CF average of 0.46 but no systemic trends have been detected. The breakdown of air accidents was two category 'A' accidents (CT114 Tutor, CT155 Hawk) and seven category 'C' accidents (two CH146 Griffon, two CC130 Hercules, one CH149 Cormorant, one CF188 Hornet and one CC177 Globemaster III).

The accident rate for UAVs (80) increased slightly since last year (67.9). The Air Cadet accident rate remained steady (1.29) and is within the historical norms for Air Cadet flying. Given air cadet glider flying operations involve a very large number of flights of very short duration, an elevated rate in comparison to other fleets is expected.

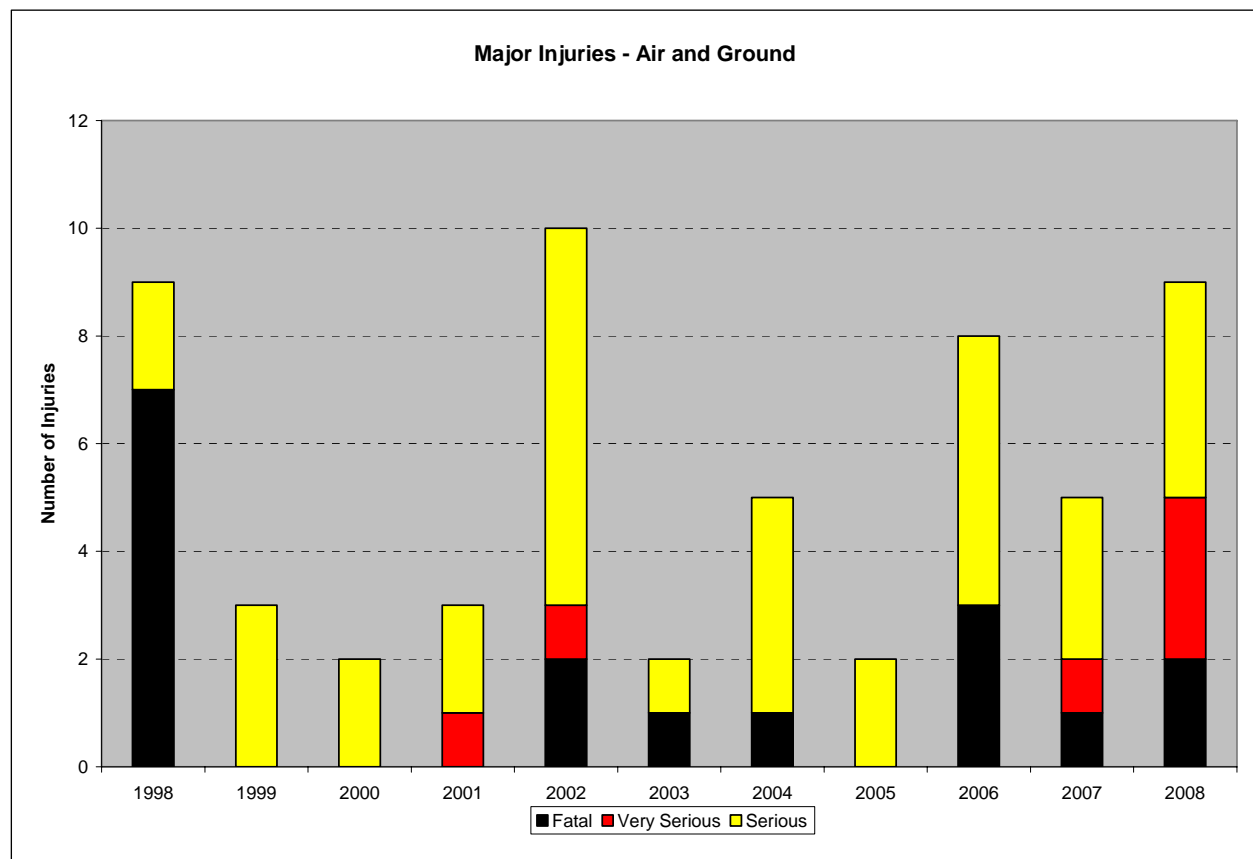
Graph 4 – Major Injuries (includes Air Cadet Glider Program)

There were two fatal injuries due to the CT114 Tutor accident (9 Oct 08). Two pilots suffered very serious injuries as a result of a CT-155 Hawk that crashed while on final emergency forced landing (18 Apr 08), and a cadet suffered very serious injuries during low level glider release (6 Sep 08). Additionally, four serious injuries occurred during the year: one civilian contractor, one cadet, one maintenance and one traffic technician.

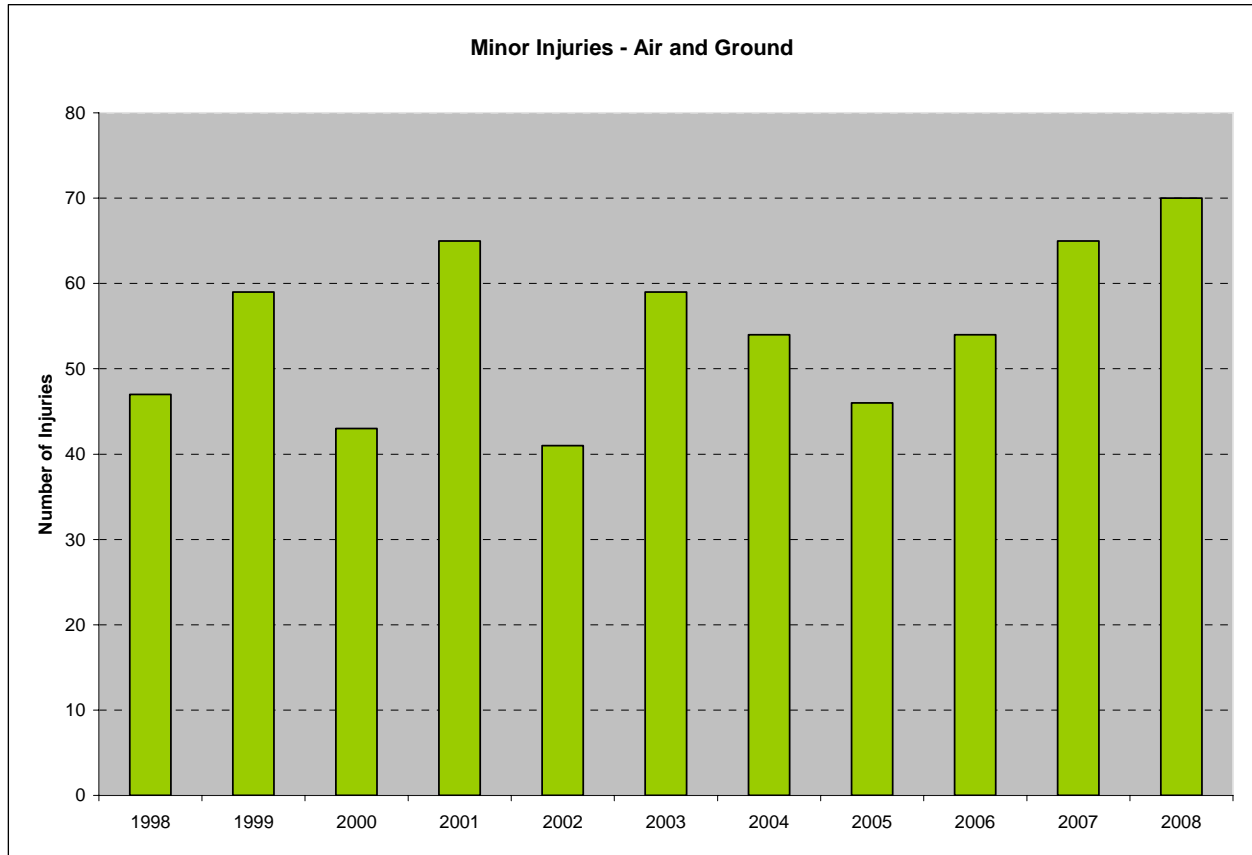
**Graph 5 - Minor Injuries**

A total of 70 minor injuries occurred in 2008, up from 65 in 2007.

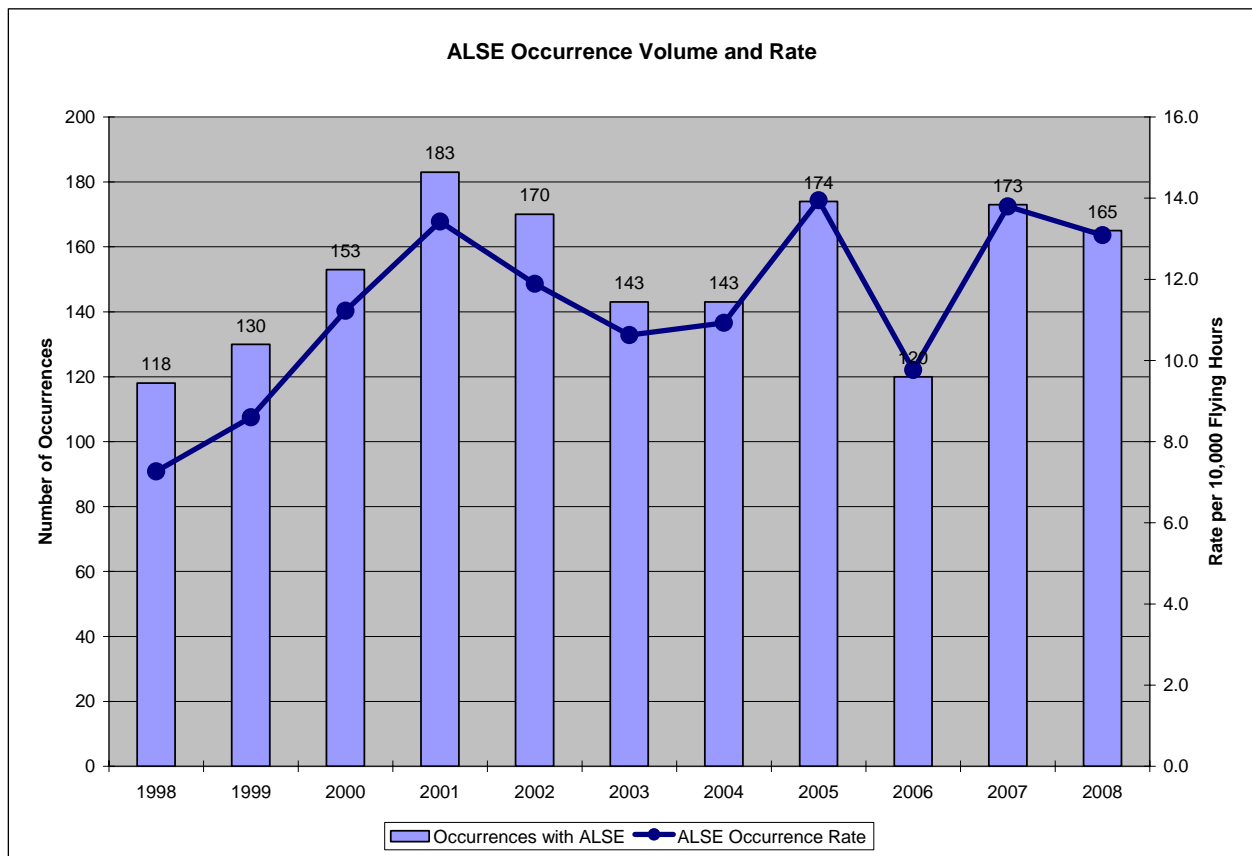
### Graph 9 - ALSE Occurrence Volume and Rate

The increase in the number of occurrences related to survival and safety equipment in several fleets was identified as a fleet wide problem in 2007. Graph 9 shows a very slight decrease of Aviation Life Support Equipment (ALSE) related occurrences over the last year. This reinforced the concerns reported in a number of recent FS Investigation Reports (FSIRs) in which ALSE was found to be deficient. DFS staff continues to pursue actively this issue with the OAA and the TAA staffs.

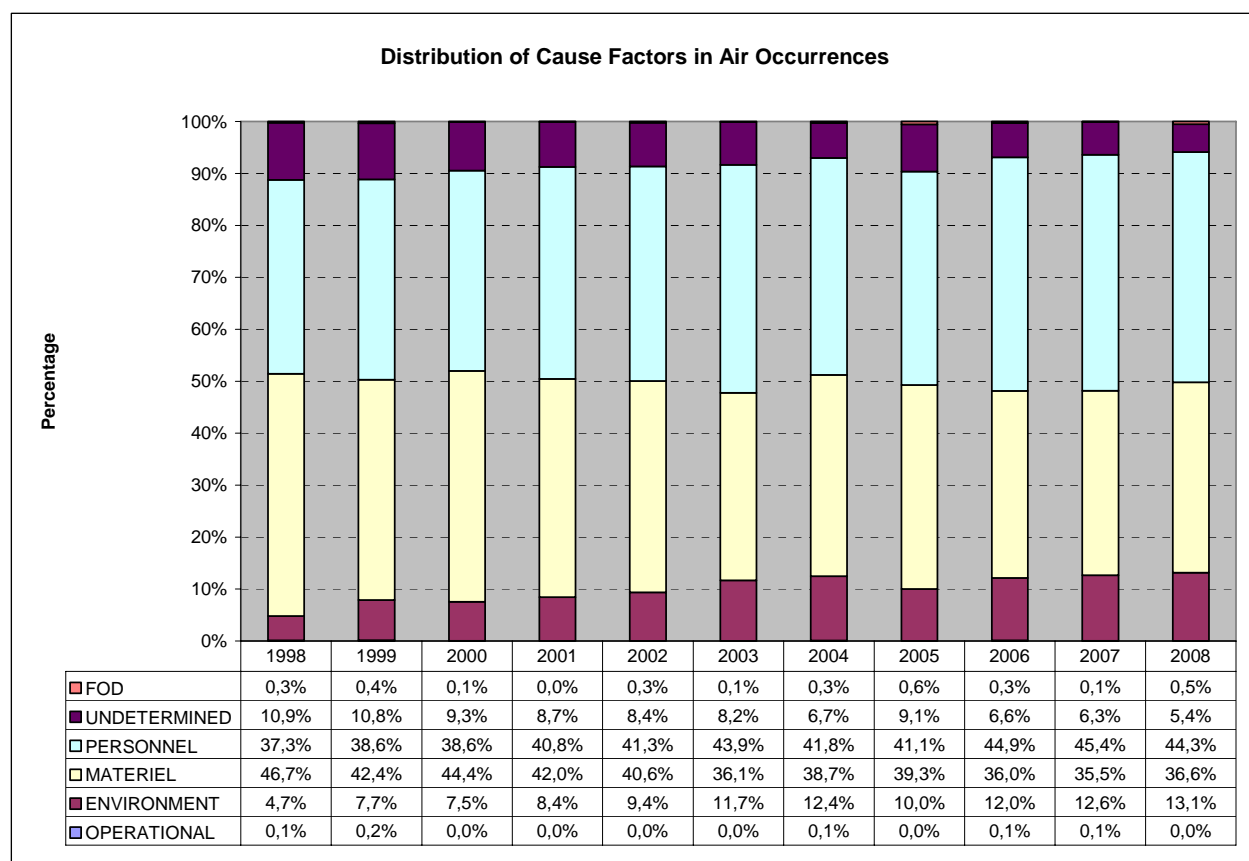
**Graph 10 - Distribution of Cause Factors in Air Occurrences**

There has been no significant change in the distribution of cause factors in air occurrences (Graph 10). The distribution for 2008 was the following in descending order:

- Personnel – 44.3%
- Materiel – 36.6%
- Environment – 13.1%
- Undetermined – 5.4%
- Operational – 0%
- Foreign Object Damage (FOD) – 0.05%

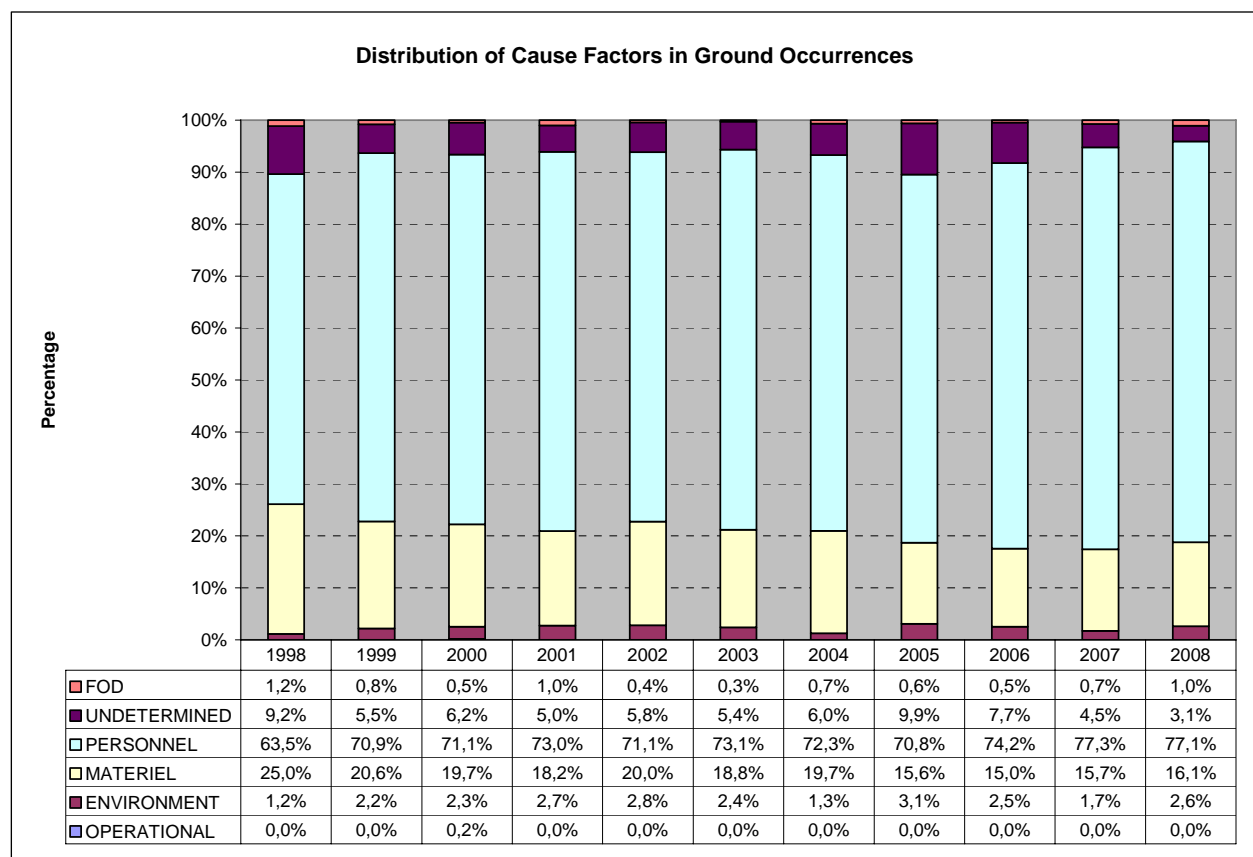
**Graph 11 - Distribution of Cause Factors in Ground Occurrences**

There has been no significant change in the distribution of cause factors in ground occurrences (Graph 11). The distribution for 2008 was the following in descending order:

- Personnel – 77.1%
- Materiel – 16.1%
- Undetermined – 3.1%
- Environment – 2.6%
- Foreign Object Damage (FOD) – 1.0%
- Operational – 0%

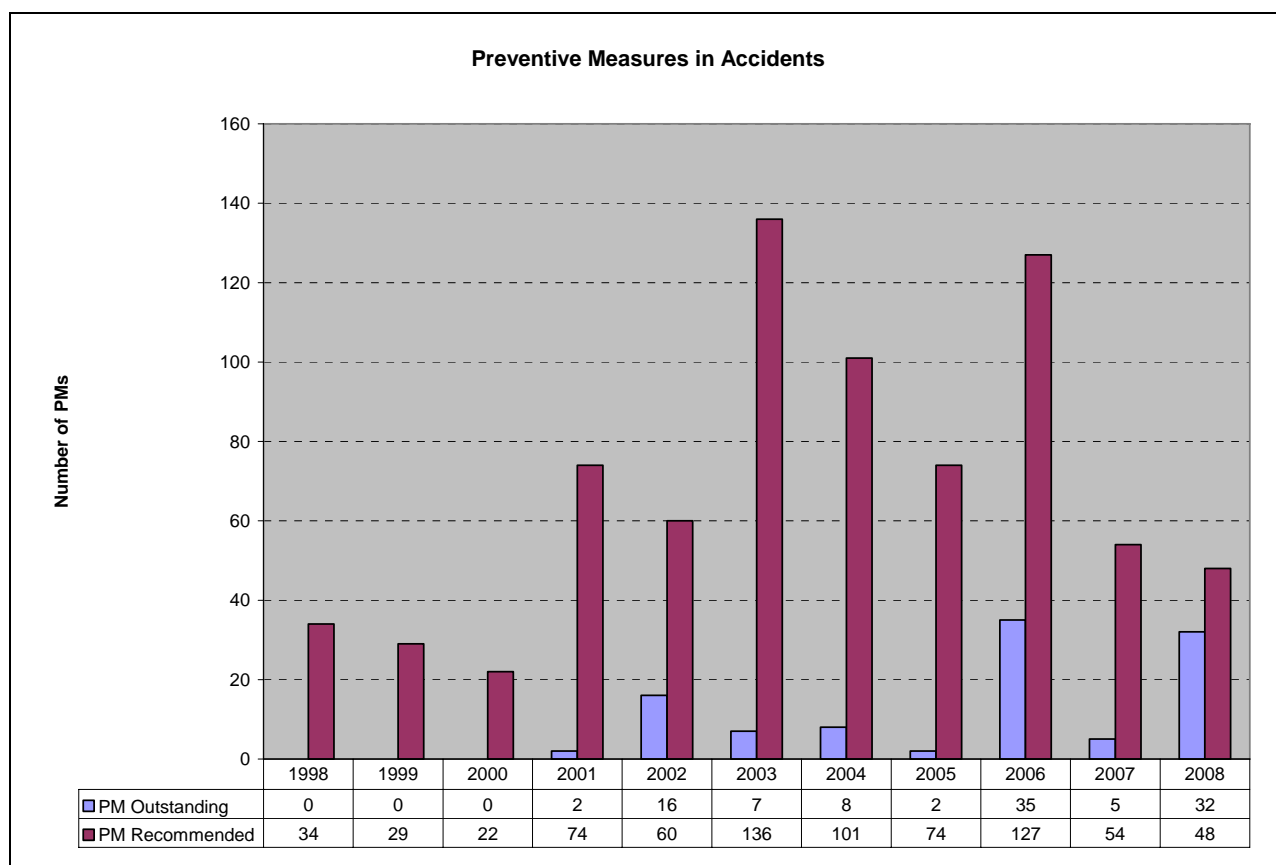
**Graph 12 - Preventive Measures in Accidents**

The development of effective Preventive Measures (PMs) by FS investigators and their timely staffing is critical to an effective prevention program. Efforts have been done in the last few years to improve the staffing of PMs in terms of time to implement and record management of measures taken or decisions made. Mitigated results have been achieved given that 214 PMs developed in 2006 or earlier are still outstanding from aircraft accident investigations (Graph 12). Graph 13 provides the same breakdown for incidents. Given the majority of PMs for incidents are staffed and closed rapidly at unit level, the relative number of outstanding PMs is much lower than accident PMs. Still, some 134 PMs are still outstanding from 2006 and earlier.

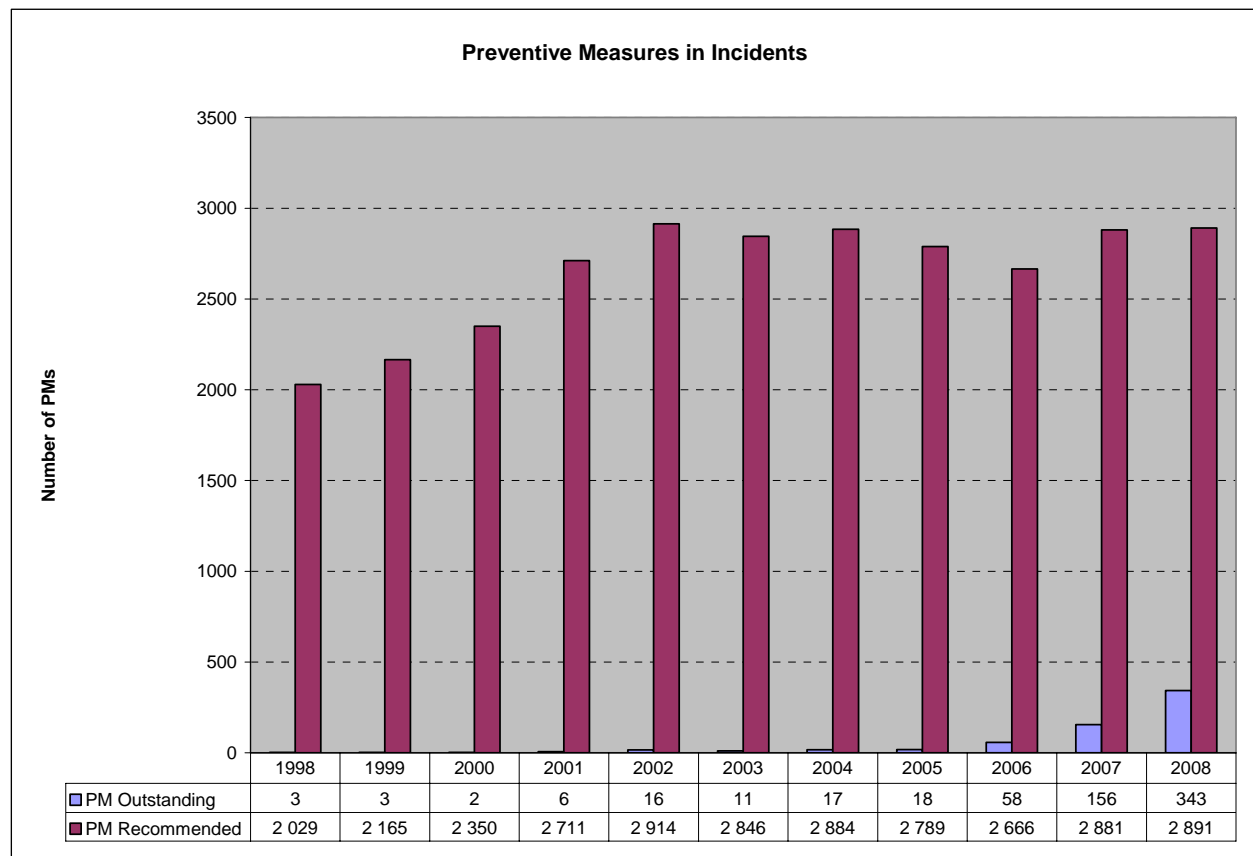
**Graph 13 - Preventive Measures in Incidents**

Graph 13 provides the breakdown by year of outstanding incidents PMs and PMs recommended. Note that some investigations are not yet complete and further PMs may be proposed as a result of the investigation recommendations. The majority of PMs for incidents are staffed and closed at unit level, and are thus closed relatively quickly in comparison to accident PMs. Still, some 70 PMs are still outstanding from 2006 and earlier.
