AVIATION INVESTIGATION REPORT

A09Q0210

DECREASE IN ROTOR SPEED FOLLOWED BY COLLISION WITH TERRAIN

ROBINSON R44 II (HELICOPTER) C-GDSF
MONTRÉAL, QUEBEC
16 DECEMBER 2009

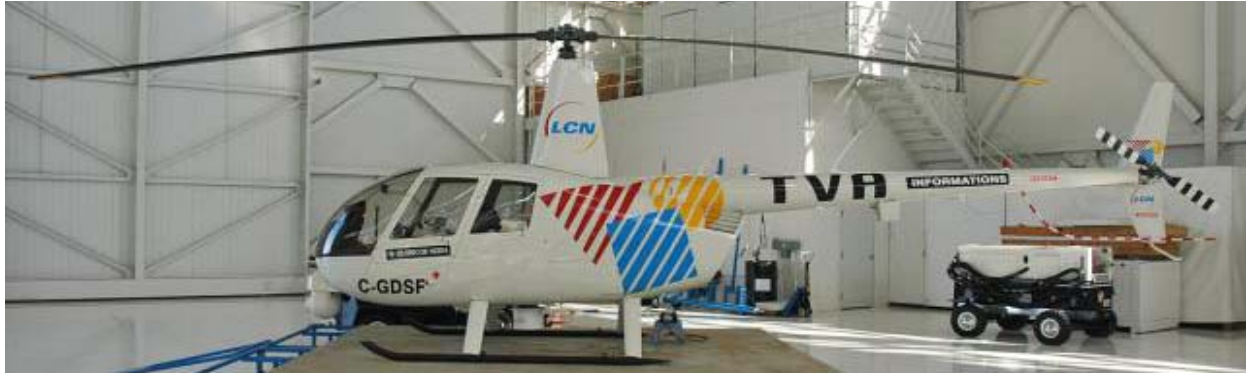
Photo 1. Robinson R44 II ENG version (C-GDSF)

The Electronic News Gathering (ENG) version of the Robinson R44 is a turnkey aviation platform designed to transmit back to the TV studio video images captured by the helicopter's belly camera (see Photo 1), along with audio from the occupants. The R44 ENG is a three-seater helicopter with a two-bladed single rotor and fuel injected piston engine (Lycoming IO-540-AE1A5). It also features a 28-volt electrical system, a spotlight, a communication system, a gyro-stabilized nose-mounted infrared camera and a main battery located on the underside of the tail boom to offset the weight of the camera.

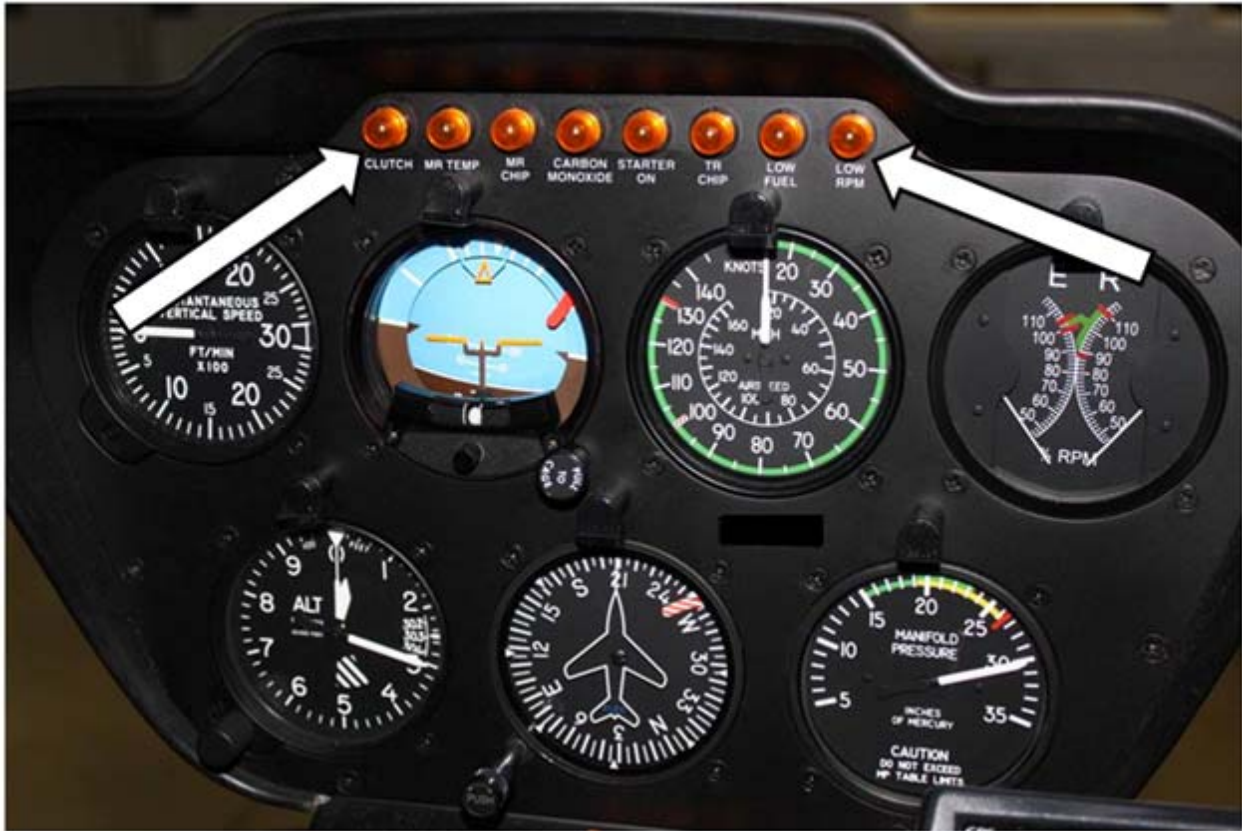
Photo 2. Instrument panel of a typical R44

The Robinson R44 has a single warning horn that activates when the rotor RPM is low. The warning horn sounds and a LOW RPM amber caution light (see Photo 2) is illuminated to indicate that rotor RPM has fallen below the established 97% safe limit. The horn stops and the amber caution light is extinguished when:

During the pre-flight checks on the morning of the occurrence, the warning horn and light were working normally.

The green arc for safe operation of main rotor RPM, with engine stopped is between 90% and 108%. The "danger" area on the RPM gauge is 90% RPM and is indicated by a red line. The danger of low rotor RPM leading to a main-rotor aerodynamic stall during autorotation is covered during ground school.
