**RAILWAY INVESTIGATION REPORT
R07E0129**

**CANADIAN NATIONAL TRAIN NUMBER 417
AND
CANADIAN NATIONAL TRAIN NUMBER 342
MILE 112.1, EDSON SUBDIVISION
PEERS, ALBERTA
27 OCTOBER 2007**

Report Number R07E0129

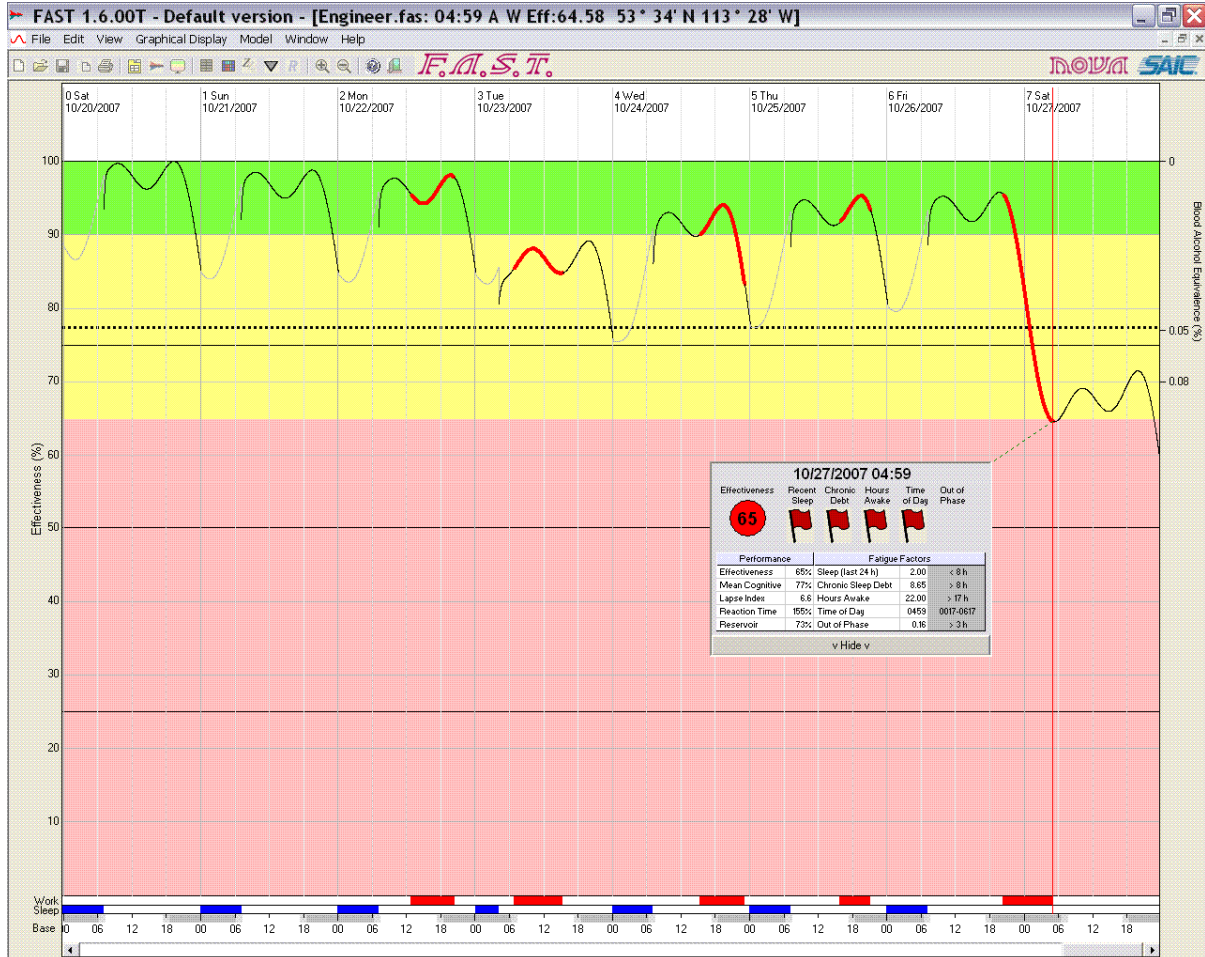
FAST Table for Locomotive Engineer – Train 417

1. From time to time, fatigued train crews will feel compelled to report for work without adequate rest, creating the risk of an accident.
2. In the absence of procedures that recognize the risks inherent in an authority gradient, intra-cab communication can fail.
3. Had Train 417's crew been advised of the upcoming meet, the likelihood of collision would probably have been reduced.
