**RAILWAY INVESTIGATION REPORT  
R07T0240**

**MAIN TRACK TRAIN DERAILMENT**

**CANADIAN PACIFIC RAILWAY  
FREIGHT TRAIN No. 230-25  
MILE 42.80, BELLEVILLE SUBDIVISION  
TICHBORNE, ONTARIO  
25 AUGUST 2007**

Report Number R07T0240

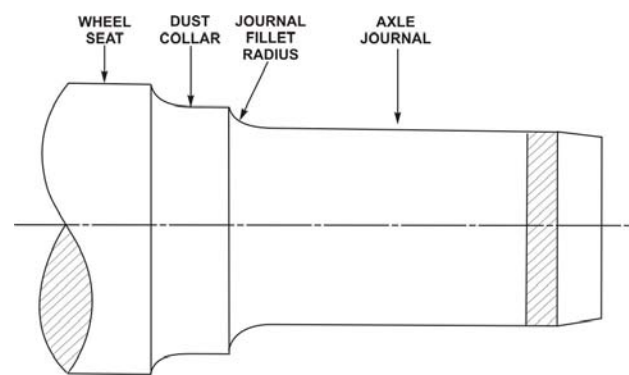
**Figure 3.** Freight car axle

During wheelset assembly, railway wheels are press-fit onto the axle wheel seats and then roller bearings are press-fit onto the axle journals. The axle wheel seat and journal have different cross-sectional diameters connected by two consecutive radii, the dust collar and the fillet radius, that transition from the larger diameter wheel seat to the smaller journal (see Figure 3). Both the dust collar and fillet radius require smooth, contoured transitions.
