RAILWAY INVESTIGATION REPORT
R07T0323

MAIN TRACK DERAILMENT

CANADIAN NATIONAL
TRAIN NUMBER M-38461-29
MILE 9.30, HALTON SUBDIVISION
MALPORT, ONTARIO
30 OCTOBER 2007

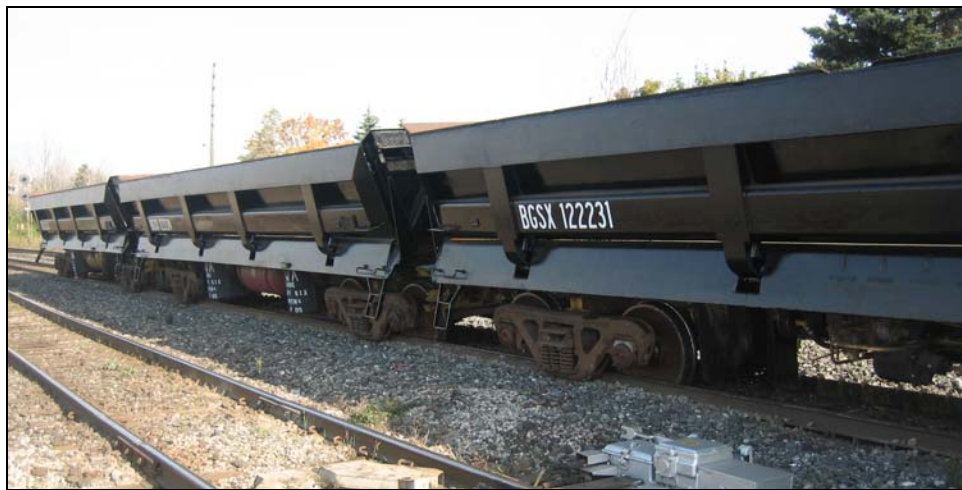
Photo 4. BGSX series air dump cars

The air dump cars (BGSX series) involved in this derailment were designed and manufactured for use in the mining industry. These cars had been custom designed to operate on severe curvature track and on track built on loose fill (for example, temporary track). To minimize the possibility of a derailment, the cars were equipped with Association of American Railroads
