Transport
Canada

TP 185E
Issue 3/2013

AVIATION SAFETY LETTER

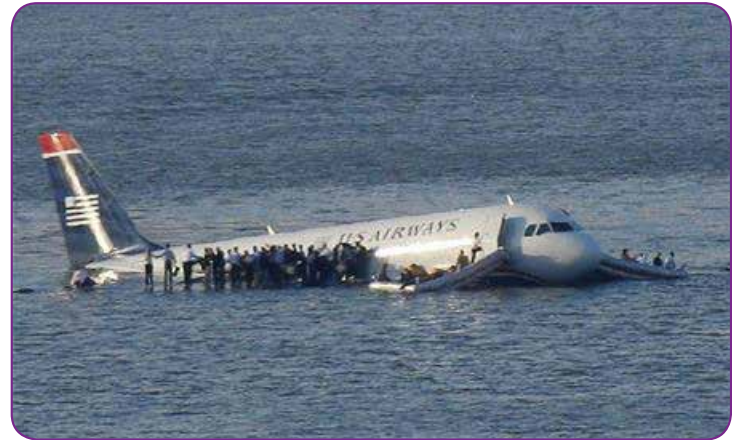
Several explanations were offered by investigators. "Although the accident flight attendants did not command passengers to don their life vests before the water impact, two passengers realized that they would be landing in water and retrieved and donned their life vests before impact, and a third passenger attempted to retrieve his life vest but was unable to do so and, therefore, abandoned his attempt," the report said. "Many passengers reported that their immediate concern after the water impact was to evacuate as quickly as possible, that they forgot about or were unaware that a life vest was under their seat, or that they did not want to delay their egress to get one. Other passengers stated that they wanted to retrieve their life vest but could not remember where it was stowed." In all, 101 life vests were left stowed under passenger seats.

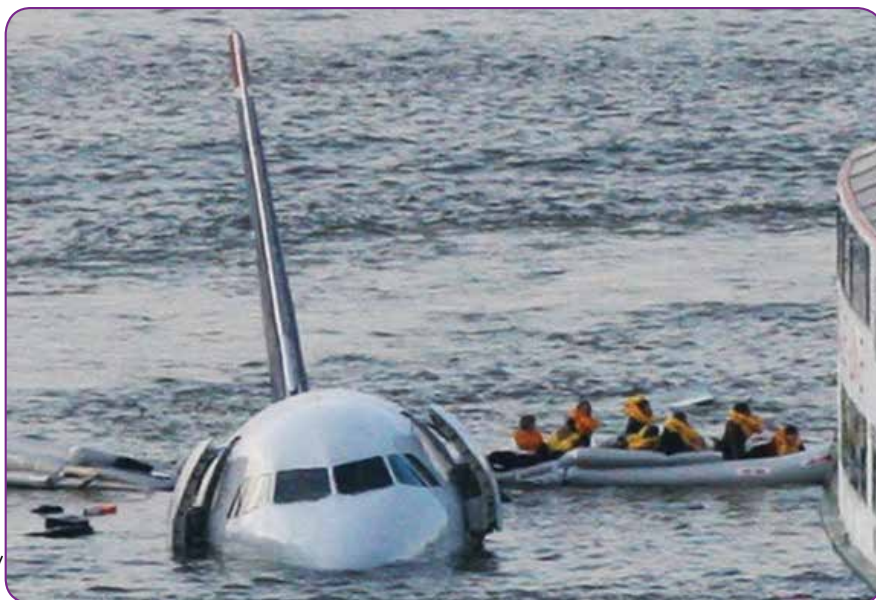
The off-wing ramp/slides on the accident airplane, as is typical in the industry, had no quick-release girts to enable occupants to free the ramp/slides from the sinking airplane for flotation out of the water or for use as handholds.

“Some passengers immediately recognized their usefulness and boarded the ramp/slides to get out of the water,” the report said. “Eventually, about eight passengers succeeded in boarding the left off-wing slide and about 21 passengers, including the lap-held child, succeeded in boarding the right off-wing ramp/slide.”

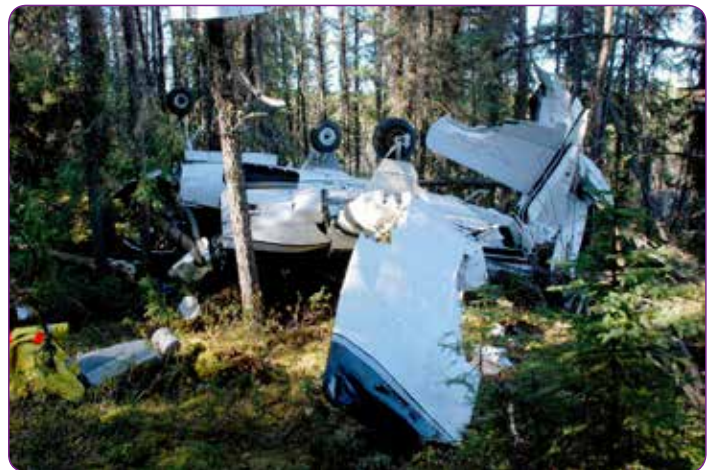
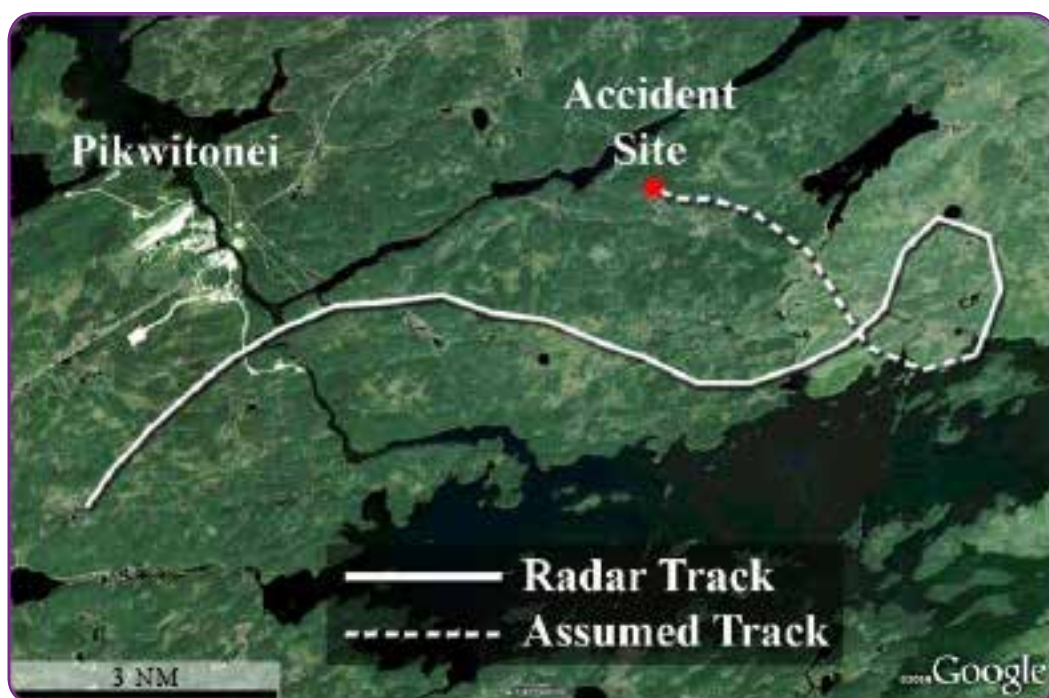
TSB Final Report A10C0060—Fuel Starvation and Forced Landing

The first indication of a loss of electrical power occurred immediately after takeoff, when the electrically-operated landing gear did not fully retract and all avionics power was lost. The transponder also stopped transmitting and the aircraft was no longer being tracked by radar.

The engines stopped shortly after the aircraft was rocked to lock the landing gear. The loss of fuel supply and the stoppage of the right engine were likely due to fuel exhaustion as the fuel in the right main tank became depleted. The left engine stopped almost immediately after the right engine had stopped. The stoppage of the left engine may also have

resulted from fuel exhaustion if the engines had burned an equal amount of fuel since the aircraft had last been fueled. It is more likely, however, that the engine stopped as a result of fuel starvation as the low level of fuel in the tank allowed the port to become uncovered when the aircraft experienced yaw from asymmetric thrust. The decision not to feather the propeller on the right engine would have resulted in increased drag and greater yaw forces, causing the fuel to move away from the fuel port at the inboard edge of the left tank. With the gear already down, the pilot's decision not to feather either propeller increased the rate of descent and reduced the pilot's ability to control the forced landing.

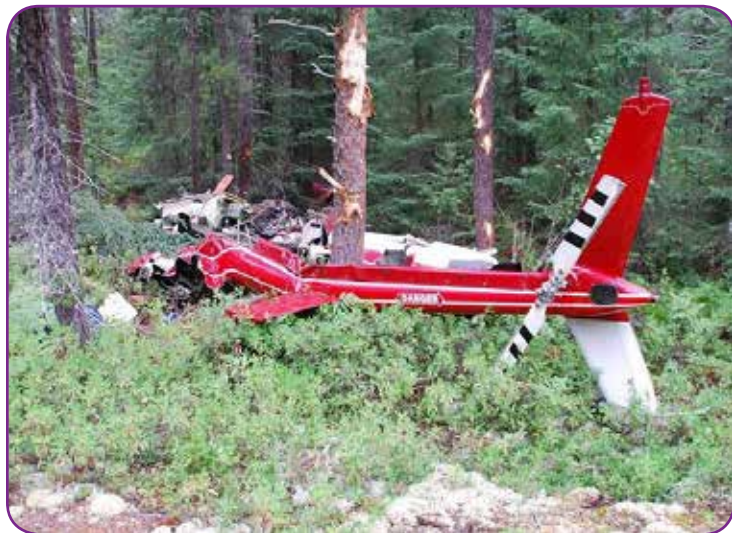
On July 23, 2010, at 12:26 EDT, a commercially registered Bell 206B departed North Bay for a VFR flight to Kapuskasing, Ont. The pilot was repositioning the helicopter for sightseeing flights planned at a local festival the next day. Another company pilot was a passenger. During the flight, poor weather conditions were encountered and approximately 1 hr and 12 min after departure, in the vicinity of Elk Lake, the helicopter collided with a tower approximately 79 ft in height. The helicopter then struck the ground approximately 430 ft beyond the tower and was destroyed. Both occupants were fatally injured; there was no post-impact fire. The emergency locator transmitter (ELT)

functioned, but its range was reduced significantly as its antenna was sheared on impact. *The TSB authorized the release of this report on November 16, 2011.*

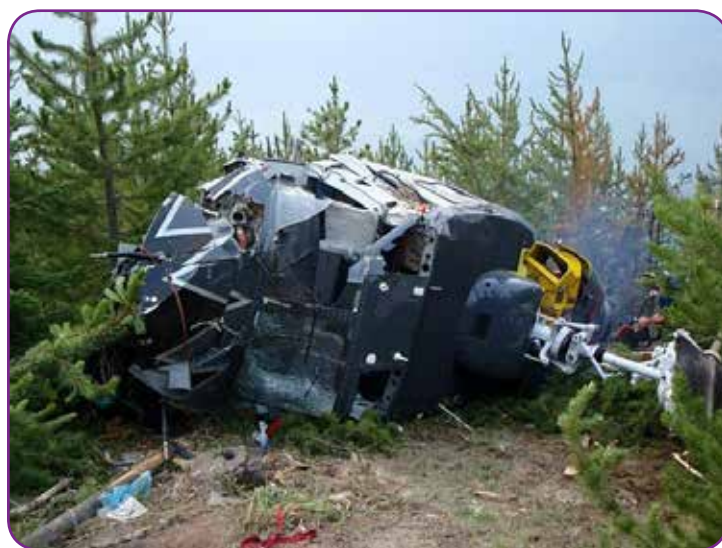
and started to descend past a ridgeline into the creek valley, the engine lost power. The pilot-in-command, seated in the left-hand seat, immediately turned the helicopter left to climb back over the ridgeline to get to a clearing, released the water bucket and the 130-foot long-line from the belly hook, and descended toward an open area to land. The helicopter touched down hard on uneven, sloping terrain and pitched over the nose. When the advancing main rotor blade contacted the ground, the airframe was in a near-vertical, nose-down attitude, which then rotated the fuselage, causing it to land on the left side. A small post-crash fire ignited. The pilot-in-command sustained a concussion and was rendered unconscious. The co-pilot escaped with minor injuries and dragged the pilot-in-command from the wreckage. The pilot-in-command regained consciousness a few minutes later. The helicopter was substantially damaged. The 406 MHz emergency locator transmitter (ELT) activated, but its antenna fitting was fractured; as a result, the search and rescue satellite network did not receive a signal. *The TSB authorized the release of this report on April 17, 2013.*

The occurrence helicopter experienced a loss of power at a critical phase of flight while the pilot was preparing to drop a load of water. In response to the power loss, the pilots identified a nearby landing area and carried out an emergency landing. However, the nature and slope of the terrain in the touchdown area caused the helicopter to roll over after touchdown. The combination of low airspeed, high-density altitude (approximately 9 000 ft), height above ground at the time of the power loss, gross weight of the helicopter, and nature and slope of the terrain precluded an uneventful landing.

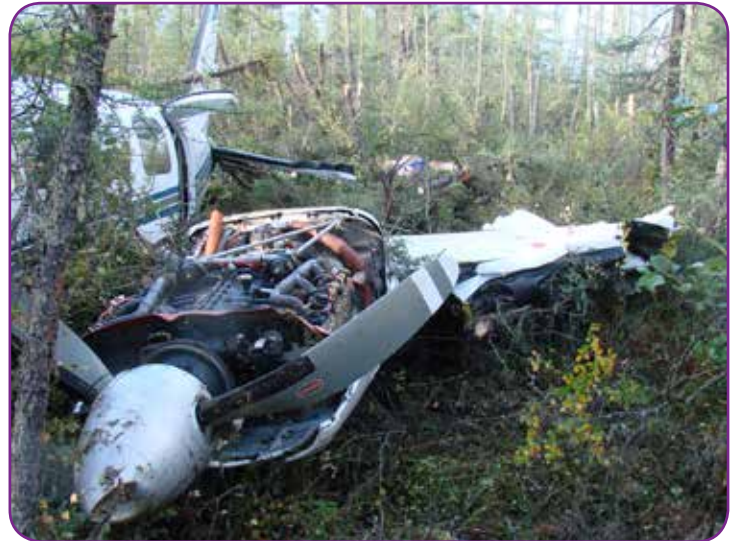
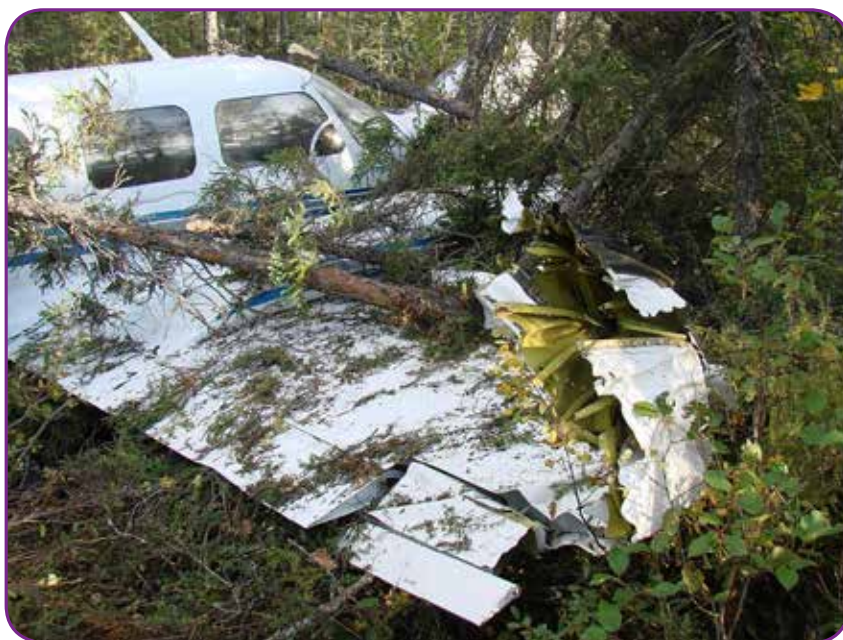
TSB Final Report A10C0159—Engine Shut-down and Forced Landing

The initiating event of the occurrence was a magneto failure in the left engine. This failure was the result of the loss of retention of the bushing in the distributor block of the left magneto. The subsequent misalignment of the distributor rotor caused the rotor to fall out of synchronization with the engine. This caused the left engine to run rough, backfire and lose power. The clean, shot-blasted appearance of the piston crowns indicates that the rough running and back firing likely released combustion products that contaminated spark plugs of both magneto systems. It could not be determined whether the engine would have been capable of producing significant power running on the right magneto alone.

1. The left magneto distributor rotor gear teeth uncoupled from the input pinion gear, placing the distributor rotor out of time with the engine. As a result, the left engine began to run rough, backfire and lose power.
2. The pilot shut down the left engine, but did not immediately adjust the power on the operating engine. Airspeed then decreased to a point where the addition

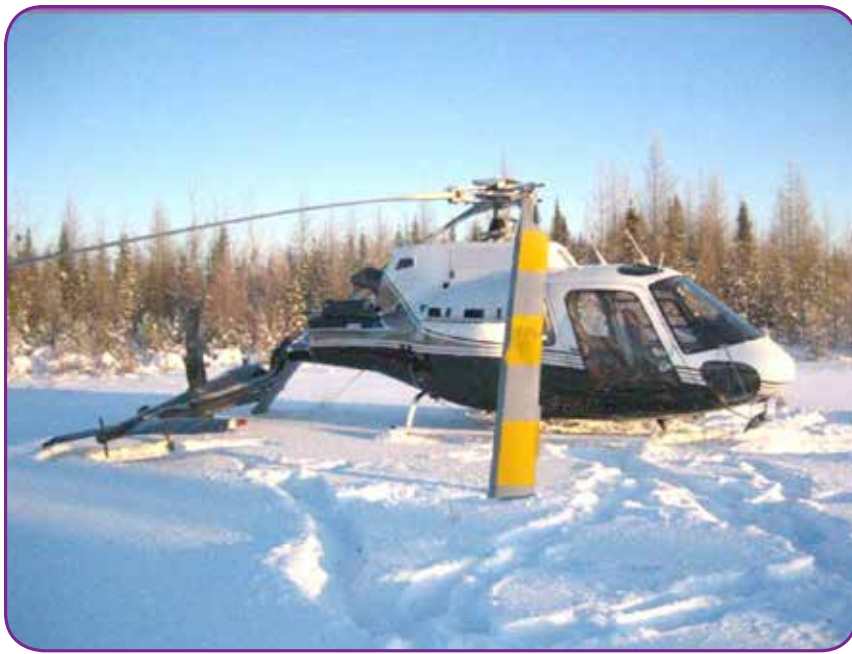
TSB Final Report A10C0214—Engine Power Loss and Autorotative Landing

Testing of the engine and its fuel system could not identify a mechanical reason for the engine power loss. A blockage in the air inlet or fuel delivery system could cause an engine to flame out, but no such blockage or contamination was noted. Testing of the fuel system showed that air can become entrapped in the fuel system which could not be bled out by normal maintenance action prior to flight. The analysis will therefore examine the role that air entrapment may have played in this occurrence.

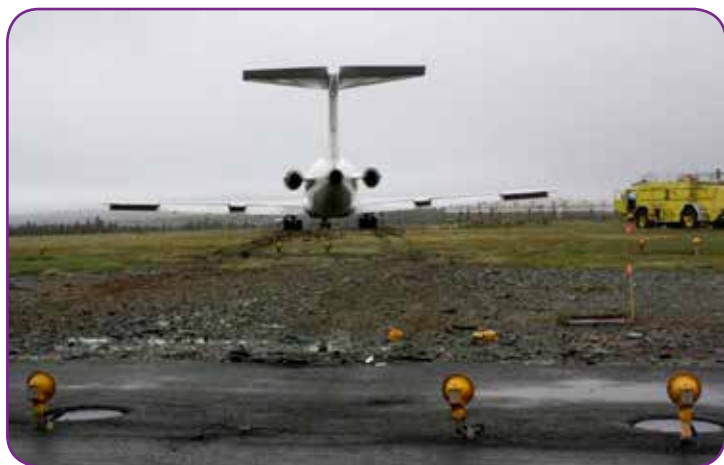
TSB Final Report A11A0035—Runway Overrun

On July 16, 2011, at 06:45 NDT, a Boeing 727-281 departed Moncton International Airport, N.B., for St. John's International Airport, N.L., on a scheduled cargo flight with three crew members on board. An instrument landing system (ILS) approach was carried out and at 08:09 NDT the aircraft touched down on Runway 11. Following touchdown, the crew was unable to stop the aircraft before the end of the runway. The aircraft came to rest in the grass, with the nose wheel approximately 350 ft beyond the end of the pavement. There were no injuries and the aircraft had minor damage. *The TSB authorized the release of this report on January 23, 2013.*

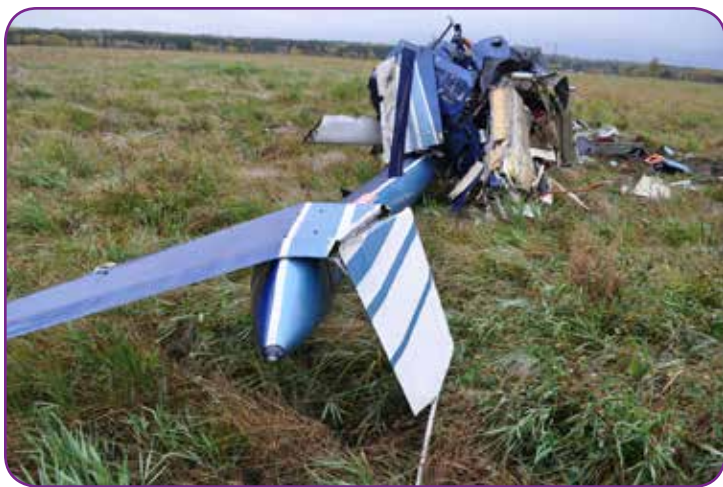
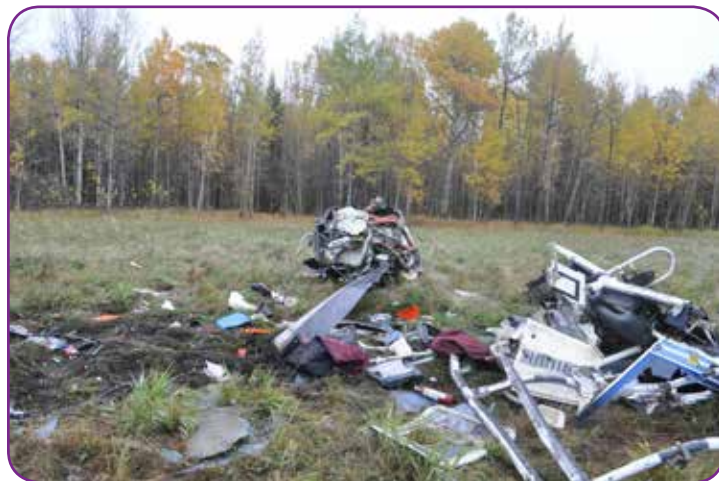
On October 5, 2011, a Bell 206B helicopter was on a VFR flight from Whitecourt, Alta., to Drayton Valley Industrial Airport, Alta. The flight encountered and continued into instrument meteorological conditions (IMC). The aircraft collided with terrain approximately 1 NM south of Drayton Valley Industrial Airport, at 18:20 MDT, during daylight hours. There was no post-crash fire. The pilot, who was the sole occupant, was fatally injured. No emergency locator transmitter (ELT) signal was received by search and rescue authorities. *The TSB authorized the release of this report on October 31, 2012.*

The pilot was in the habit of not wearing the available shoulder harnesses. These harnesses serve to maintain occupants in an upright position in order to take full advantage of all the crashworthiness features of the aircraft. To what extent this may have contributed to the injuries sustained could not be determined. The fact that the pilot was not wearing a helmet likely would not have been a factor in survivability due to the severity of impact forces.

1. The pilot continued the VFR flight into weather conditions that required descent through cloud to reach destination.
2. The pilot did not arrest the rate of descent, resulting in a collision with terrain in which the impact forces were not survivable.
