TP 185E  
Issue 2/2014

# AVIATION SAFETY LETTER

TSB Final Report Summaries

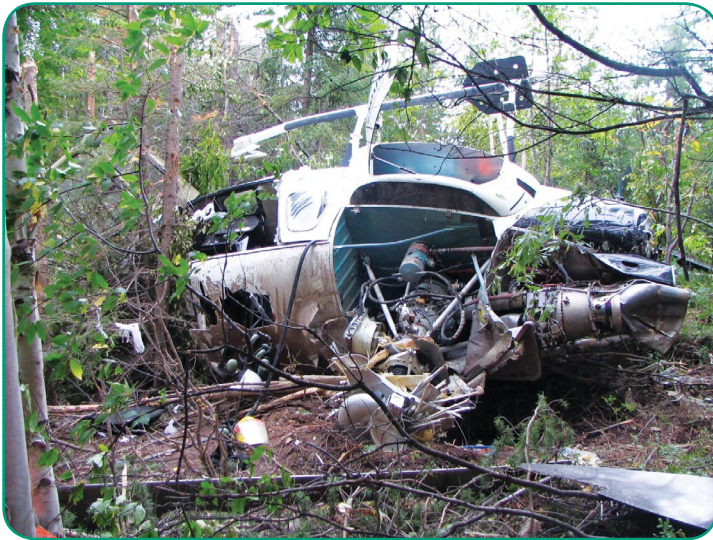
### **TSB Final Report A10Q0148—Loss of Visual Reference—Collision With Trees**

When visibility decreased to approximately 1 mi. in moderate rain, the pilot elected to deviate from the direct GPS route toward a blueberry field to execute a precautionary landing and wait for better conditions. At no time prior to this did the pilot think it necessary to change course and fly out of the line of thunderstorms. The pilot knew the terrain well and therefore, at that point in the flight, did not perceive any risk in continuing. When visibility decreased further in heavy rain, the pilot was compelled to land immediately on the gravel road. The pilot was aware that the rain was intensifying as the aircraft approached its destination; however, the pilot was surprised by the suddenness of the decrease in visibility as the decrease had been gradual over the last 20 to 30 NM and the cloud ceiling had remained VMC. Visual reference with the ground and trees was lost while manoeuvring at low speed, on final approach to the road. While in a hover over the trees, 75 ft from the road side, the helicopter descended vertically without the pilot realizing it and struck the trees and then the ground. The helicopter was not equipped with windshield wipers which might have been useful in this phase of flight and in the weather conditions encountered. The decision to deviate out of the weather and land was taken too late.

1. Although the pilot was aware of the passage of a cold front forecast for the time of the return flight, a weather update was not obtained as weather at the worksite was VMC throughout most of the day.
2. The pilot had not anticipated catching up with the line of thunderstorms which had previously passed over the worksite. The decision to deviate and/or land prior to encountering conditions of reduced visibility in heavy rain was made too late.
3. While attempting to execute a landing on a gravel road to wait for the weather to improve, the pilot lost all visual references in conditions of reduced visibility in heavy rain; consequently, the helicopter collided with the trees and ground.

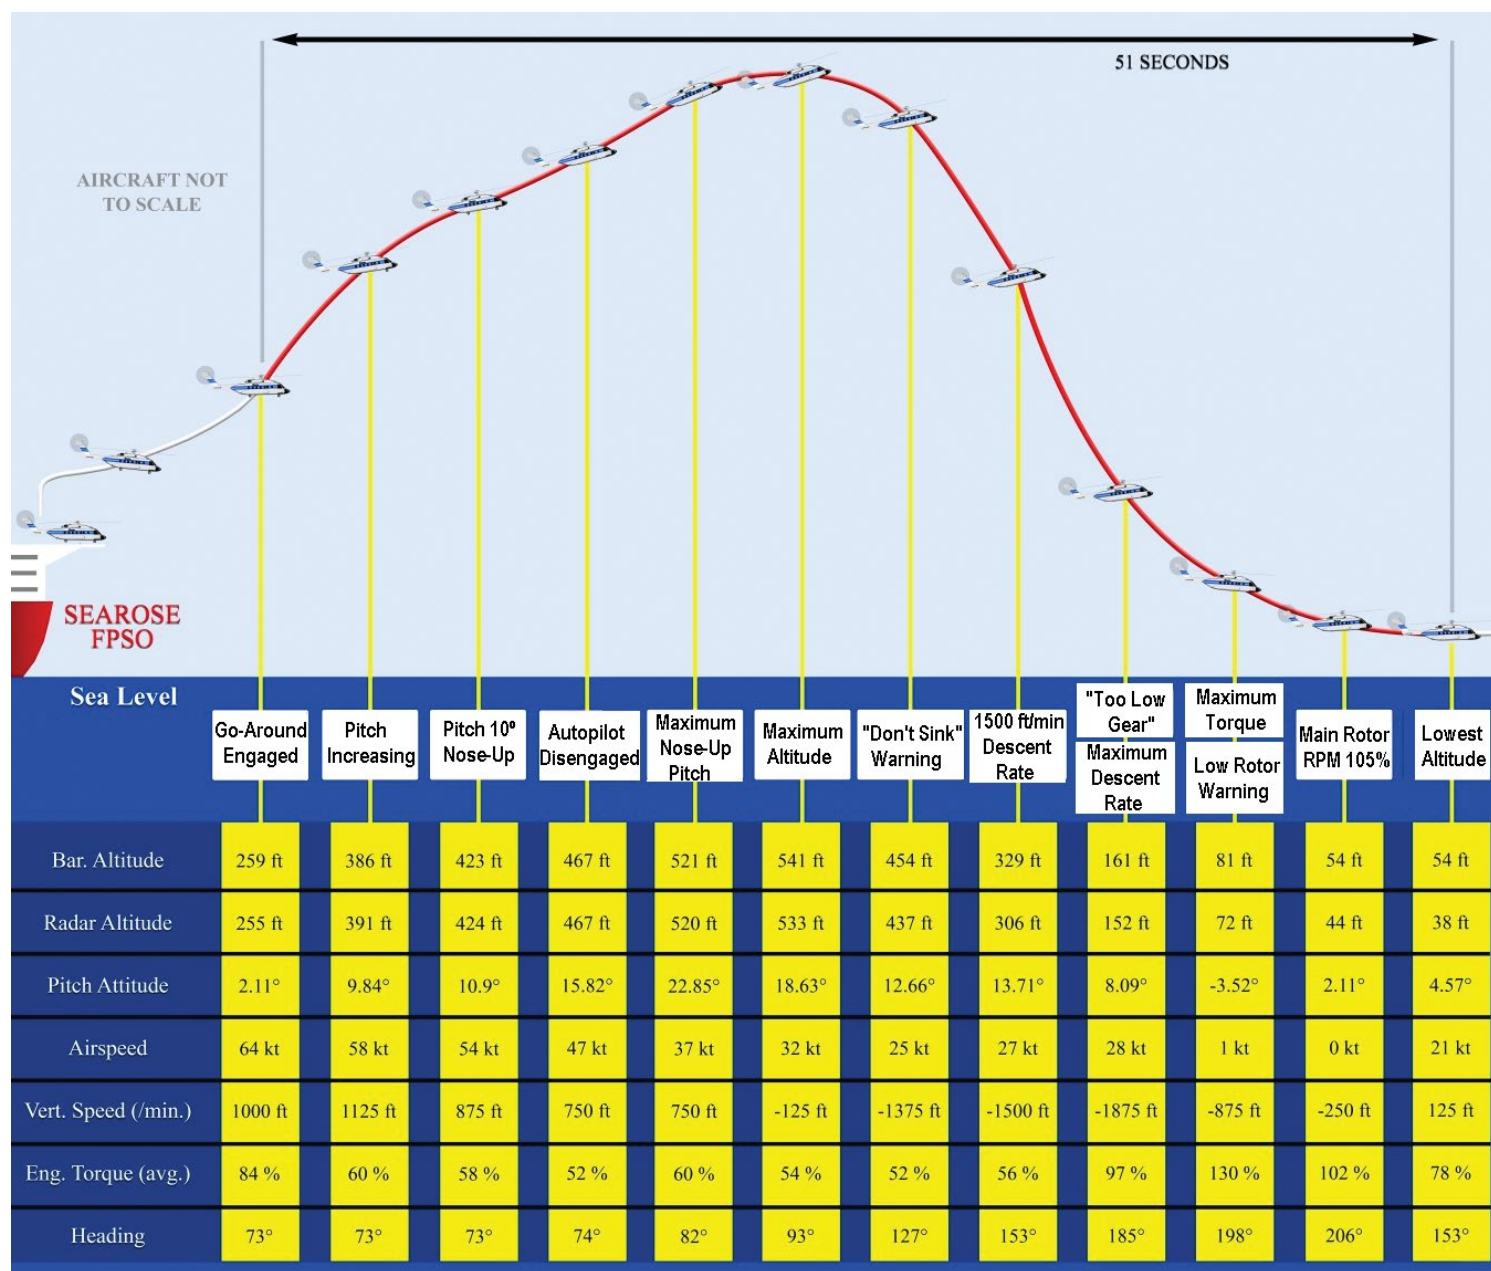
Departure profile (derived from flight data recorder (FDR) data)

1. During the departure procedure, the captain made a large, rapid aft cyclic input just before the cyclic trim button was released and the go-around (GA) mode was engaged, which caused the helicopter to enter a nose-high, decelerating pitch attitude.

3. As the airspeed of the helicopter decreased to within 5 kt of the minimum control speed in IMC ( $V_{MINI}$ ), the captain momentarily pressed the cyclic force trim release button and made an aft cyclic input. This caused the helicopter's airspeed to decrease below  $V_{MINI}$ , and the helicopter to enter a 23° nose-high unusual attitude.

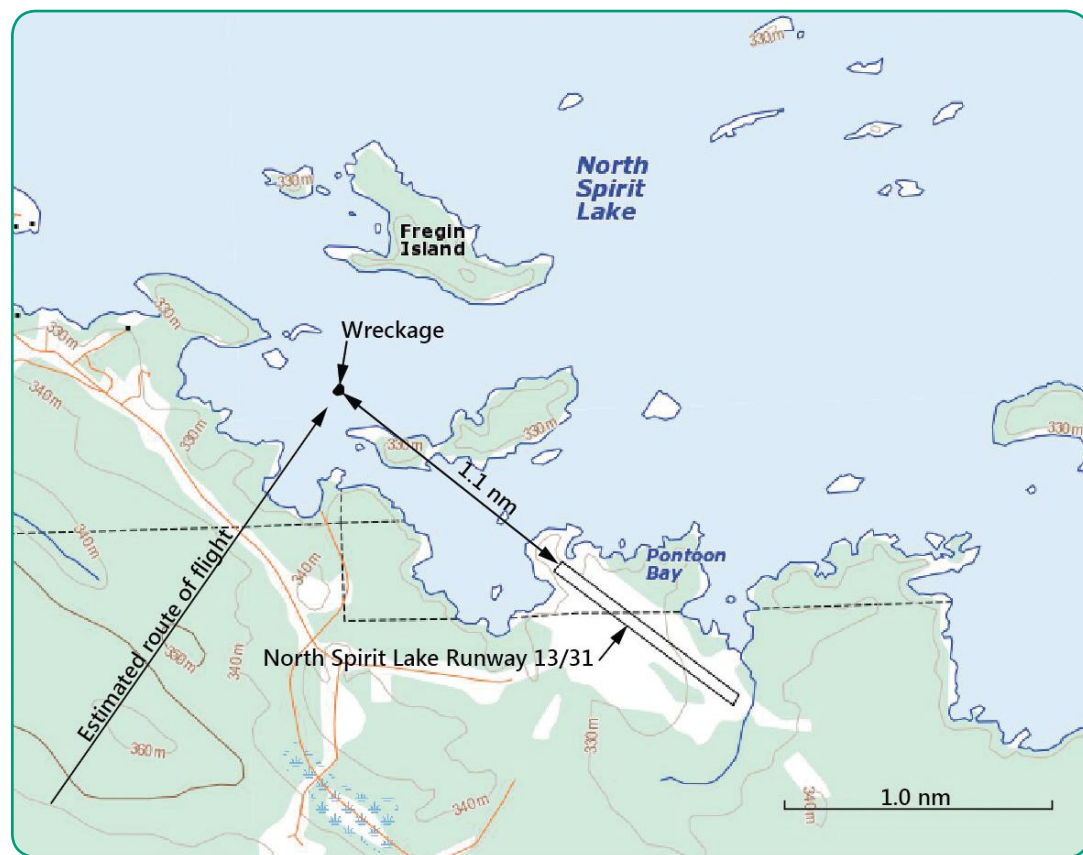
Wreckage location

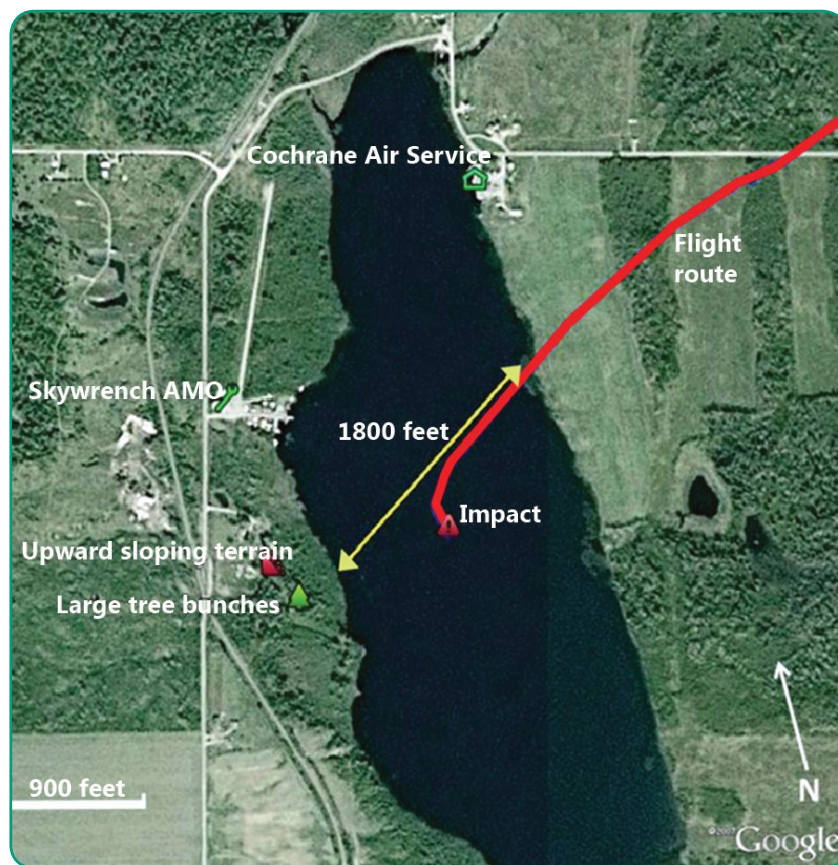
Lillabelle Lake

On May 25, 2012, a de Havilland DHC-2 Mk.1 Beaver floatplane departed Edgar Lake, Ont., with two passengers and 300 lb of cargo on board. The aircraft was destined for the company’s main base located on Lillabelle Lake, Ont., approximately 77 mi. to the south. On arrival, a southwest-bound landing was attempted across the narrow width of the lake, as the winds favoured this direction. The pilot was unable to land the aircraft in the distance available and executed a go-around. At 14:08, EDT, shortly after full power application, the aircraft rolled quickly to the left and struck the water in a partially inverted attitude. The aircraft came to rest on the muddy lake bottom, partially suspended by the undamaged floats. The passenger in the front seat was able to exit the aircraft and was subsequently rescued. The pilot and rear-seat passenger were not able to exit and drowned. The ELT activated on impact. *The TSB authorized the release of this report on September 19, 2013.*

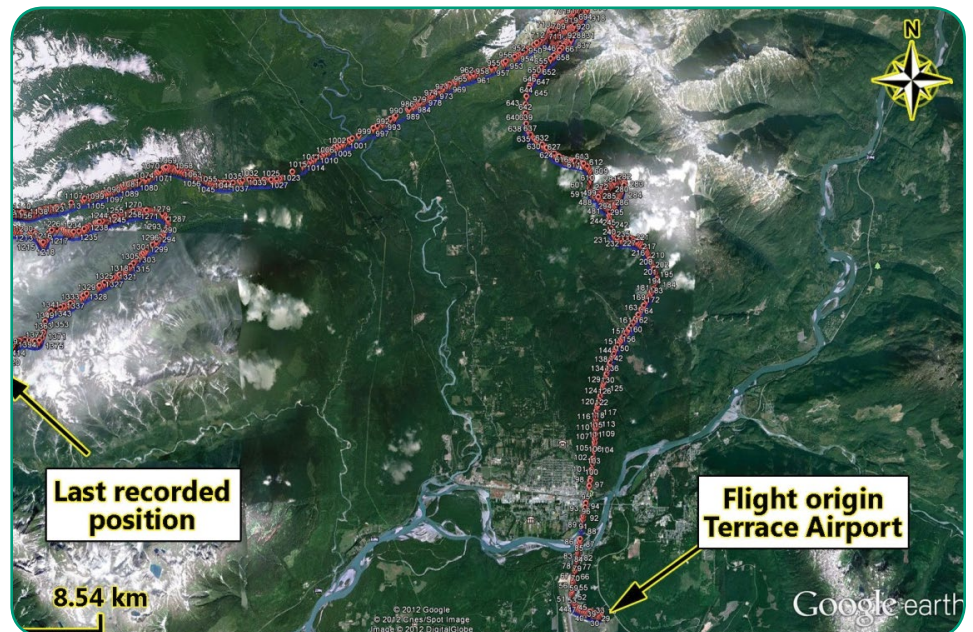
*Plot of GPS data from the occurrence flight  
(Image: Google Earth, diagram added by TSB)*

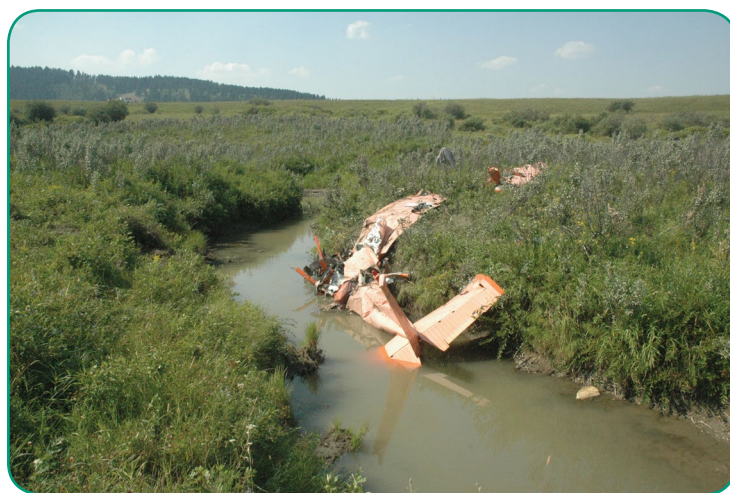
### TSB Final Report A12W0121—Loss of Control and Collision With Terrain

On August 26, 2012, a Cessna 172M departed Springbank Airport (CYBW), Alta., on a VFR flight to conduct a pipeline patrol to the south, through foothill terrain. While the aircraft was circling a pipeline stream crossing on Chaffen Creek, approximately 22 NM west-northwest of Claresholm, Alta., near the Chain Lakes Reservoir, it entered a spin, descended steeply, and collided with terrain at 17:34 MDT. The pilot, who was the sole occupant of the aircraft, sustained fatal injuries. The aircraft was destroyed by impact forces, and there was no post-impact fire. The 406 MHz ELT activated on impact. The accident occurred during daylight hours. *The TSB authorized the release of this report on July 17, 2013.*

There were no indications that any aircraft systems contributed to the loss of control of the aircraft and its subsequent collision with the ground. Therefore, this analysis will focus on aircraft handling and the environment in which the flight was conducted.
