**AVIATION INVESTIGATION REPORT
A12Q0182**

IN-FLIGHT ENGINE FIRE LEADING TO A FORCED LANDING

**PIPER PA-34-200, C-GNAS
NADEAU AIR SERVICE INC.
VICTORIAVILLE, QUEBEC, 2 NM E
15 OCTOBER 2012**

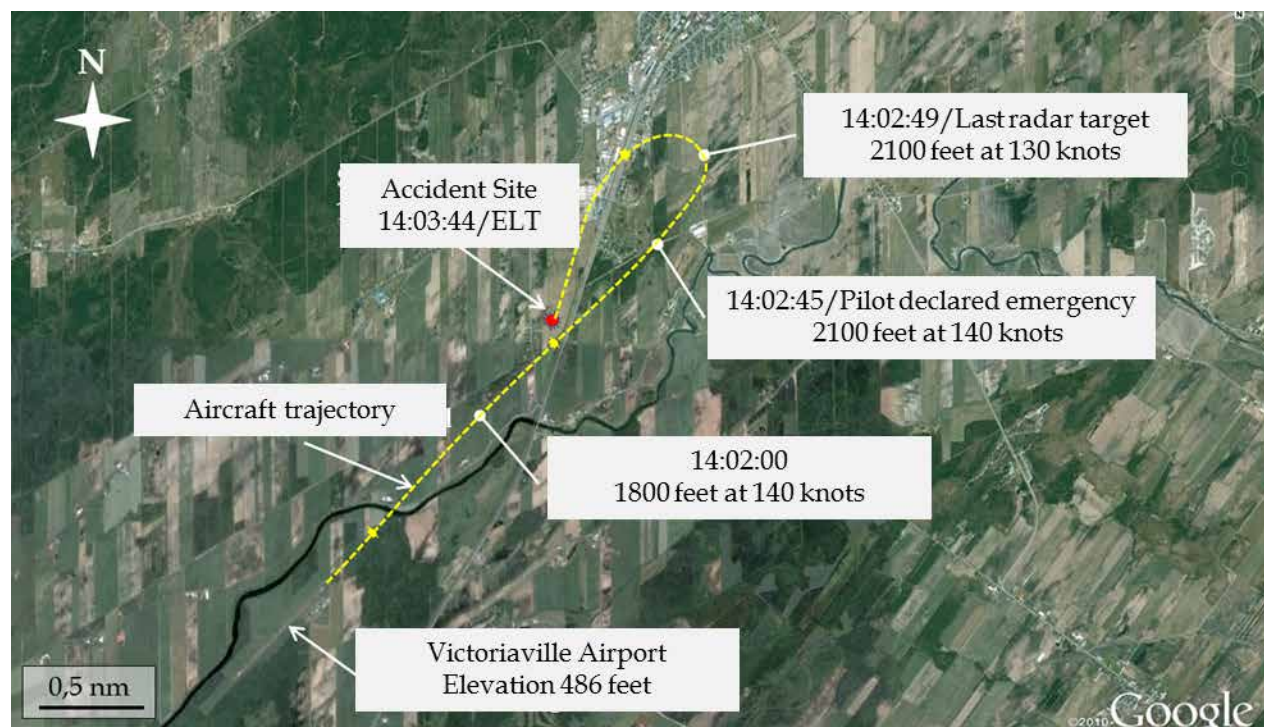
Figure 1. Aircraft trajectory after the missed approach (source: Google, with annotations by TSB)

The PA-34-200 turned back toward the airport (Figure 1). The smoke cleared when the pilot opened his window and the instructor opened his door slightly. At the same time, flames from the right side of the aircraft appeared at the instructor's feet, setting fire to his trousers. The instructor immediately transferred control back to the pilot, urging him to make an emergency landing as he tried to smother the flames on his clothing with his hands. Smoke then filled the

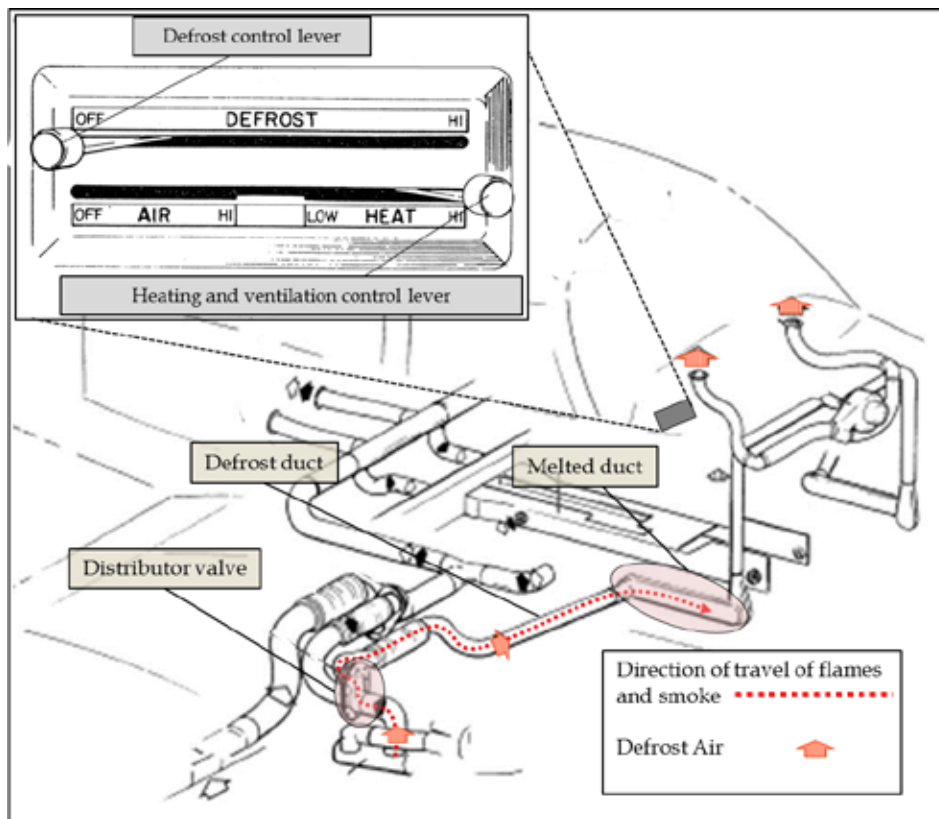
Figure 2. Heating, ventilation and defrost system

The ventilation system is designed in such a way that the distributor valve prevents smoke from seeping into the cockpit and the cabin. Anomalies such as an engine oil leak can sometimes allow contaminants such as engine oil to seep into the ram air system. The pyrolysis of these contaminants can create smoke and odour in the supply lines for the heating and defrosting system.
