TECHNICAL EVIDENCE

CHAPTER SIX TECHNICAL EVIDENCE

DIVING SURVEY

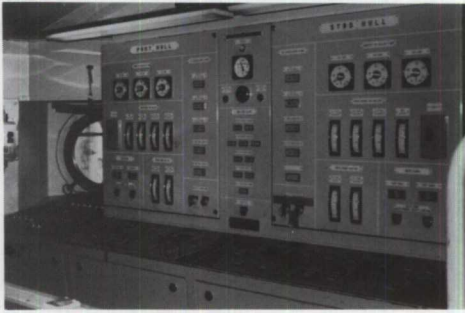
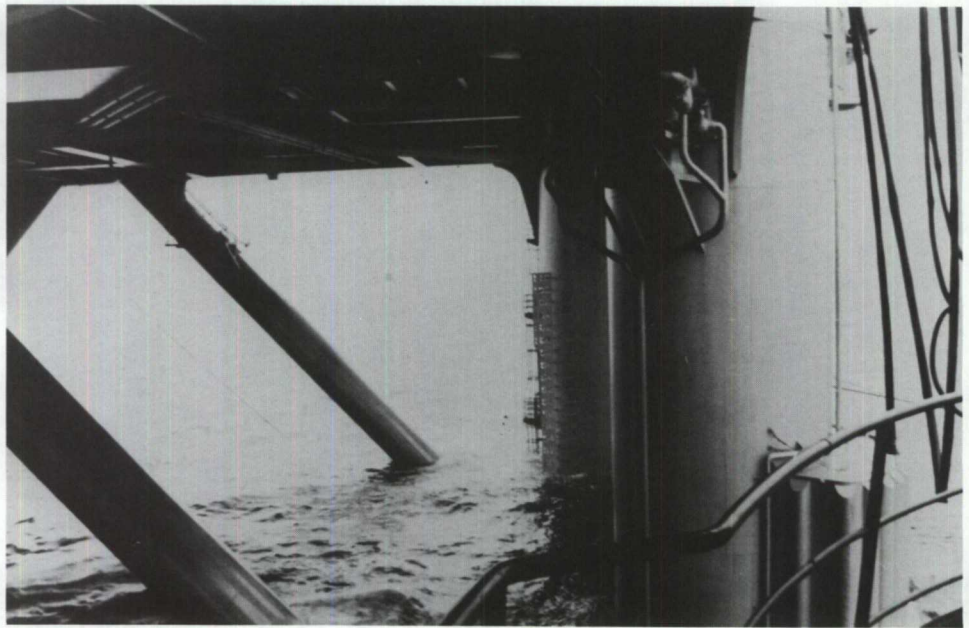
7.2 These photographs show the ballast control console and the view of the draft marks from porthole #3 at the extreme left.
