EVACUATION AND EMERGENCY RESPONSE

CHAPTER EIGHT EVACUATION AND EMERGENCY RESPONSE

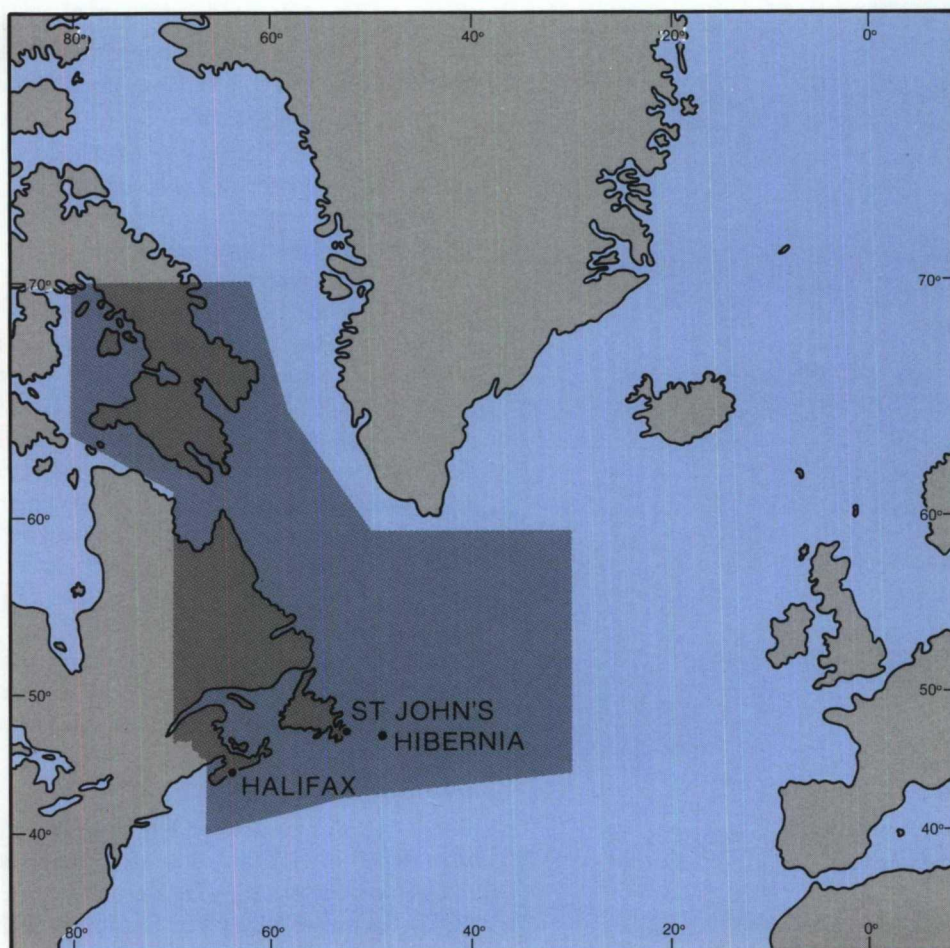
9.4 RCC Halifax is responsible for co-ordinating all Search and Rescue operations within an area of approximately 1.8 million square miles, of which 1.2 million square miles is over water.

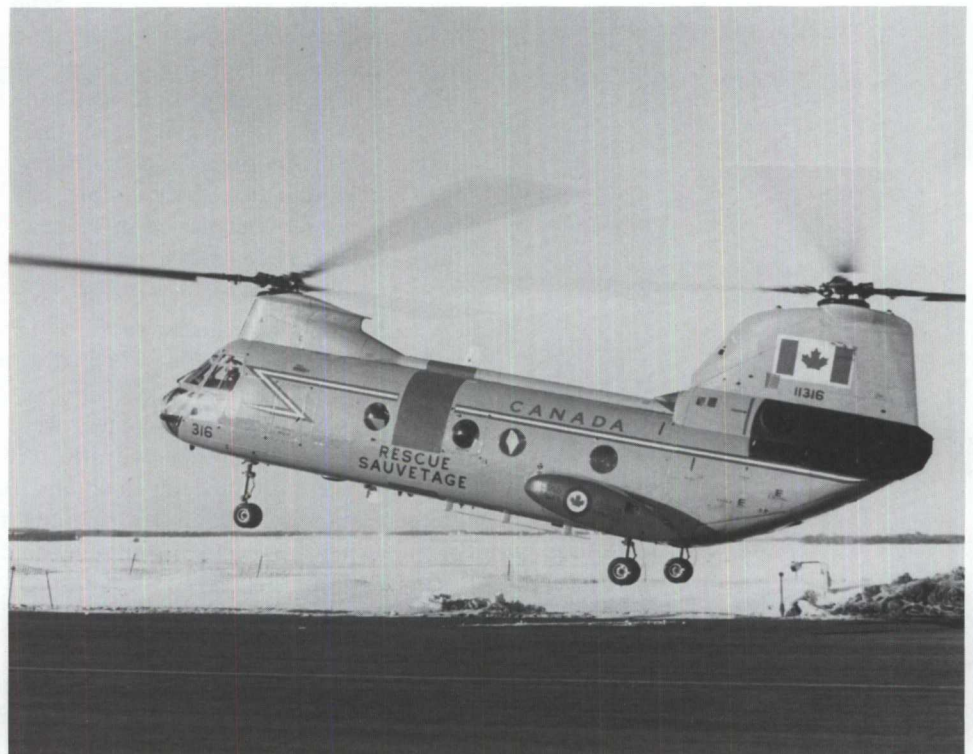
9.6 A SAR Labrador/Voyageur helicopter.
