REPORT "F"
ENGINEERING REPORT EP 333/83
BALLAST CONTROL PANEL TESTS
8 September 1983

REPORT "G"
ENGINEERING REPORT 195/82
BALLAST CONTROL ELECTRICAL
SYSTEM
AND OVERALL ANALYSIS
8 September 1983

REPORT "H" ENGINEERING REPORT EP 72/84 PUMP SWITCH FAILURE DEMONSTRATION 01 March 1984

REPORT "I"
ENGINEERING REPORT EP 73/84
MICROSWITCH FAILURE ANALYSIS
01 March, 1984

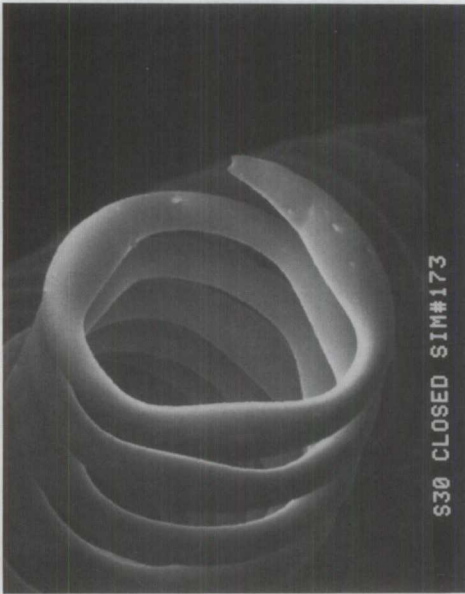
PHOTO 9 Filament from simulation panel flooded with water.

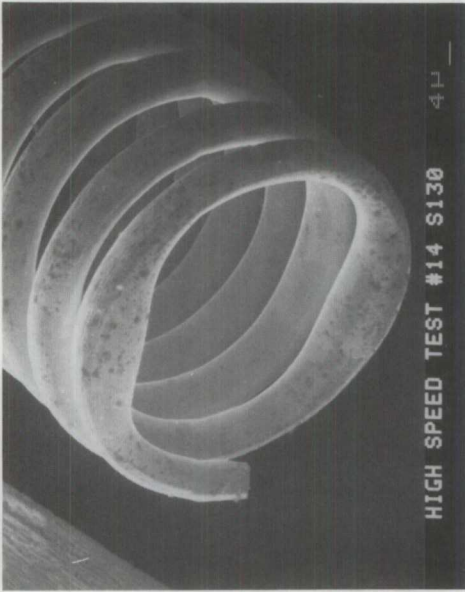
PHOTO 10 Filament experiencing 70 volts AC in the laboratory.

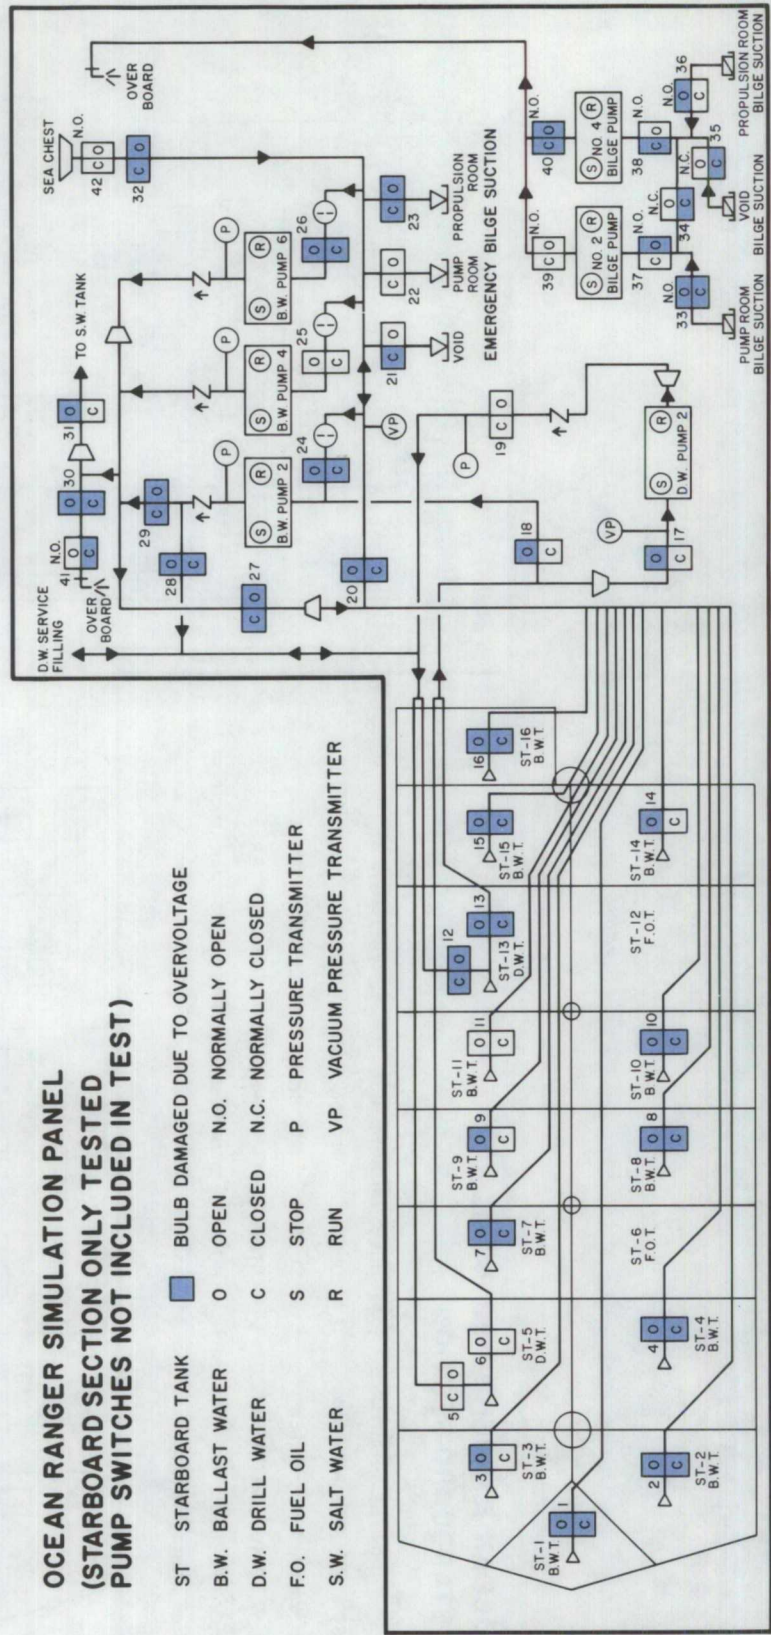
FIGURE 3 Starboard Mimic Panel (Simulator).

OCEAN RANGER SIMULATION PANEL (STARBOARD SECTION ONLY TESTED PUMP SWITCHES NOT INCLUDED IN TEST)

| ST | STARBOARD TANK | ■ | BULB DAMAGED DUE TO OVERVOLTAGE |

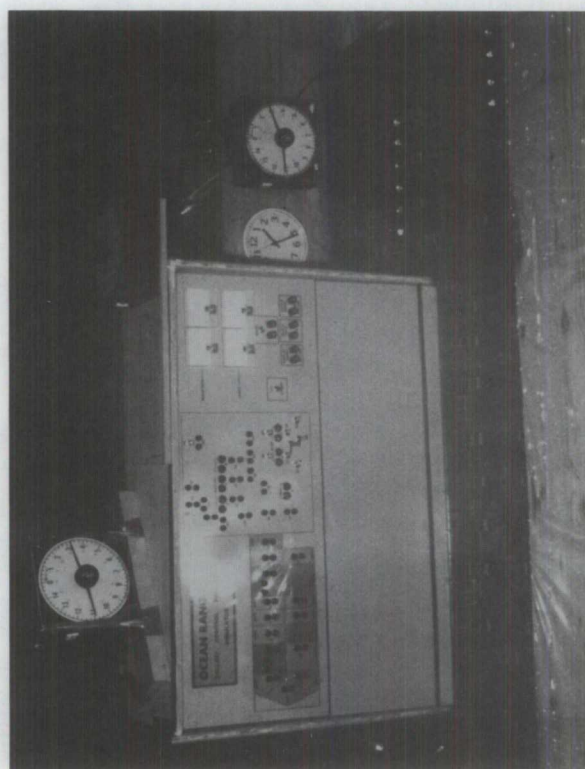
3.2 Appropriate scaffolding and a 50 gallon capacity trough was constructed to douse the panel with sea water in a manner similar to how it was believed to have occurred on the night of the capsizing. Photo 7 shows the test set-up just before the test.

3.3 Fifty gallons of sea water were poured on the panel over a three second period while all valve and switch lights were red. The observed effects were immediate. The 24 volt mimic panel light circuit fuse blew. On checking the blown fuse it was discovered that it was a five ampere fuse instead of the intended ten ampere fuse. The fuse was replaced with a ten ampere fuse which also blew after a few minutes. The fuse blew as a result of salt-water entering most of the switch lamp housings shorting out the lights and causing an increased load on the circuit.

PHOTO 7 Panel set-up just prior to test.

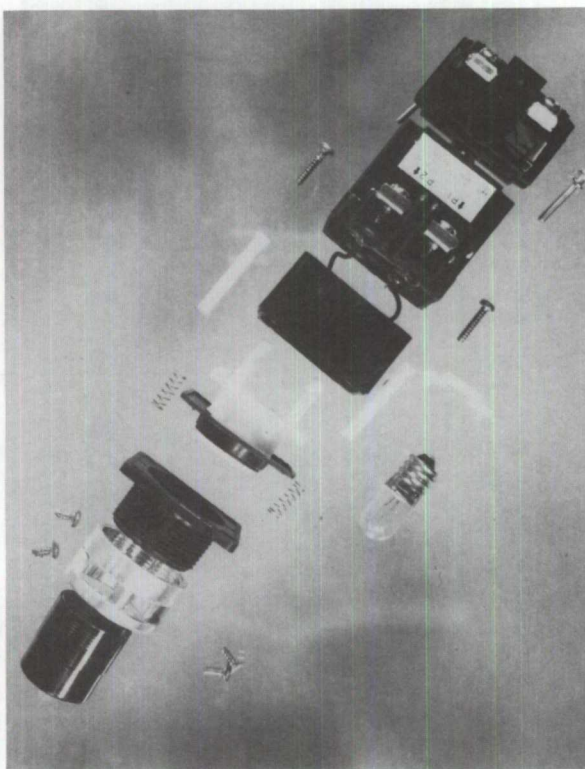
PHOTO 2 The same pump switch disassembled.

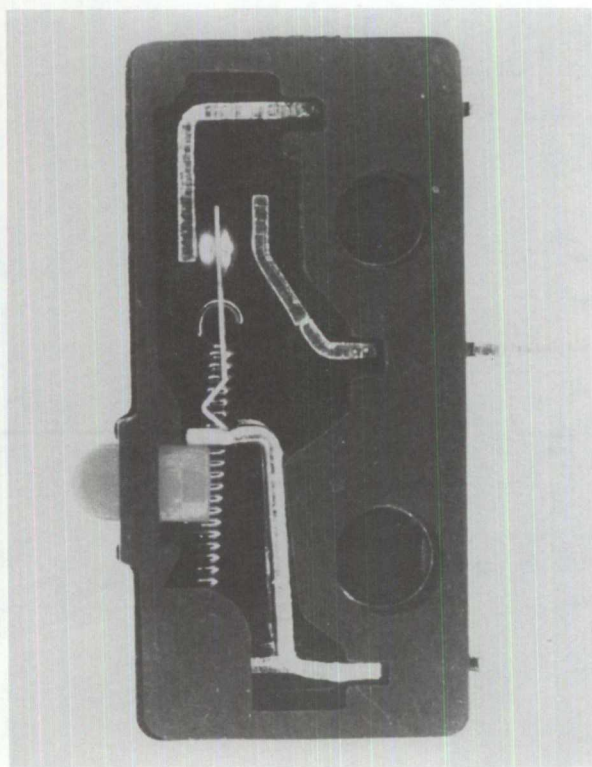
PHOTO 2 A typical microswitch with the side of its housing removed, showing its mechanism.

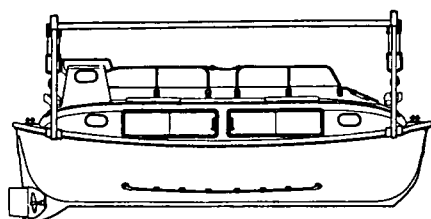
FIGURE 2A Harding lifeboat #1 shown in normal stowage position in davit.

Figures 2a through 2d depict a series of events which could account for the damage sustained by this boat. Note that there were no surviving witnesses to the release of this boat or any of the other boats, and consequently no testimony to support this scenario. It is deduced from the damage found during the post-casualty inspection of the boat, and in the opinion of the author represents the most probable series of events. The following is a description of the events depicted in Figures 2a through 2d:

d. Finally, the support shoe was torn out of its keel connection. This allowed the boat to separate completely from the unit and float away. Damage to the helmsman's tower could also have occurred at this point since the boat dropped stern first.

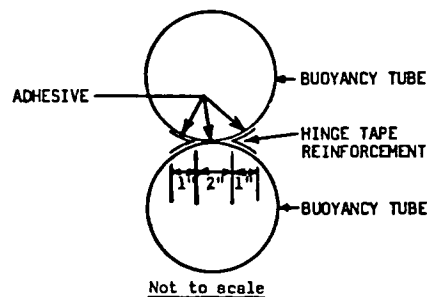
Three of the rafts and the separated floors had separated at the joints that hold the floor to the buoyancy tubes and that hold the buoyancy tubes to each other. Only one of the painter lines was complete from the raft to the point of the weak link. The other painters were severed at a point short of the weak link. Some damage to the rafts was incurred on recovery. Testimony from persons on-scene indicates that some rafts were properly inflated and others were damaged before they were picked up. One was described as being a few bubbles of jumbled liferaft material with ropes wrapped around it (references 11d, 11e).

FIGURE 3 Normal construction of liferaft.

Examination of the areas of the raft that had joint separation showed in most cases, adhesive adhered to one side of the joint, but not the other. Failure appeared to be in the peel mode, but it could not be conclusively determined by examination where the peeling began or why. Glued joints are generally weakest in the peel mode. Figure 3 illustrates the normal method of joining upper and lower tubes. On raft 715, the central area shown as 2 in. wide in the figure was actually much narrower and did not have any evidence of adhesive joining upper and lower tubes directly. Adhesive was evi-
