**AVIATION INVESTIGATION REPORT
A13H0002**

COLLISION WITH WATER

**GOVERNMENT OF CANADA, DEPARTMENT OF TRANSPORT
MBB BO 105 S CDN-BS-4 (HELICOPTER) C-GCFU
M'CLURE STRAIT, NORTHWEST TERRITORIES
09 SEPTEMBER 2013**

On 09 September 2013, at 1638 Mountain Daylight Time, the Canadian Coast Guard Messerschmitt-Bölkow-Blohm BO 105 S CDN-BS-4 helicopter (registration C-GCFU, serial number S 727) operated by the Government of Canada, Department of Transport, call sign CCG364, took off from the Canadian Coast Guard Ship (CCGS) *Amundsen* with 1 pilot, the vessel's master and a scientist on board for a combined ice measurement and reconnaissance mission in the M'Clure Strait, Northwest Territories.

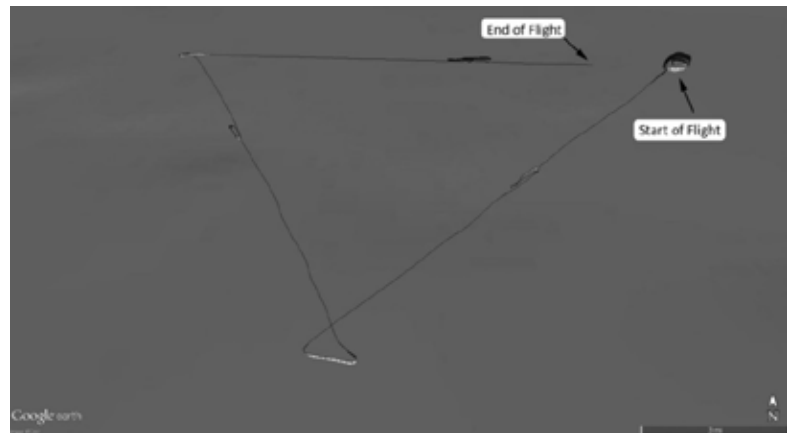
Figure 3. Plot of the entire flight track

At 1805, 27 minutes after CCG364's last broadcast, the helicopter's position was checked on the flight following system's (FFS) control display unit (CDU) located in the wheelhouse. The FFS CDU indicated that the helicopter was at a distance of 3.2 nm, on a bearing of 287° true from the vessel. The last and only displayed position available to the crew in the wheelhouse was on the FFS CDU as N 74° 45.56, W 117° 49.52¹³ at 1741. Several¹⁴ attempts to establish contact with CCG364 were then made, to no avail.

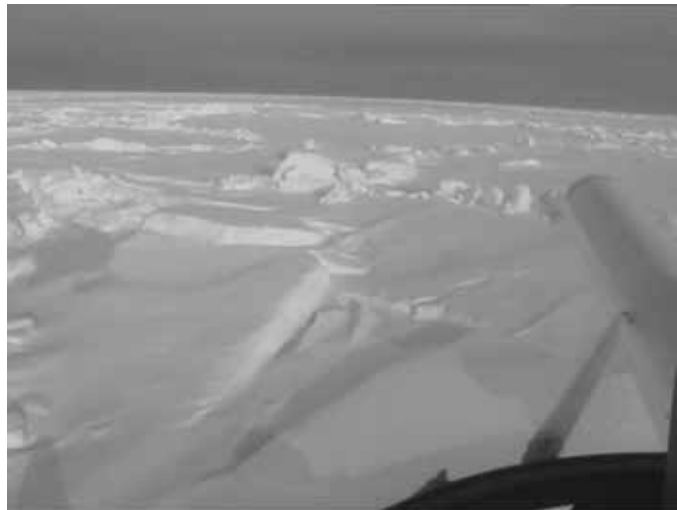
Figure 6. Screen capture taken at 1733:34 in video 3

There was a significant difference between the video and still images and it is believed that the still images are more representative of the actual light conditions at the time. While the first video was recorded in colour, the second and third videos were recorded in black and white (Figure 6).

- the light was brighter than in the previous 2 videos;
- shadows were discernible and the sun was low in the sky, at approximately the helicopter's 5 o'clock position;
- dark overcast sky ahead created a distinct horizon against the white ice surface;
- the texture of the ice varied from smooth to jagged and broken; and
- no open water was in view.³⁹

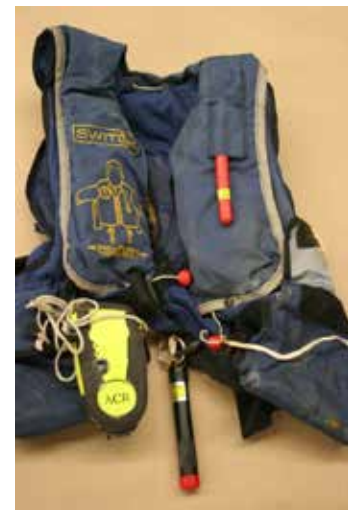
Photo 6. Switlik HV-35C helicopter crew vest

The Switlik HV-35C helicopter crew vest has a mesh back and is equipped with 2 buoyancy chambers, each with its own manual CO₂ inflator,⁶⁴ and an oral inflation tube. The vest incorporates 2 pockets, each with a cover flap, which is held in place by a hook-and-loop type fastener and a locking buckle (Photo 6).

The HV-35C is FAA-certified in accordance with TSO C13d. According to TC, life preservers that are certified to TSO C13d are approved for use in Canada.

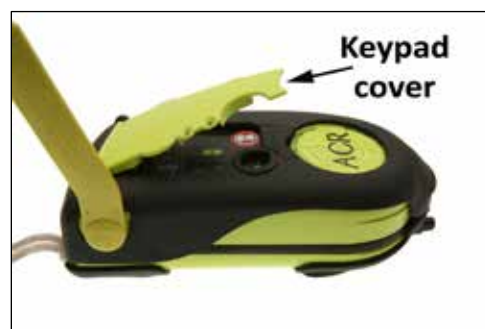
Figure 9. Aerofix 406 GPS/IO, model PLB-200

The 3 occupants' PFDs were equipped with a waterproof⁶⁹ PLB (Aerofix 406 GPS/IO, model PLB-200) manufactured by ACR Electronics Inc. (Figure 9).

When initially provided to TSB investigators, the master's and scientist's PLBs were found stored in their PFD's right side pocket, whereas the pilot's PLB was found outside of the pocket, attached to the PFD via its lanyard. It could not be determined if the pilot had pulled the PLB out of the pocket or if it had been accidentally pulled out during or after recovery.

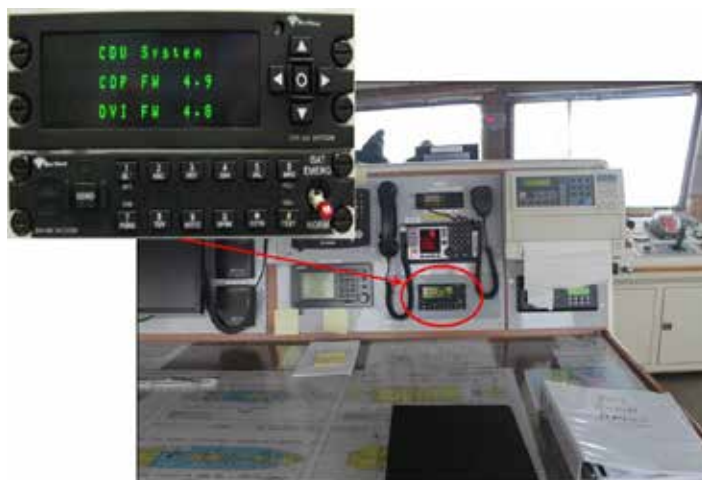
Figure 10. Location of FFS CDU user interface at chart table

Vessel officers and helicopter pilots can obtain each other's position information using the FFS through a control display unit (CDU) that combines 2 units—a CDP300 (serial number 104-300-01) and a DVI300 (serial number 105-300-01). On board the helicopter, the CDU is located at the bottom center of the instrument panel. On the CCGS *Amundsen*, the CDU is located at the chart table on the aft, starboard side of the wheelhouse (Figure 10).

At the time of the occurrence, the *Shipboard Helicopter Information and Procedures Manual* had not been updated to reflect the use of the new FFS, which was still in the development phase. According to the manual, the responsibility for monitoring the NavLink equipment during flight operations rests with the officer of the watch. Pending amendment to the manual, the CCG issued the Operations Circular (OC 07-2013) in June 2013, which outlined standard operating procedure (SOPs) for the use of the new FFS.
