**RAILWAY INVESTIGATION REPORT
R14W0256**

**MAIN-TRACK DERAILMENT
CANADIAN NATIONAL RAILWAY
FREIGHT TRAIN A40541-05
MILE 74.58, MARGO SUBDIVISION
CLAIR, SASKATCHEWAN
07 OCTOBER 2014**

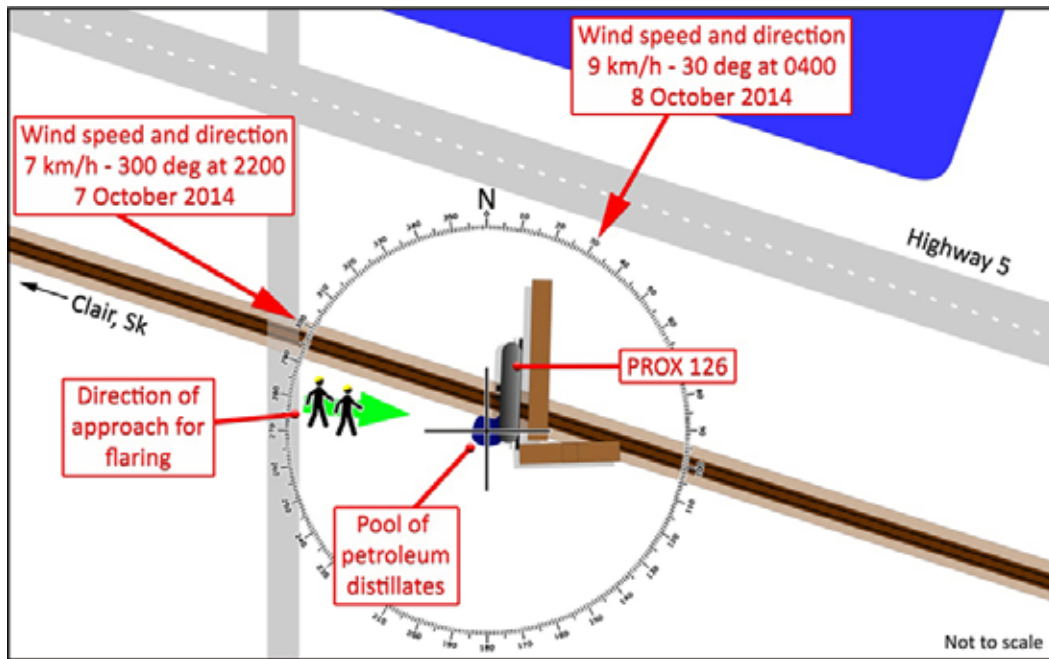
Figure 2. Wind direction during site remediation and tank car PROX 126 flaring activity

- 0400 - At about this time, the wind, although light, had shifted from predominantly northwest to northeast. The CN SDGO and AVP, who were wearing fire retardant clothing, hard hats, safety glasses, and boots ignited a road flare and approached the pool from a slightly downwind position in line with the pool and the thermal tear in PROX 126 (Figure 2).

The product pool ignited and began to burn at the base of the tank car (Photo 4) when an unexpected flash fire occurred as the vapors inside the breached tank car ignited, sending a large fire ball toward the CN SDGO and AVP (Photo 5).

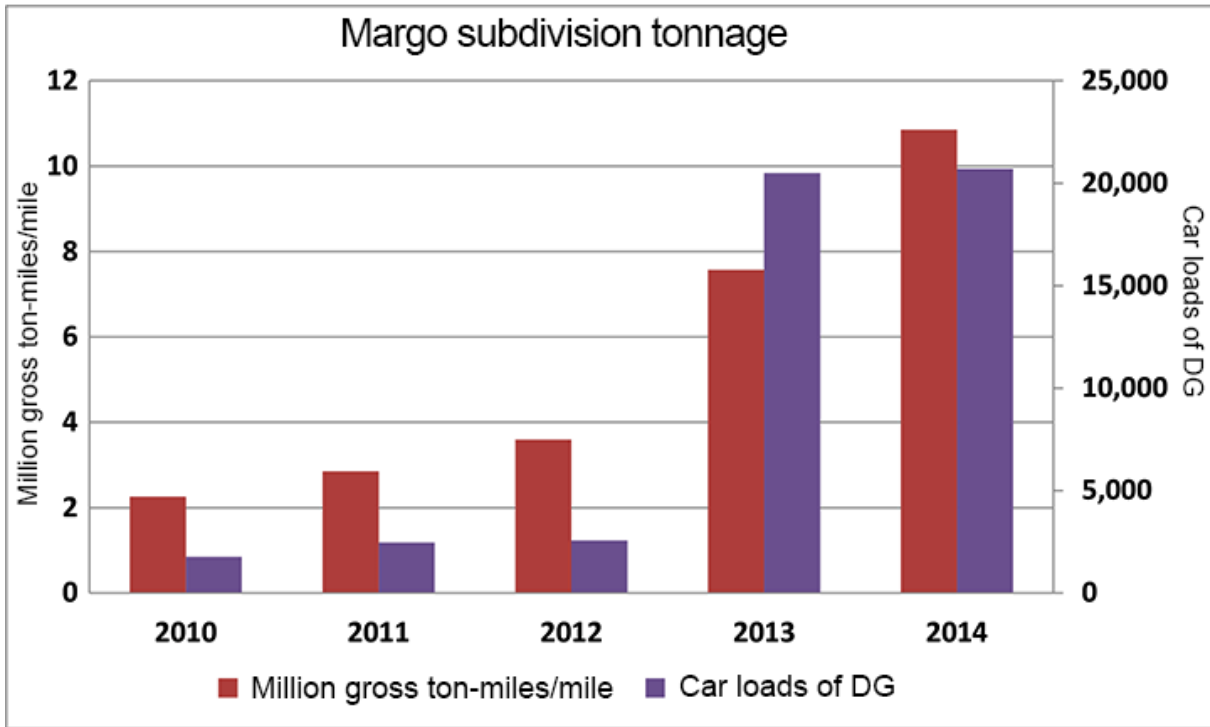
Figure 3. Rail traffic over the Margo Subdivision in million gross ton-miles per mile, from 2010 to 2014

Over the previous 5 years, the rail traffic, as measured in million gross ton-miles per mile (MGTM/M), had increased significantly (i.e., by approximately 480%) from 2.26 MGTM/M in 2010 to 10.85 MGTM/M in 2014, with a significant increase in 2013 and 2014 (Figure 3). CN operated an average of 1 train per day in 2010, which increased to 3 trains per day in 2013 and 2014. The increase in traffic volumes was directly related to the increase in bulk products (grain) and flammable liquids being transported on the PNL. Several new crude oil rail loading terminals had been constructed between Saskatoon, Saskatchewan, and Edmonton, from 2010 to 2014.

Rail grinding programs can be either corrective or preventive. Corrective programs restore the damaged surface of the rail. Preventive programs are proactive and are conducted at a frequency that ensures the rail surface does not deteriorate to the point where a corrective program is required. CN generally conducts grinding programs on its mainlines about every 20 MGTM/M. On the Margo Subdivision, rail grinding was conducted in 2010 and again in 2012, after approximately 7 MGTM/M. It had been planned for 2015, but there was a significant increase in tonnage starting in 2013 (Figure 3).

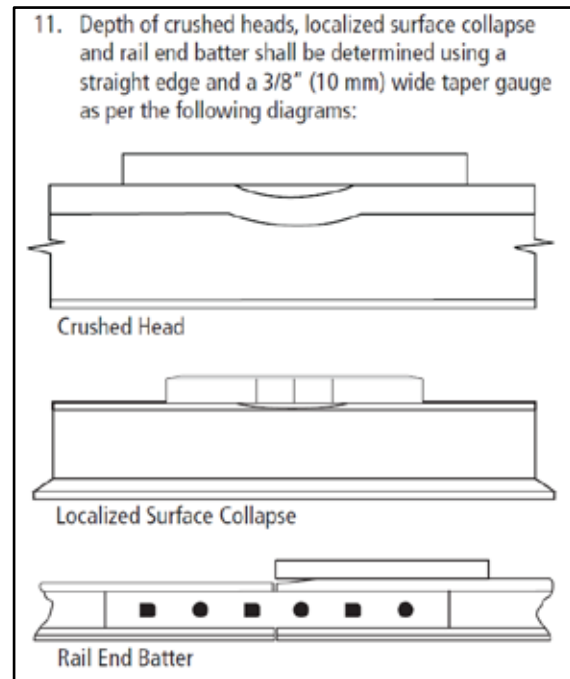
Figure 5. Canadian National Railway Engineering Track Standard 1.7 11

CN Engineering Track Standard (ETS) 1.7 10a, *Rail Testing and Remedial Action for Broken Rail*, requires that LSC conditions that are less than 5 mm in depth, on rail worn to less than 75% of the vertical rail wear condemning limit, must be monitored and then repaired once the condemning limit is reached (Figure 4). The depth of an LSC is measured using a straight edge and a 10 mm wide taper gauge as described in ETS 1.7 11 (Figure 5).
