# RAILWAY INVESTIGATION REPORT R15M0034

**MAIN-TRACK DERAILMENT  
CANADIAN NATIONAL RAILWAY  
FREIGHT TRAIN M30511-17  
MILE 212.8, NAPADOGAN SUBDIVISION  
SAINT-BASILE, NEW BRUNSWICK  
17 APRIL 2015**

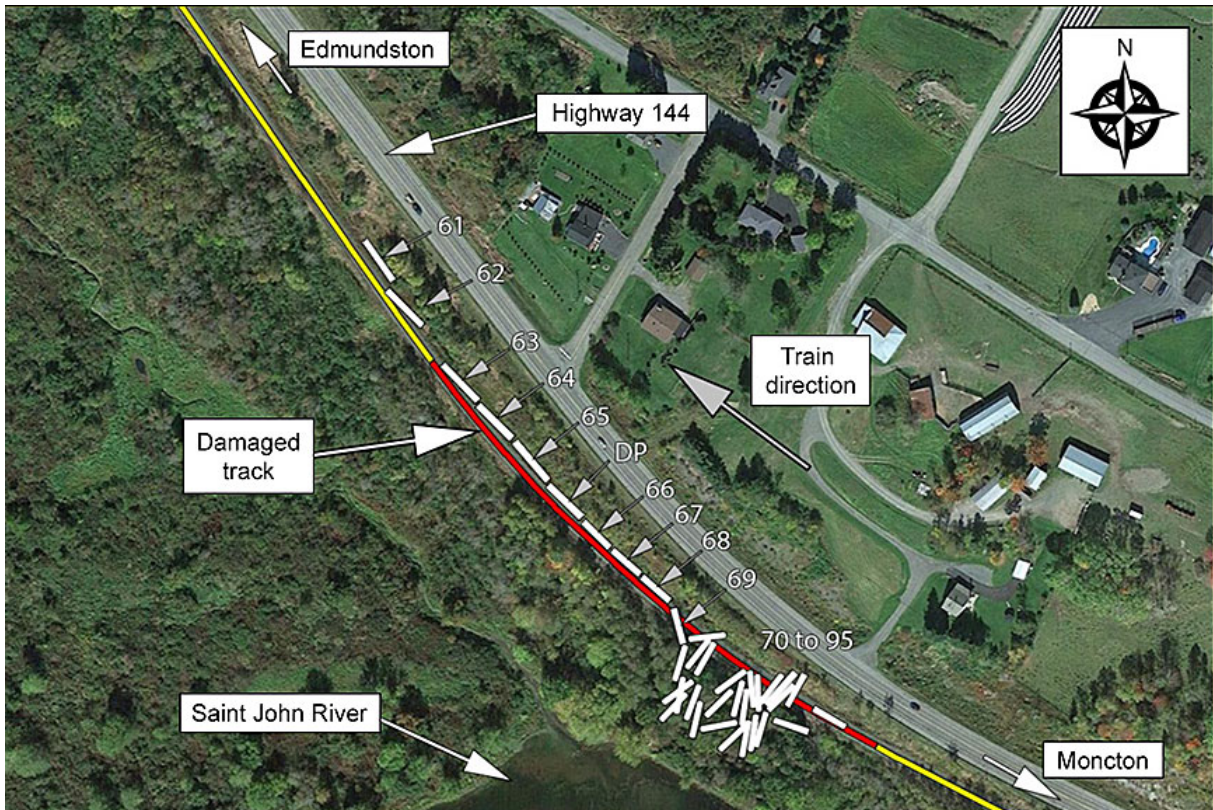
Figure 2. Site diagram identifying equipment in positions 61 to 95 (Source: Google Earth, Image © 2015 DigitalGlobe, with TSB annotations)

The derailment occurred in a rural area adjacent to Highway 144 (Figure 2). In this area, the track runs along the Saint John River that forms the international boundary between Canada and the United States. The derailed cars came to rest on both sides of the track, and many of the cars slid down the embankment toward the Saint John River.

- The head-end locomotives and the first 60 cars had separated, and the 60th car came to a stop on the main track approximately 1500 feet west of the derailment site.
- The 61st to 95th cars had derailed (Photo 1 and Photo 2). The last derailed car was in position 95.
- The trailing 65 cars (that is, positions 96 to 160) of the train consist had remained on the track.
- The derailed cars consisted of 5 centre beam flat cars carrying lumber, 1 flat car carrying wallboard, 8 box cars carrying paper, 20 residue tank cars (Class 111) that had last contained petroleum crude oil (UN 1267, Class 3), and 1 empty hopper car.
- The DP locomotive, which was located between the 65th and 66th cars, derailed and came to rest with its leading end near Mile 212.87.
- The derailment destroyed about 900 feet of track, extending from Mile 212.93 to Mile 212.76.

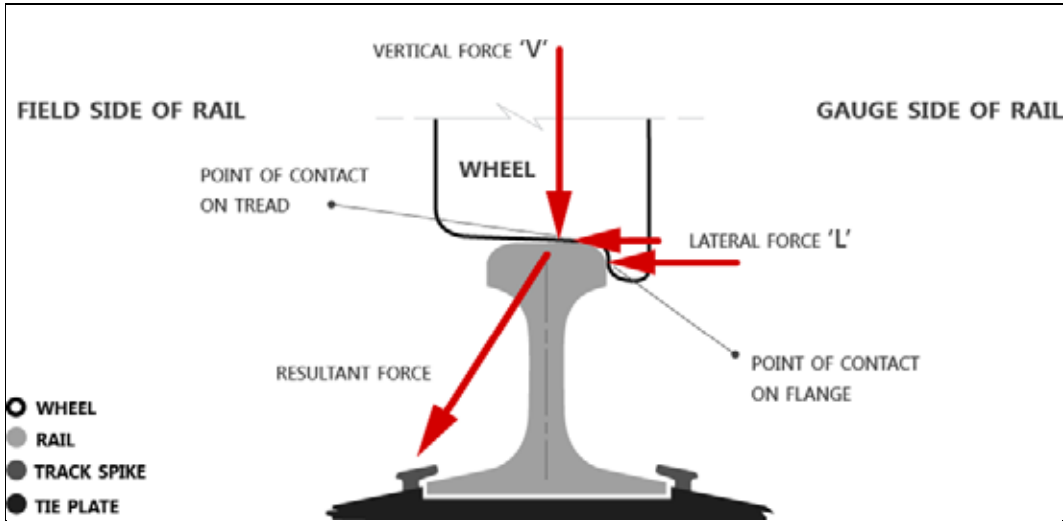
Figure 4. Lateral to vertical forces between wheel and rail (Source: Association of American Railroads)

There is a combination of lateral forces and vertical forces at the wheel-rail contact. The ratio of lateral-to-vertical (L/V) forces provides an indication of the likelihood of a derailment. The traditional L/V threshold for rail rollover on a loaded car is 0.65. If the resultant force acts beyond the outer edge of the rail base, rail rollover can occur (Figure 4).

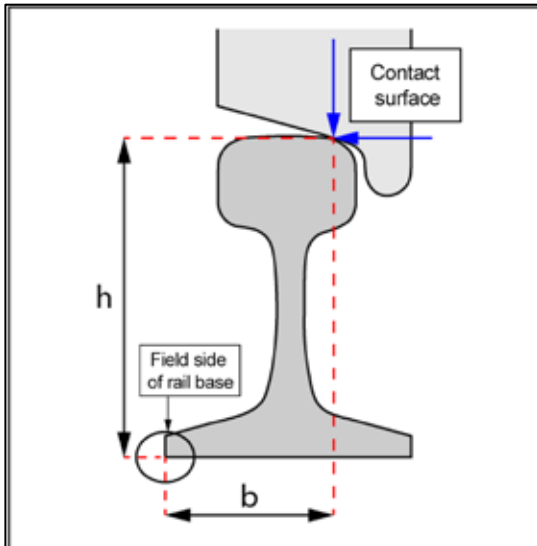
Figure 5. Rail stability diagram (Source: TÜV Rheinland Rail Sciences, with TSB annotations)

The lateral stability of a rail is linked to its  $b/h$  ratio (Figure 5). The  $b/h$  ratio represents the lateral dimension to the field side of the rail base relative to the height of the contact surface.<sup>8</sup> Under equilibrium conditions, just before the rail starts to rotate and roll over, the resultant force created by the lateral and vertical forces acts at the field side of the rail base.

Under normal circumstances, the wheel-to-rail contact surface is located at the inner gauge corner of the rail head. When the wheel load is shifted toward the field side,  $b$  decreases and  $b/h$  decreases. The  $b/h$  ratio can vary from greater than 0.6 for contact at the gauge side to approximately 0.2 when the contact surface shifts toward the outer edge of the rail base (the field side), as shown for the L-1 wheel of the 62nd car (Photo 8).

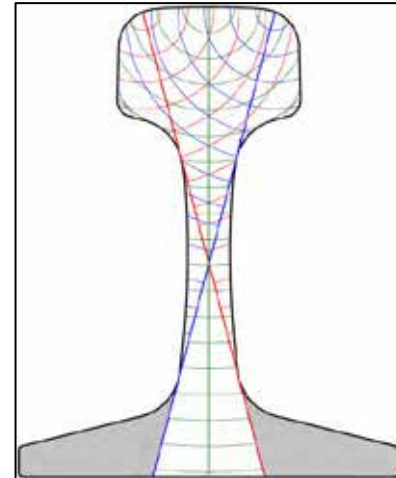
Figure 6. Grey area denotes portions of the rail base typically missed by ultrasonic rail inspection (Source: Transportation Technology Center, Inc.)

The Association of American Railroads (AAR) has determined that some defects in the base of the rail on either side of the web cannot be detected because they are outside the reflective field of current ultrasonic testing (UT) techniques (Figure 6).

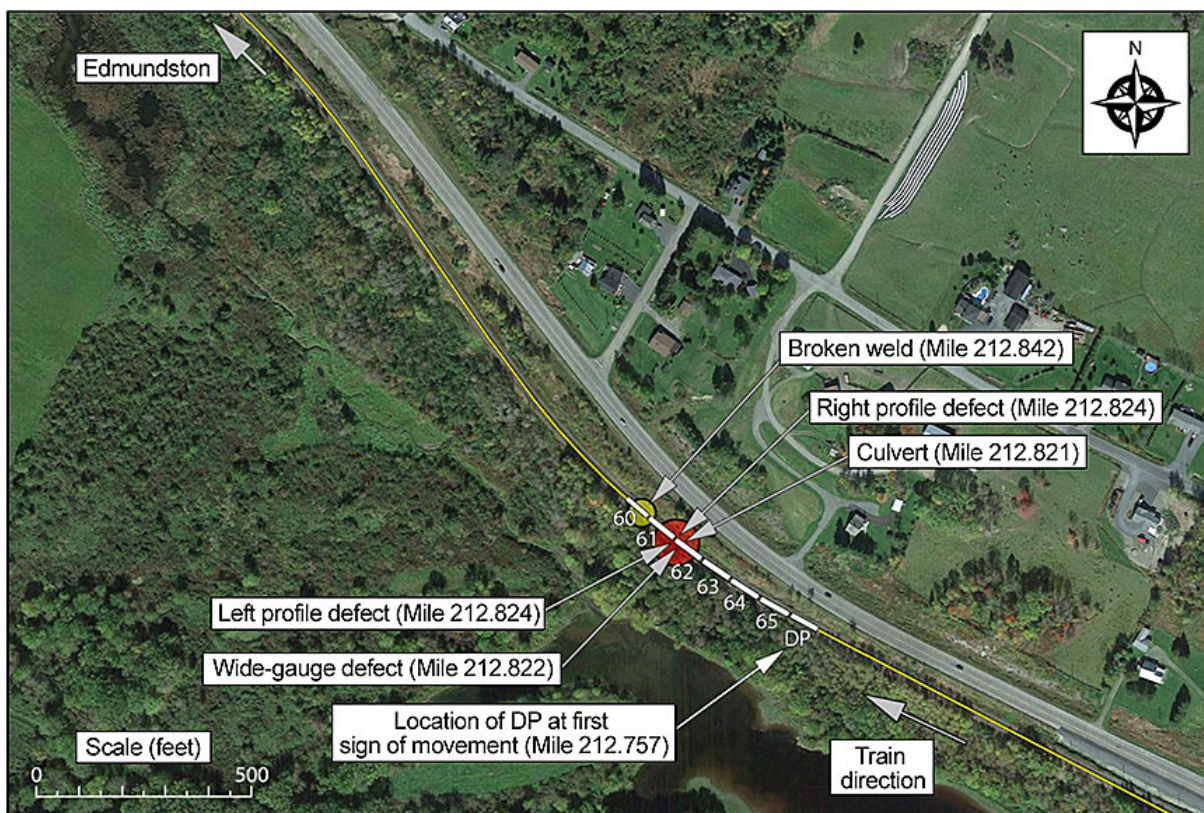
Figure 7. Location of the distributed power locomotive at first sign of movement in on-board locomotive video recording (Source: Google Earth, Image © 2015 DigitalGlobe, with TSB annotations)

When the first unusual lateral oscillation started, the DP locomotive was located at about Mile 212.75 and the second derailed car at Mile 212.82 (the location where combined gauge and surface conditions were present, as identified by the TEST car inspection). The DP locomotive came to rest approximately 600 feet west of the location where the unusual lateral oscillations began (Figure 7).
