**MARINE INVESTIGATION REPORT**  
**M15C0006**

**GROUNDING**

**SELF-DISCHARGING BULK CARRIER *ATLANTIC ERIE***  
**CHENAL DU HAVRE DE LA GRANDE ENTRÉE**  
**ÎLES DE LA MADELEINE, QUEBEC**  
**11 JANUARY 2015**

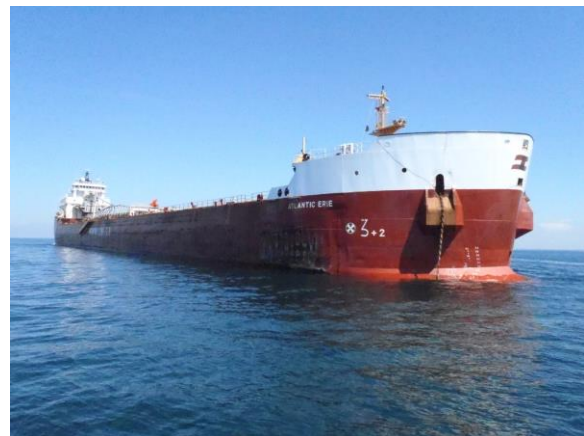
**Photo 1. *Atlantic Erie***

The *Atlantic Erie* is a dry bulk cargo vessel of steel construction with machinery space and accommodations located aft (Photo 1). The vessel has 5 cargo holds and is fitted with a self-discharging system that allows cargo to be released from the bottom of the cargo holds onto conveyor belts, transported above deck level via an elevator system, and then transferred onto a discharge boom conveyor and off-loaded. The vessel is fitted with an electric bow thruster with a controllable-pitch propeller.
