Institute for
Research in
Construction

The 1989 Loma Prieta (San Francisco Area) Earthquake: Site Visit Report

Internal Report No. 594

Date of issue: May 1990

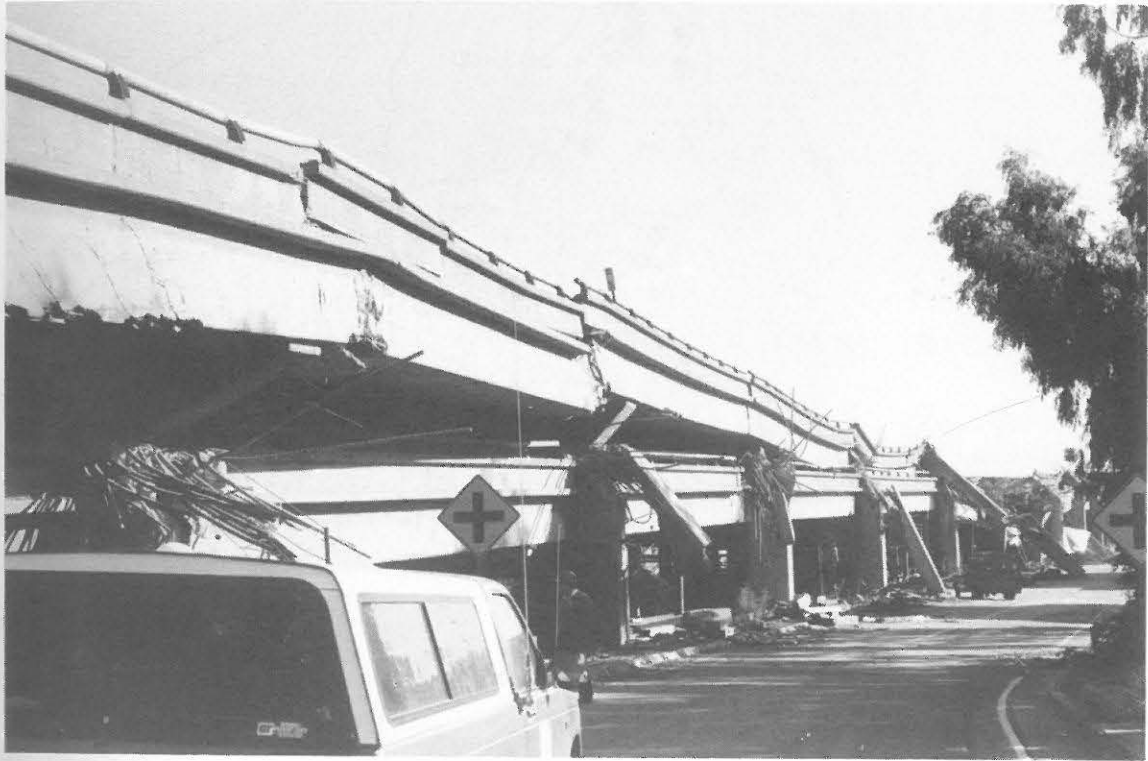
Fig. 2.1 The collapse of the Nimitz Freeway in Oakland

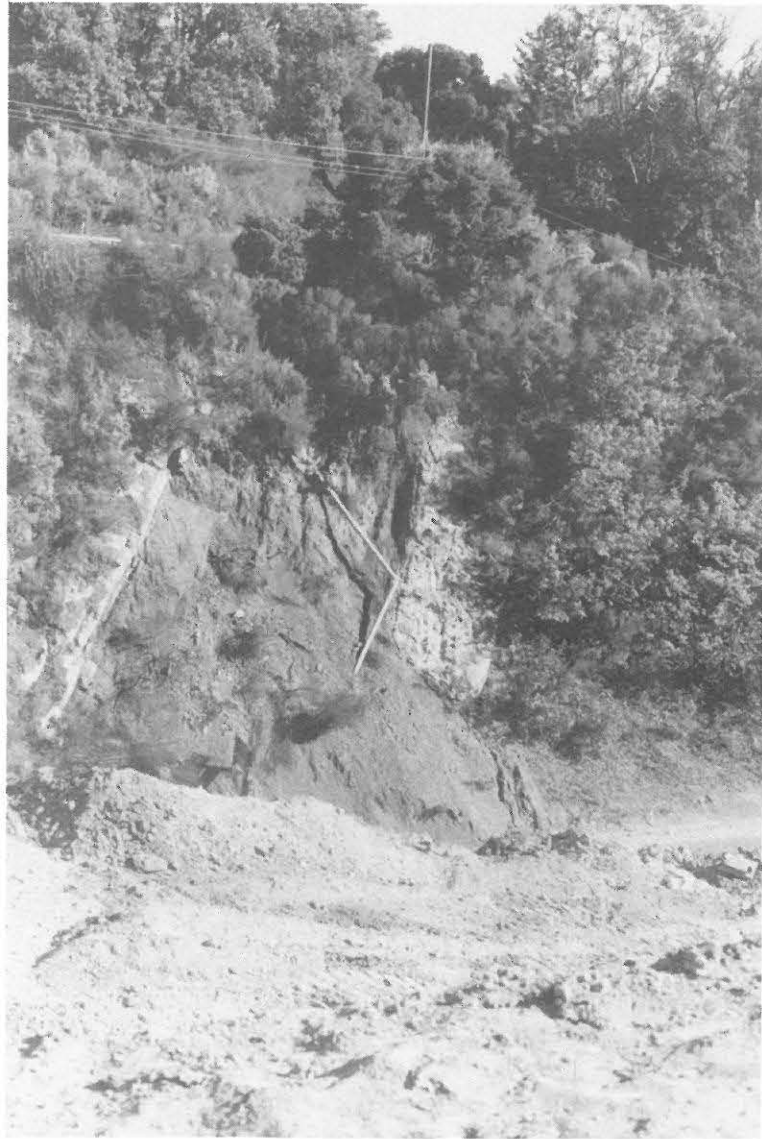
A large number of landslides and rockfalls were reported in the Santa Cruz Mountains near the fault rupture zone. Many of these landslides (Fig. 2.8) were partly caused by rain that came after the earthquake. Highway 17, one of the two main highways from the north to Santa Cruz, was partially closed. A number of single family houses were destroyed.

Fig. 2.8 Landslide on Highway 17

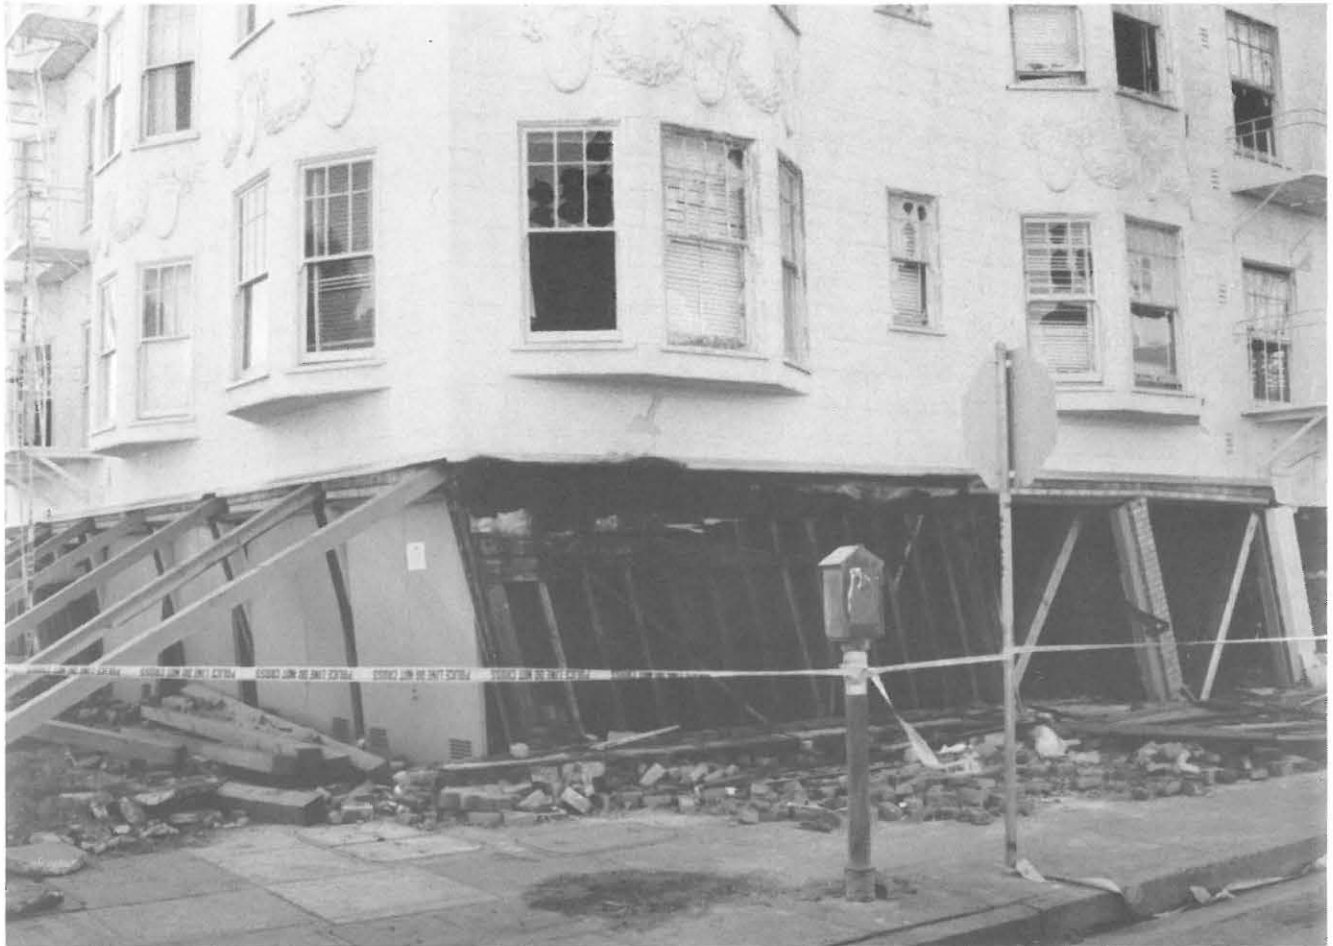
Figures 3.11 - 3.14 show examples of the "soft storey" effect. An almost-collapsed 4-storey apartment building at the corner of Beach and Broderick Streets is shown in Fig. 3.11. The corner bracing is inadequate to prevent the shift of about 50 cm in one horizontal direction. Extensive shoring is required to prevent total collapse. A close-up of the first "soft storey" effect is presented in Fig. 3.12. Hinges were created and a very extensive racking took place. Another corner building with the first storey entirely taken by garages is shown in Fig. 3.13. A detail of the post connection to the second floor framing is visible in Fig. 3.14. On some buildings situated at the block corners, but with more sheathed walls (horizontal boards), the amount of damage was much smaller (Fig. 3.15) while at other locations end buildings suffered more damage than interior ones. In some cases brick walls collapsed onto sidewalks, creating some danger to pedestrians (Fig. 3.16).

Fig. 3.11. Almost collapsed 4-storey wood-frame apartment building due to "soft storey" effect at the corner of Beach and Broderick, Marina District, San Francisco

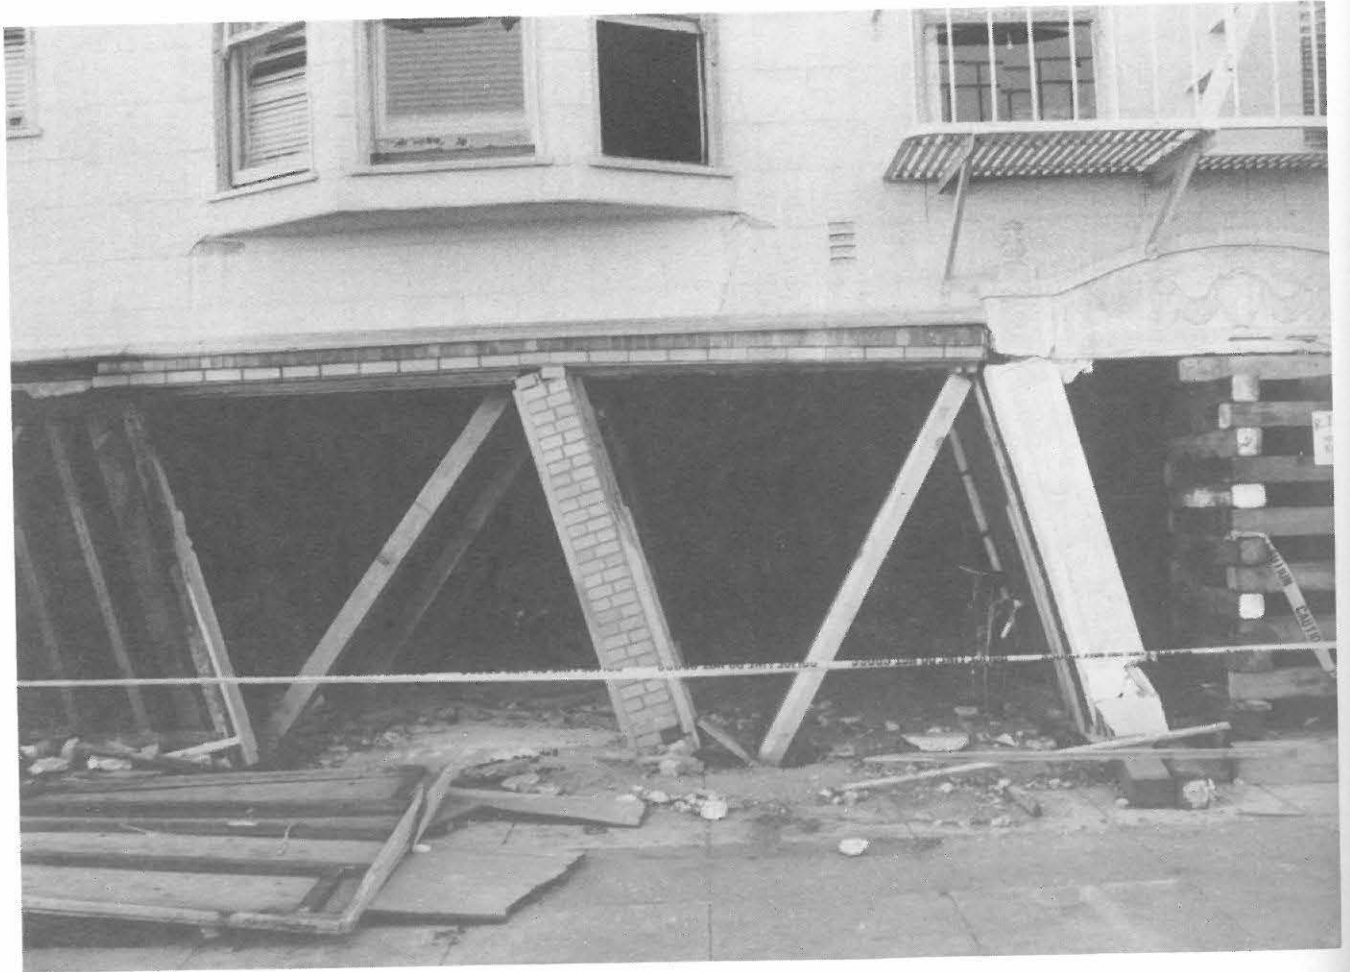
Fig. 3.12. Close-up of the first "soft storey", Beach/Broderick Streets, Marina District, San Francisco

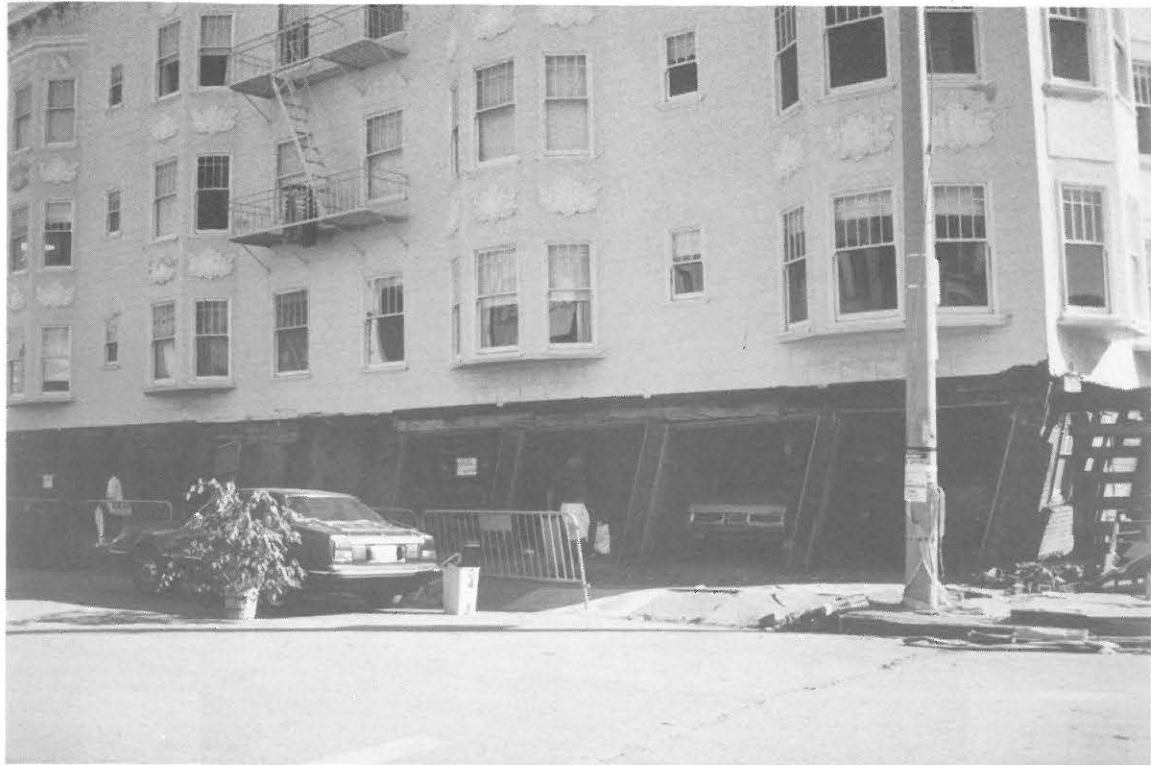
Fig. 3.13. Another example of "soft storey" effect on Jefferson St., Marina District, San Francisco (note horizontal boards on posts and over the garage doors)

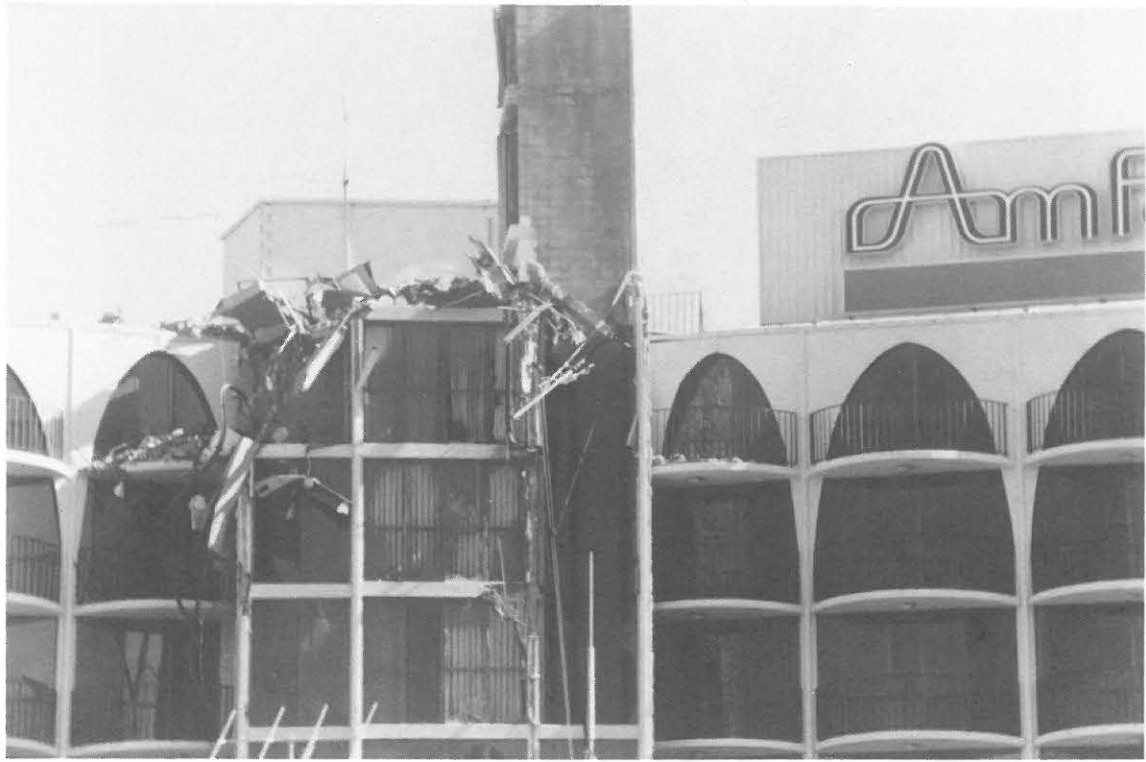
Somewhat non-typical damage was observed in case of the Amfac Hotel at the San Francisco International Airport. A penthouse together with a heavy water tank fell and inflicted heavy damage to the surrounding reinforced concrete structure (Fig. 3.24).

Fig. 3.24. Collapsing water tank destroyed a penthouse at the top of Amfac Hotel at the San Francisco Airport

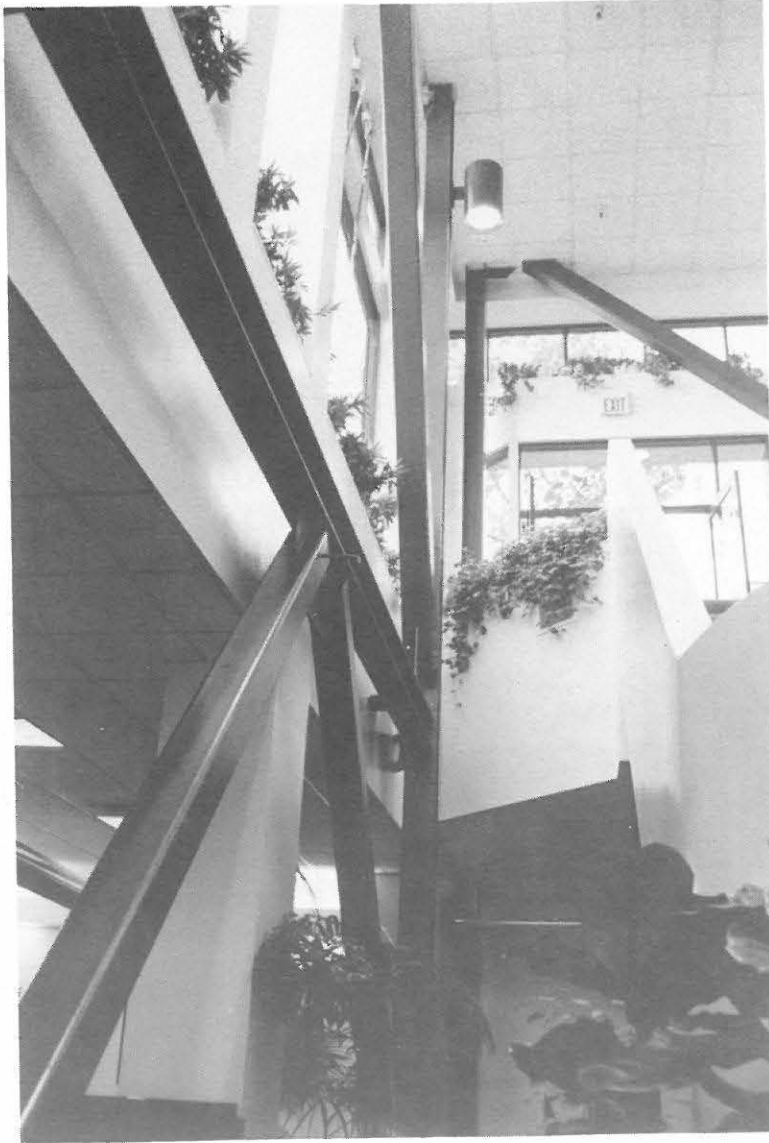
Fig. 3.25. An old structure of the corner building upgraded after 1971 San Fernando earthquake performed well

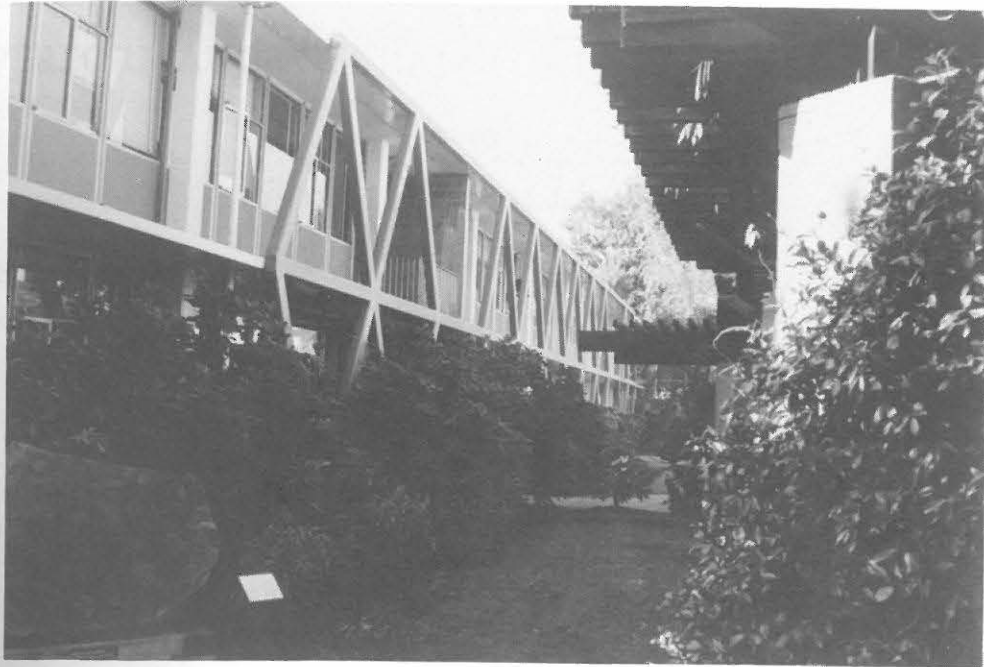
Fig. 3.26. Seismically upgraded concrete-frame building of the U.S. Geological Survey in Menlo Park, California

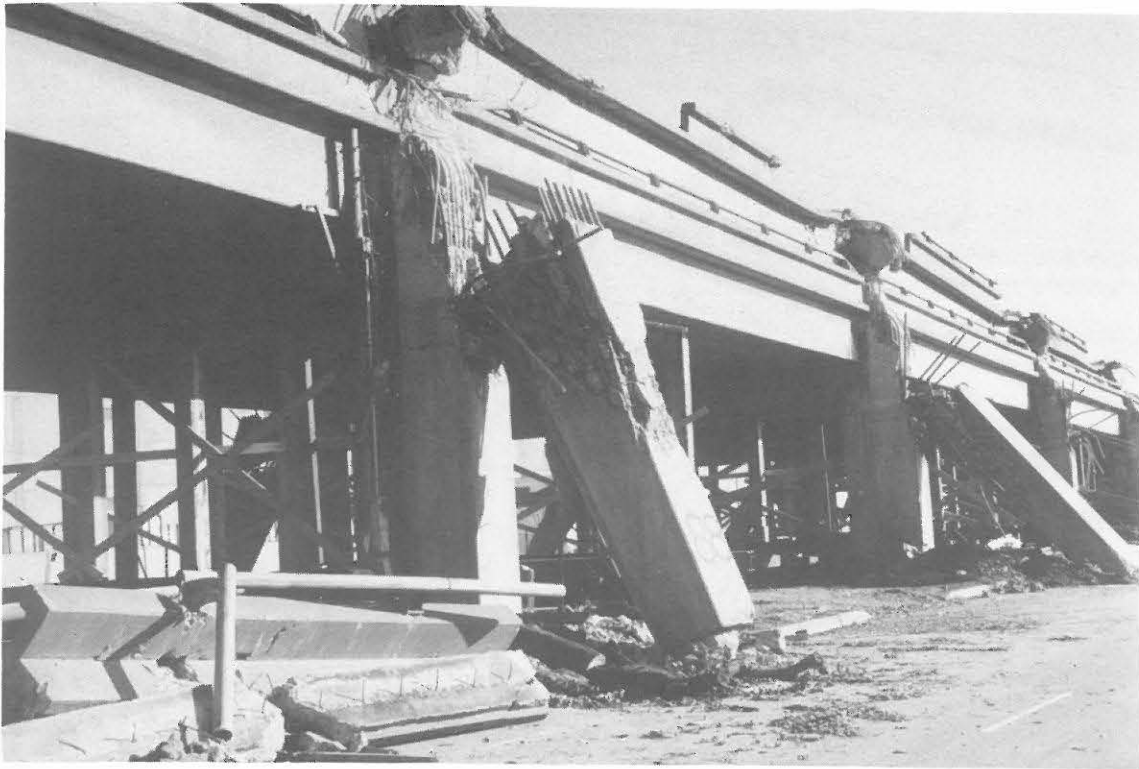
Fig. 4.3 Collapsed Cypress Street viaduct

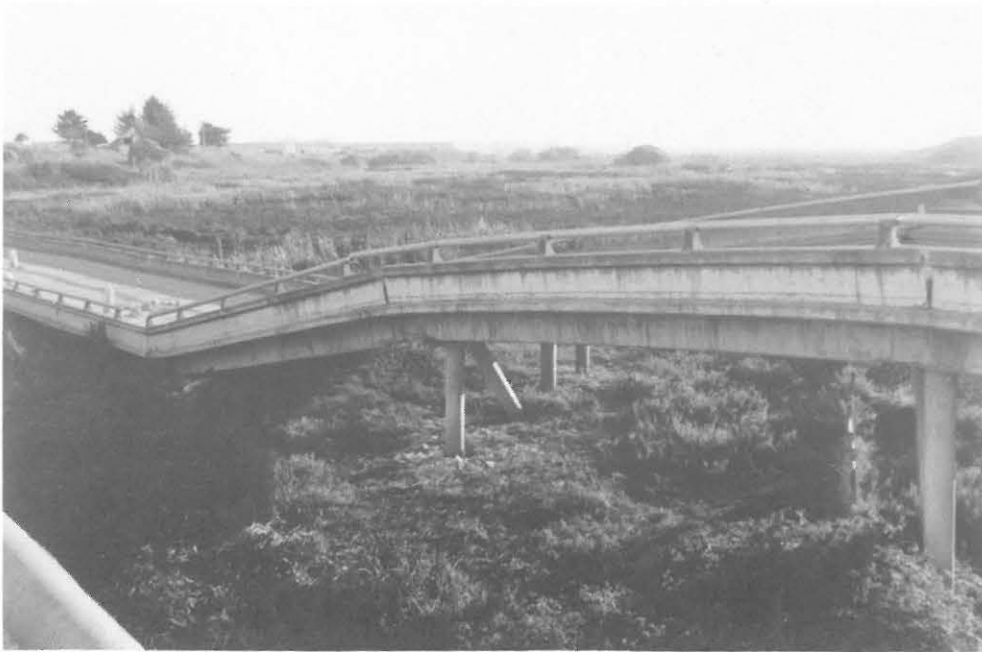
Fig. 4.17 The difference between levels before and after collapse - the Struve Slough Bridge

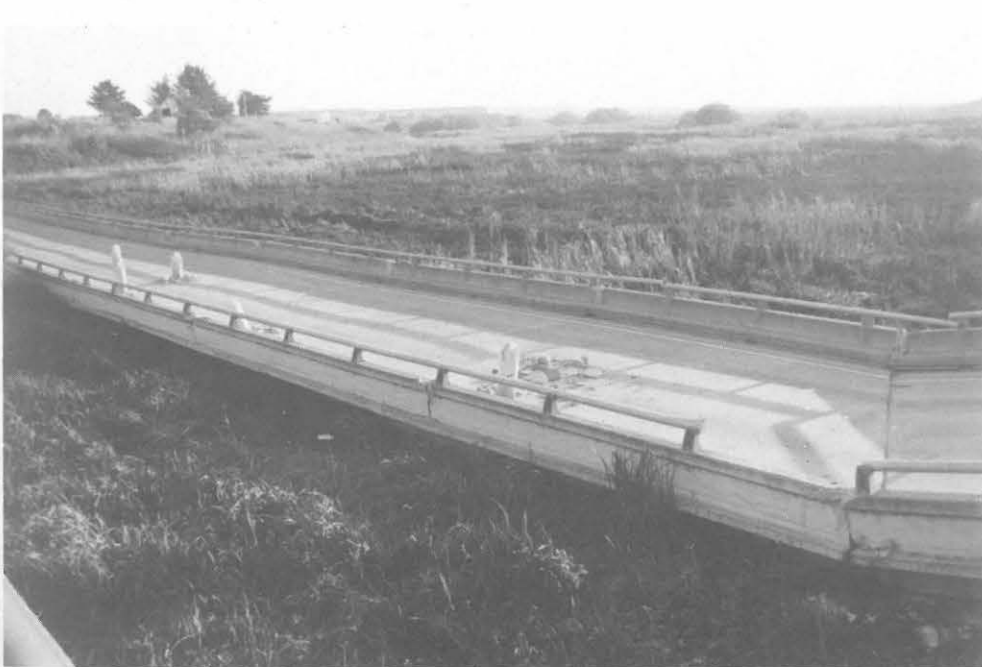
Fig. 4.18 The collapsed portion of the deck of the Struve Slough Bridge did not disintegrate during the earthquake

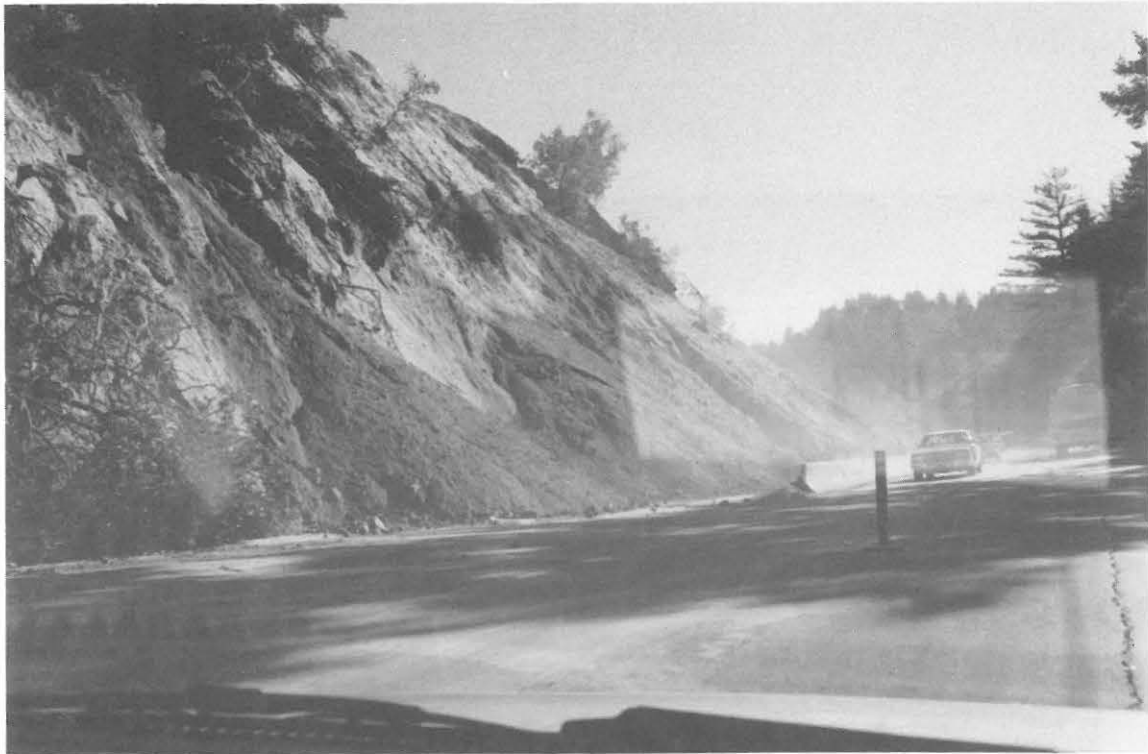
Fig. 4.19 A landslide triggered by the Loma Prieta earthquake on Highway 17 in the Santa Cruz Mountains

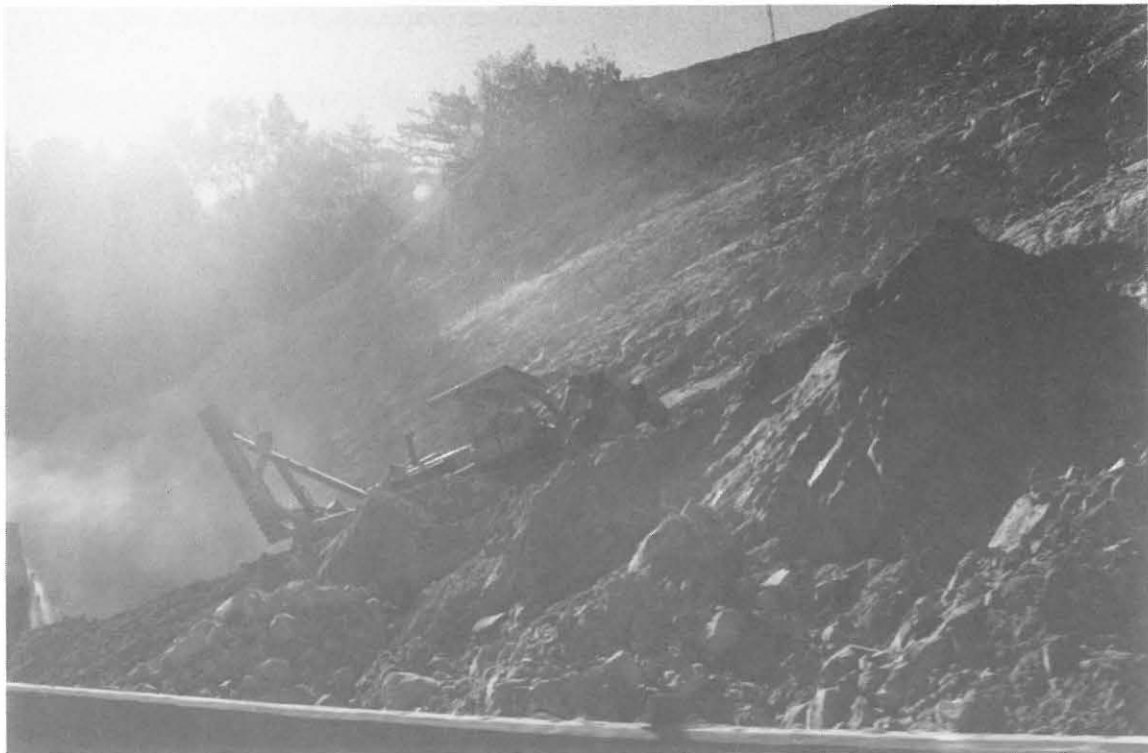
4.20 A dangerous landslide being removed on Highway 17 in the Santa Cruz Mountains

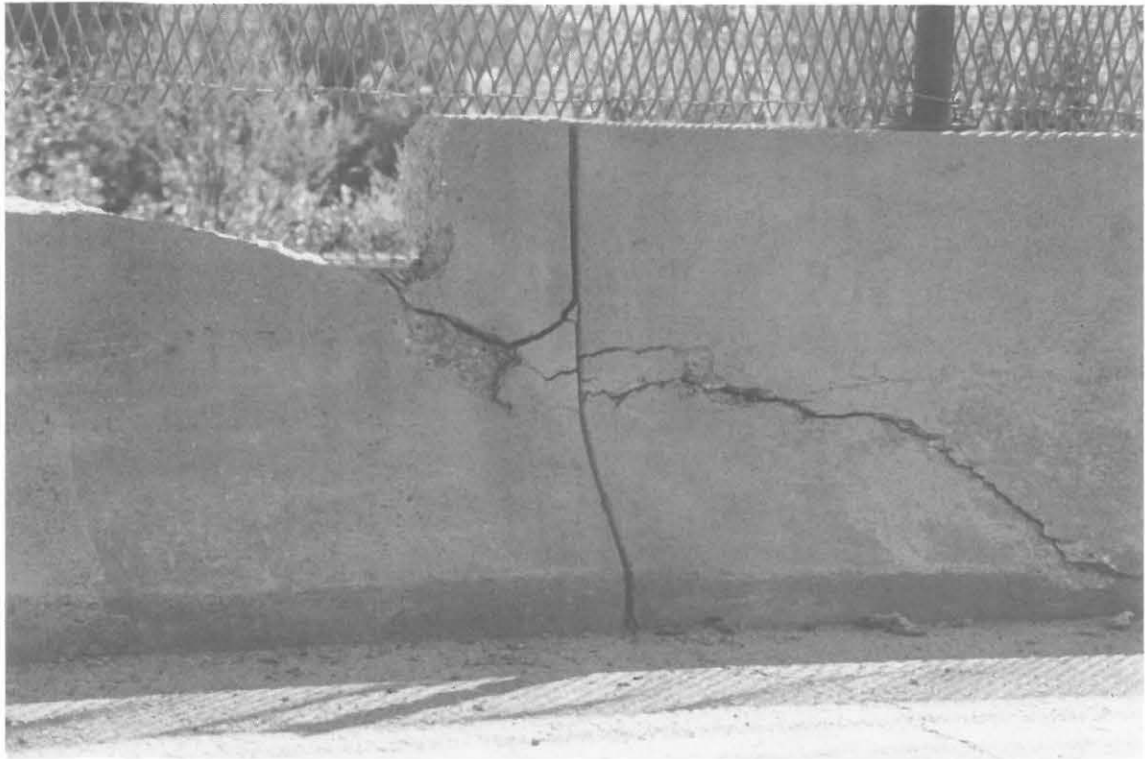
Fig. 4.21 A destroyed road barrier on Highway 17 near Los Gatos

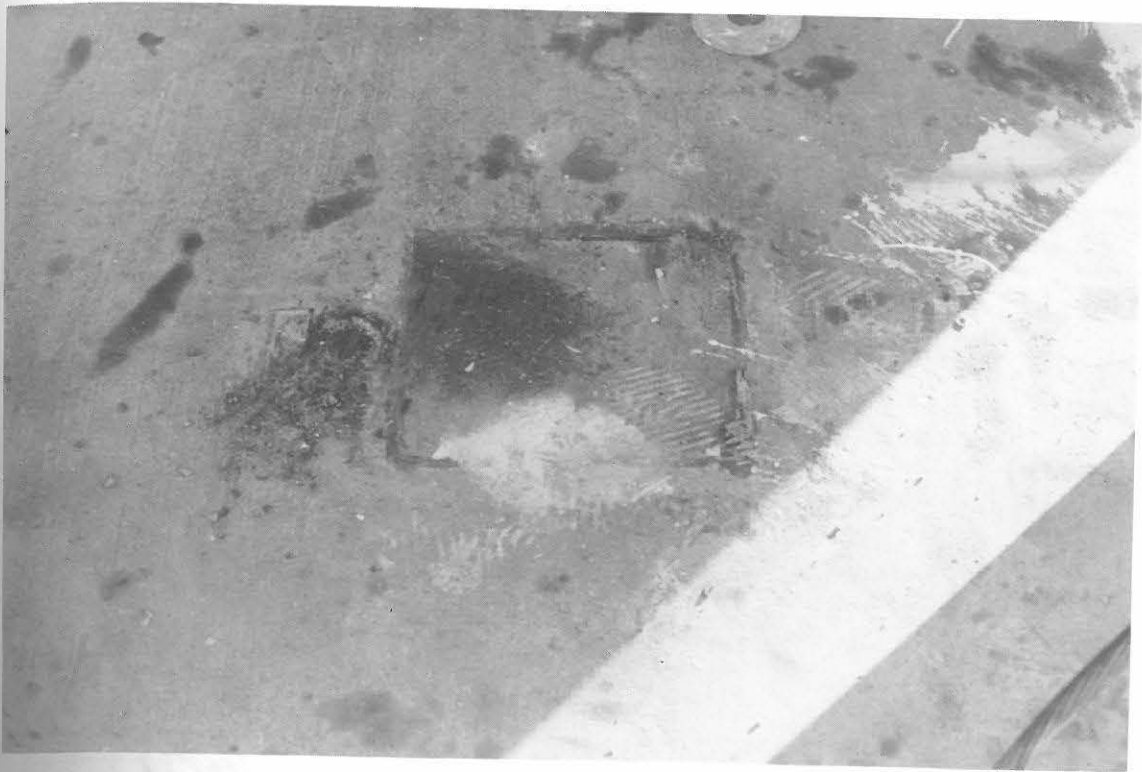
Fig. 5.30 Location of the base plate and of the anchored bolts (an old concept)

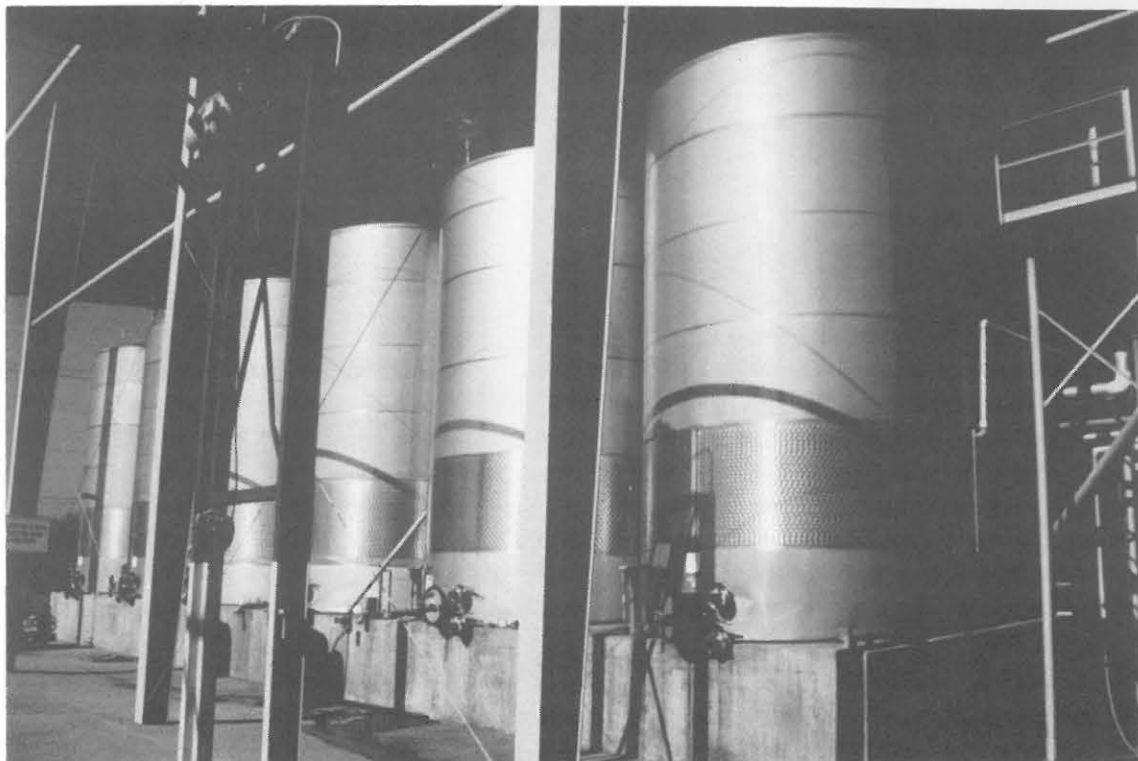
The outdoor thin-walled, stainless steel tanks are shown in Fig. 6.3. These tanks have slightly sloped bottoms for better drainage, and are anchored to the concrete foundation pad 2 to 4 feet (0.6 to 1.2 m) above the ground by anchor bolts. The storage tanks have cooling jackets around part of the cylindrical shells about 2 feet (0.6 m) above the base. Coolant is circulated through the jacket to maintain the liquid content at the proper temperature.

Fig. 6.3 The outdoor stainless steel tanks with cooling jackets

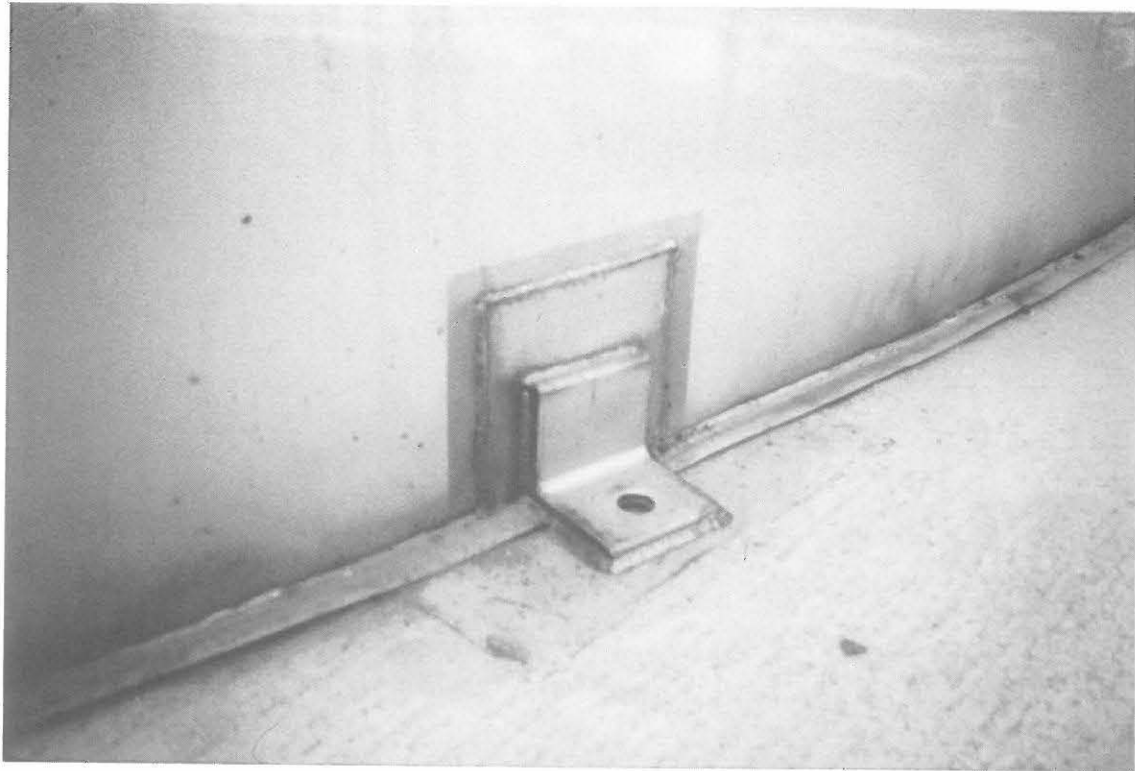
The undamaged tanks have slightly different anchorage arrangement. Six angle pieces are welded to the tank wall that is reinforced by additional steel plates. The other side of the angle piece is welded to the embedded anchorage plate in the concrete foundation as shown in Fig. 6.15. This arrangement distributes the anchorage forces more evenly than the design of damaged tank. For the survival of anchored tanks in earthquake, it is important to design the details of the anchorage system properly.

Fig. 6.15 Anchorage of undamaged tank
