FLIGHT COMMENT

MAY · JUNE · 1957

ISSUED BY
DIRECTORATE OF FLIGHT SAFETY
R.C.A.F. HEADQUARTERS • OTTAWA, ONT.

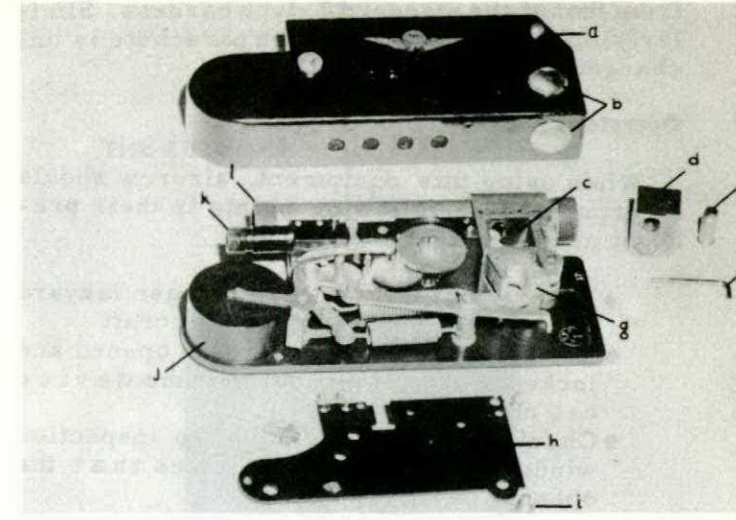
Fig 7. Partially dismantled G-Q auto-rip Mk VII assembly. (a) cover (b) inspection windows (c) breech (d) breech block (e) .22 calibre (rim-fire) blank cartridges (f) breech block locking pin (g) firing hammers (h) top plate (i) top plate securing screw (j) barostat (k) arming wire tunnel (l) barrel.

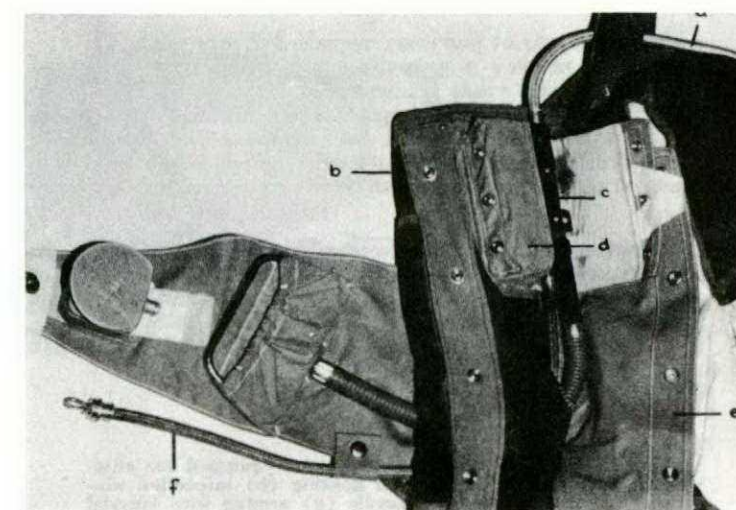
Fig 8. G-Q auto-rip Mk VII installation in Standard Irvin 24-foot parachute. (a) rip cord housing (b) left-hand parachute flap (c) G-Q auto-rip Mk VII (d) retaining pocket (e) cover flap for auto-rip installation (f) arming lanyard housing.

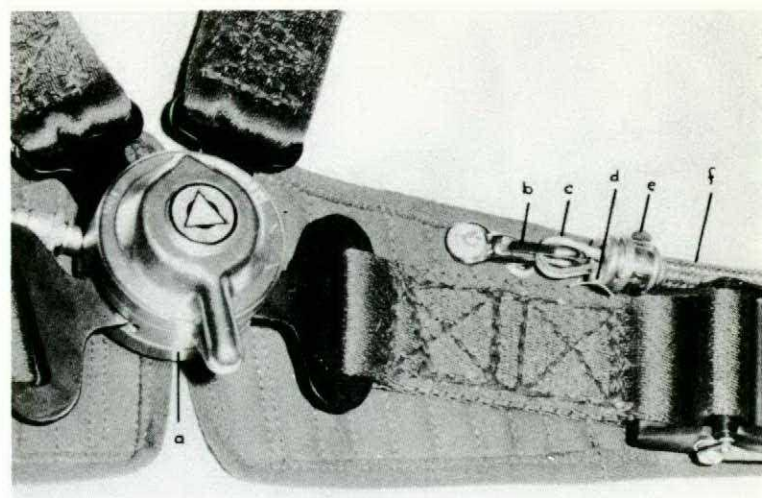
Fig 10. Arming assembly for automatic parachute operation. (a) "Z" box in closed position (b) arming lanyard snap hook (c) parachute arming lanyard (d) safety shear wire on arming lanyard (e) spring clip for retaining arming lanyard housing (f) arming lanyard housing

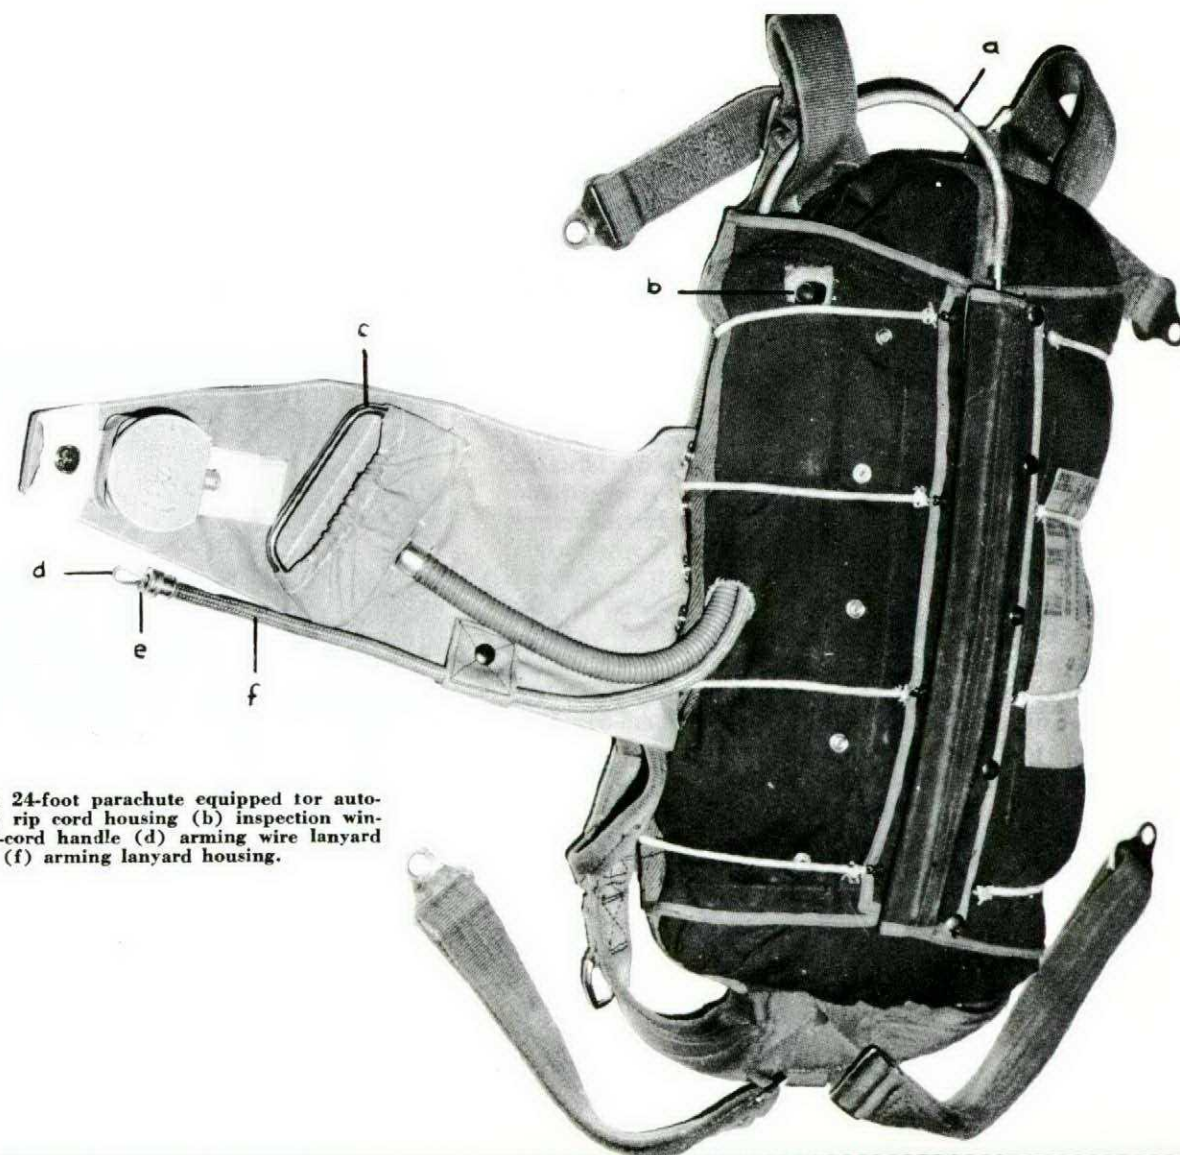
Fig 9. Standard Irvin 24-foot parachute equipped for automatic operation. (a) rip cord housing (b) inspection windows (c) manual rip-cord handle (d) arming wire lanyard (e) safety shear wire (f) arming lanyard housing.

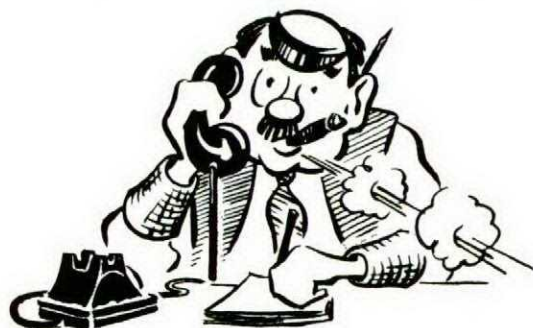
Flaps and Bellcranks

"The Otter Flap" (Flight Comment, Nov - Dec 56) reminded me of some information that may or may not be useful. While I was working out at CEPE Namao in the summer of '54 one of my duties was minor and major inspections on a float-equipped Otter aircraft. The aircraft ferried men and freight from Cold Lake to Primrose Lake in Alberta and was usually fully loaded. While checking the flap mechanism I found that the bellcrank had what looked to be a small crack on it. After removal from the aircraft it was found that the bellcrank could be flexed and that the crack was much worse than I had first suspected. Failure of this part in flight would have been disastrous because it would have knocked out the flap system, and probably the aileron system in one wing.

The crew chief was to have submitted a technical failure report on this bellcrank but it may have been lost or misplaced. At the time of this occurrence (1954) the bellcranks were being made from magnesium. Naturally I am curious to know if there is any further evidence of this bellcrank failure.

A check with Air Materiel Command reveals no record of any reports of failures of this component. However, the accident inspector who wrote the article to which you refer has assured us that this bellcrank was not concerned in the cases discussed in his article. — ED

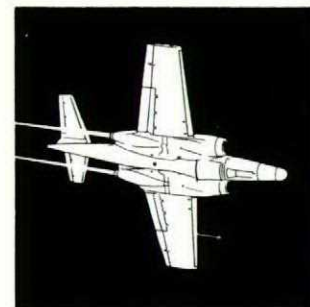
Speed Brakes

The pilot was making a descent following a night training mission when the Canuck's canopy and windscreen panels misted up. Inadvertently leaving his speed brakes extended throughout a rather steep approach, the pilot attempted to round out the aircraft but it stalled and struck the runway heavily. When application of power

failed to keep the aircraft airborne, he closed the throttles, and the Canuck came down on all three wheels. As soon as brakes were applied, the port undercarriage fractured.

Restriction to vision through iced-up side panels certainly presents a problem to the pilot trying to land an aircraft. Possibly pre-occupation with the problem caused this pilot to forget to close the speed brakes. It has been confirmed repeatedly that, at normal approach speeds, the hold-off is practically nil with those speed brakes out.

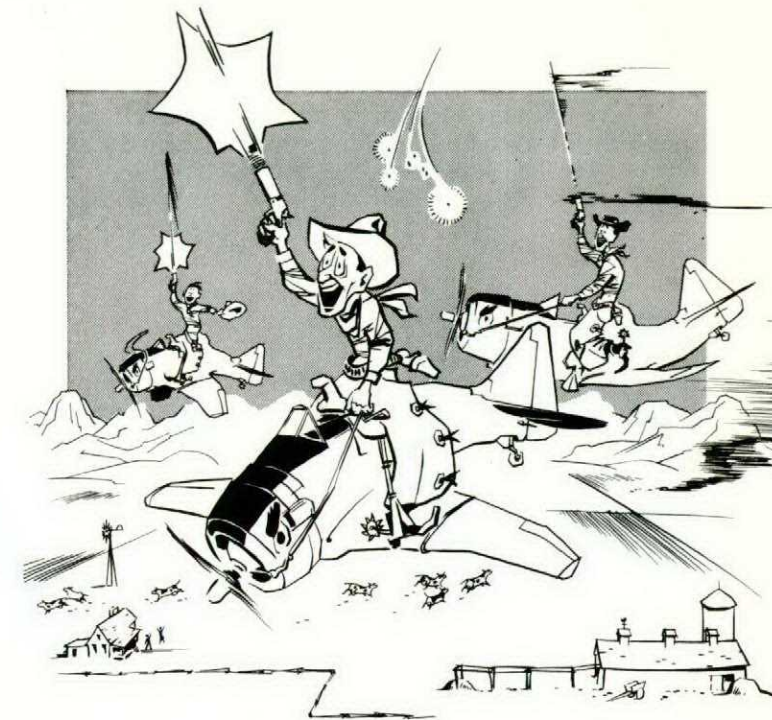
Scratched Wing

During a low pass across the field, or at the time the pull-up was initiated, the Harvard's starboard wing struck an unknown object (suspected to be a tree), causing rib fractures and a large dent on the leading edge. The pilot continued his climb, returned to base, landed and entered the damage in the L14. He then entered a report of low flying in the Low Flying Record in the Control Tower, giving engine failure as

The student delayed reporting the accident personally to someone in authority in spite of having talked to the duty pilot when he landed. It was approximately two and one-half hours later that he called at the home of his course director and reported that a "large scratch had been made on the starboard wing". From the student's report—and before seeing the aircraft—the course director was of the opinion that the scratch described did not warrant an accident investigation report. The photograph shows the extent of the "scratch".

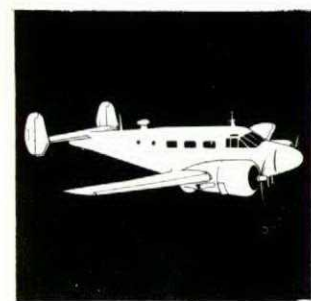
Pills, Pilots And Prescriptions

The flight was without incident until it came time to land. The pilot made what he thought was a normal approach but it resulted in a bad bounce. Instead of going around again, he tried to salvage a bad landing by checking forward on the control column. The next time the aircraft hit the runway it stayed down—but at the expense of a pair of damaged propellers.

It was the opinion of the medical officer that at the time of the accident the pilot would still have been under the influence of the medication he had taken, and that his ability to land the aircraft was impaired by the drug. Air crew personnel are only taking unnecessary chances if they mix pills and planes. Follow the medical officer's directions as to the frequency and duration of any treatment prescribed.

By continuing medication beyond the period prescribed by the medical officer, a pilot found himself involved in an accident. The medicine should have been used up on the day prior to the flight. In actual fact the pilot took the final tablet on the morning he was to fly.
