FLIGHT COMMENT

ROYAL CANADIAN AIR FORCE

MAY • JUNE • 1958

ISSUED BY
DIRECTORATE OF FLIGHT SAFETY
 R.C.A.F. HEADQUARTERS • OTTAWA, ONT.

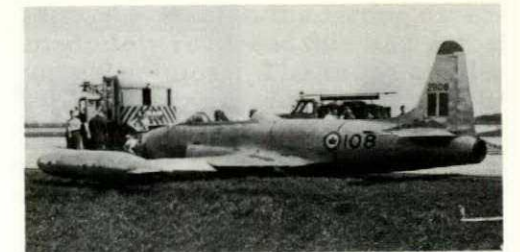
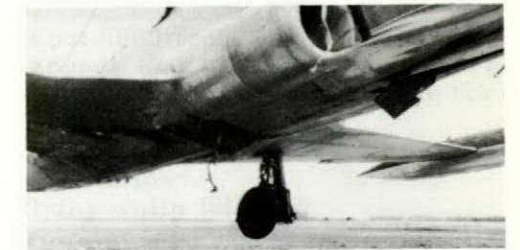
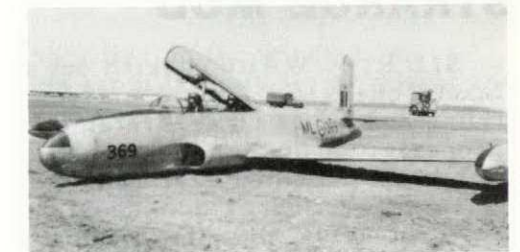
Pulling the wheels up early involves considerable risk.

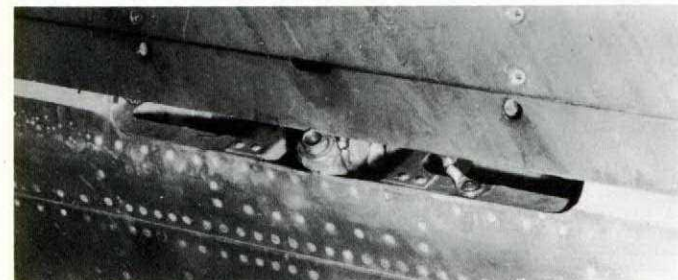
The port aileron actuator piston rod had fractured... jamming the aileron in the "up" position.

aileron actuator piston rod had fractured, the rod end assembly dropping in such a way that it jammed the aileron in the up position.

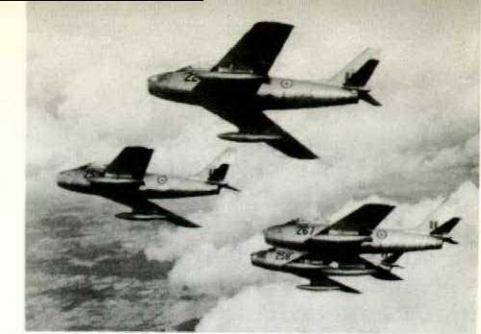
Sudden throttle movements, especially in formation, can stall the compressor.

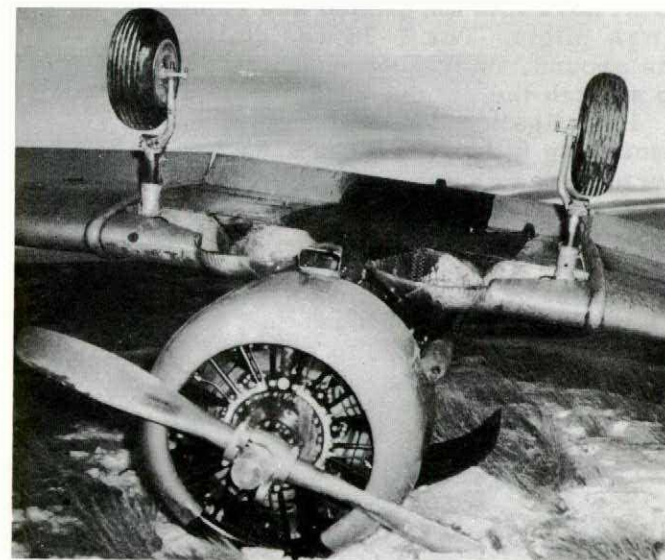
Upon investigation it was found that the rear oil sump drain plug was missing and the front sump plug was loose. When a closer examination was conducted to explain why one plug was missing and one plug was loose, some interesting information was unearthed.

It was at this point that the maintenance error was committed. LAC Jones had not worked on the oil sump plugs; but, having complete confidence in LAC Doe because they had worked on the same crew together for a long time, he decided to sign the L14-1B without checking the oil sump plugs to see if they were safely locked. The Corporal signed the L14-1B as inspected and passed because he had examined the sump plugs and filter for foreign particles

and had given the engine a test (although he had not inspected the oil sump plugs for security). He also had confidence in LAC Doe's workmanship—not knowing that LAC Doe had not put the sump plugs in but had given them to his helper and gone to band practice.

The Harvard was ultimately certified serviceable and turned over to Servicing Squadron. During its first flight, the pilot reported low oil pressure and loss of oil and was forced to make an emergency landing.

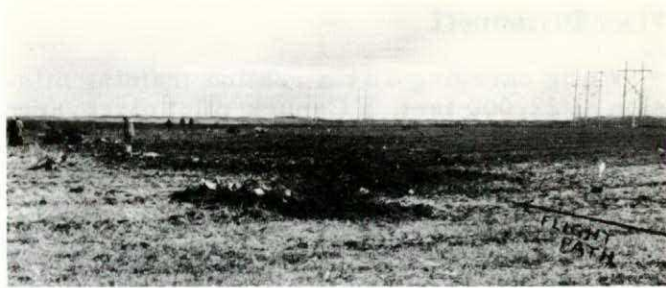
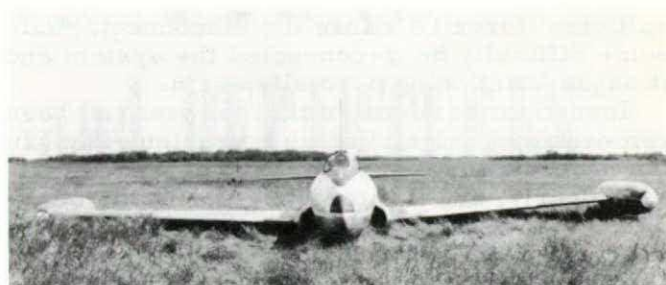
Stretched Glide

An instructor and a student took off in a T-33 on an instrument exercise. The aircraft was seen to climb straight ahead after takeoff until it was approximately 300 feet above the ground. It then appeared to level out and make a flat turn to starboard. After the turn it lost about 100 feet sharply, recovered momentarily, then began a gradual descent. As it crossed a 50-foot hydro line, the wings wavered and the aircraft dove into the ground and exploded, killing both pilots. The T-33 was stalled when it hit the ground, indicating that the pilot had tried to stretch the glide to clear the hydro wires.

Investigation showed that the engine was not producing full power. (Eye witnesses had reported that it was surging.) The cause of the engine malfunction could not be determined positively, but it is suspected that the fuselage pump was not operating.

Causes of the accident aside, it is extremely regrettable that these two pilots were killed. If they had not attempted to stretch the glide over the hydro wires, the aircraft would not have stalled. Except for these wires (under which was a clear space of 50 feet) the terrain was flat and free of obstacles—virtually ideal for a successful forced landing.

One of the two accompanying photographs depicts the accident we've been relating; the other shows what might have been. Get the picture?

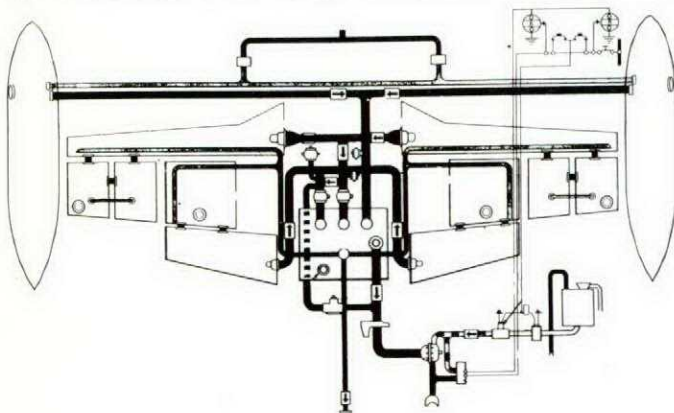
Here is the solution. First, refer to the illustration on page 746 of EO-50C-4. Note the position of the fuselage tank vent line opening,

and also the position of the vent line from the wing group into the fuselage tank. This vent line is not joined as is suggested by the illustration and the schematic diagram on page 31-32 of the POIs; the wing group vent line actually opens directly into the fuselage tank.

When the aircraft is in a climb, with tip tanks feeding, the fuel level in the fuselage tank will be above the main wing group vent opening. Normally, if the caps on the wing main tanks are sealed properly, having the fuel level in the fuselage tank above the vent opening will cause no problems. However, if a leak develops in one of the wing group filler caps, fuel from the fuselage tank will feed through the vent line to the wing tanks and out the filler cap. The venting of fuel will continue as long as the wing group vent is below the fuselage tank fuel level.

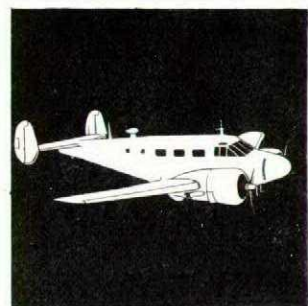
Loose Plugs and Leads

An Expeditor on a long range crosscountry experienced port engine trouble after a fuel stop. There was a 200-rpm mag drop below 1500 rpm, and a "dead cut" over 1500 rpm. Normal clearing methods did not work, so the cowlings were removed. Two leads were found dangling free and one plug was loose. These were fixed, the engine checked serviceable, and the aircraft returned to base.

Subsequent investigation at the unit showed the starboard engine to have six loose plugs, one lead off, one broken shielding, and four lead tips with springs missing. Three loose leads were found on the port engine.

The Expeditor had just undergone a fly-in repair, during which the engines were placed in long-term storage. When the aircraft arrived back at the parent unit, the acceptance check consisted of a P.I. Since this check does not require the removal of the cowlings, the loose plugs and leads were not discovered.

This is a case of maintenance errors involving two separate units. The aircraft should have been serviceable after the fly-in repair but it obviously could not have been. The parent unit would have found the unserviceability if a proper acceptance check had been done. The extent of an acceptance check is left to the discretion of the CTSO. In this instance it is apparent that the check done was not complete enough to ensure aircraft serviceability.
