# FLIGHT COMMENT

# A FORCED LANDING IS INVESTIGATED

by S/L G. L. Sheahan

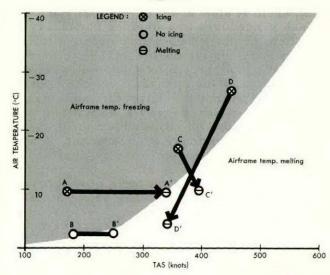
The significant data from these trials are plotted on Figure 1. Temperature - airspeed combinations which result in freezing temperatures are in the shaded area. Note that melting in each reported incident occurred while air temperatures were still well below freezing. The close agreement of these results with theoretical computations seem to justify the application of special operating techniques for jet aircraft in icing conditions—techniques which involve judicious use of the throttle. The following points should be borne in mind:

Note: Assuming the temperature distribution given on the left side of the diagram, potential icing would exist along the shaded portion of the
