FLIGHT COMMENT

2000

SEEING the SHEAR

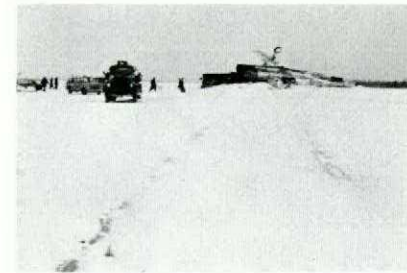
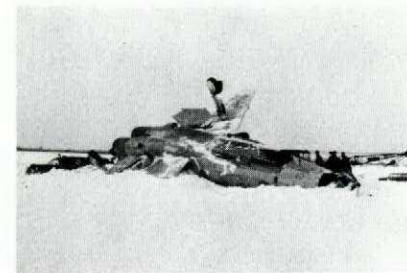
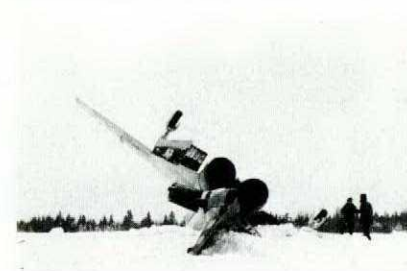
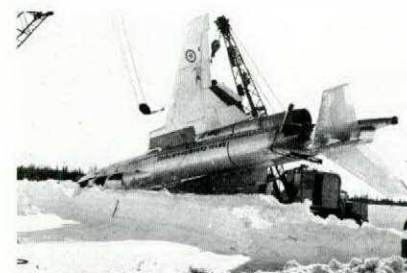
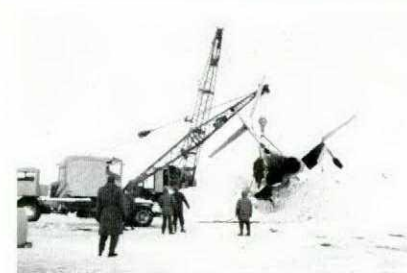
The ridge of snow, acting with considerable force on the right wheel, caused the aircraft to swing around sharply to the right so that the aircraft now began skidding towards the side of the runway, left wing first. The pilot flamed out the engines but could do nothing to control the aircraft. The extreme side loads broke off the nosewheel and then the left main wheel so that the port wing dug into the snow. This caused the aircraft to flip on its back in a five foot snow bank on the south side of the runway. The navigator noticed the airspeed as 125 - 135K. The momentum carried the aircraft on its back 150 feet before it finally came to rest, 3300 feet from touchdown.

This rather spectacular accident was assessed "Ground - Air Traffic Control". There was no element of pilot error because the pilot had not been warned of the runway conditions and once the swing started, there was absolutely nothing he could have done to control it. On the other hand, Air Traffic Control personnel who were continually monitoring the snow removal operation were well aware of the runway condition and should have declared the runway unserviceable.

Now that winter is nearly upon us again this accident reminds us of the extra caution we must take, both aircrew and groundcrew. Supervisors must also exercise precise judgement when ordering aircraft to fly from a runway which is in less than ideal condition.

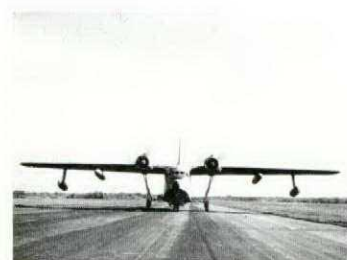
As the student pilot was actually rounding out for landing, the crewman called out over the intercom that the undercarriage was retracted. The instructor then advanced full power and assumed control by easing back on the control column. His action was too late as the aircraft hit the runway damaging the false keel. Over-shoot was then carried out with a subsequent normal landing.

The accident was assessed "Aircrew Carelessness" as both pilots neglected cockpit routine. The captain was aware that final pre-landing check was missed but did not check the items in this check.

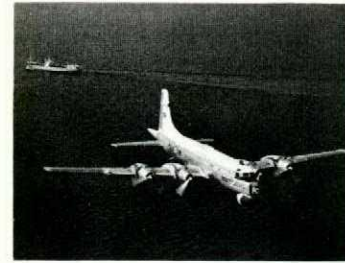
An Argus was diverted from its home base after a maritime patrol. The captain landed and parked on a bit of an incline and put on the parking brakes. The transient personnel at the station placed two chocks, one in front of the port bogey and one behind the starboard and departed without providing any further assistance. After the aircraft had been parked for about forty minutes, its brake pressure released through a faulty maxaret. The aircraft rolled back, breaking the fuel connecting line on the adaptor and fracturing the connection to the manifold.

Although there was a material failure, the captain of the aircraft is to be blamed for this accident. He didn't ensure that proper chocks were being used; also he left the brakes on, in contravention of orders.

A Flight Safety Bulletin has been issued on this accident for dissemination to all squadron pilots and ground crewmen.
