- 1 EDITORIAL
- 2 FROST - FACT AND FANTASY
- 4 GOOD SHOW
- 8 FALSE FIRE WARNINGS
- 9 SEARCH AND RESCUE
IN THE NORTH ATLANTIC
- 12 WINTER WONDERLAND
- 14 OXYGEN AGAIN
- 16 REVISED NOTAM SERVICE
- 17 ON THE DIALS
- 19 ALCOHOL - FRIEND OR FOE?
- 21 FROM AIB FILES
- 22 ARRIVALS AND DEPARTURES

FROST

Fact and Fantasy

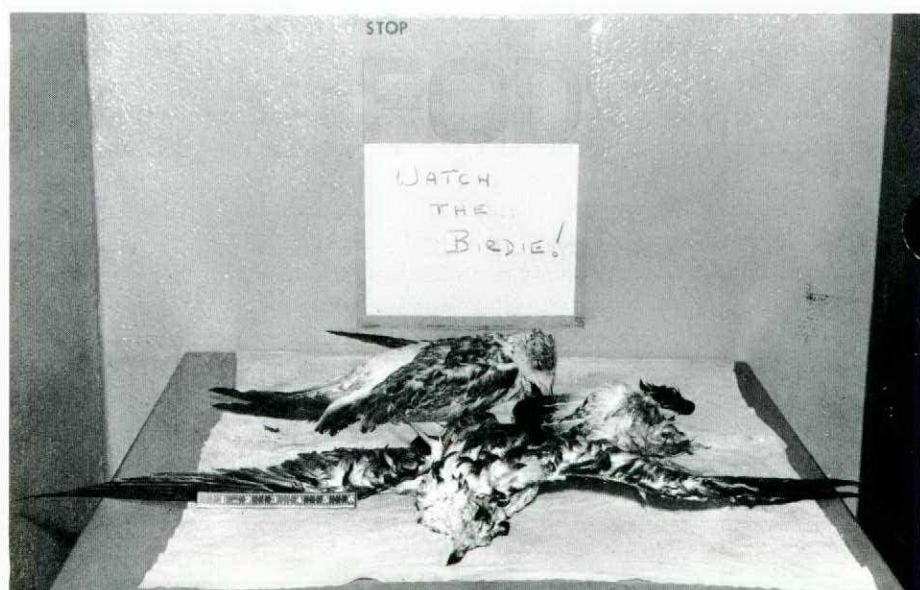
"Watch the Birdie"

Station Trenton's 06-24 runway was not the final resting place for these birds - they wound up as exhibits for a very effective FOD photo. No reports of the bird strikes were received but obviously someone's propeller or plane had been hit. A local dump has been attracting these birds and attempts are in progress to move it further afield.
