FLIGHT COMMENT

JULY • AUGUST • 1966

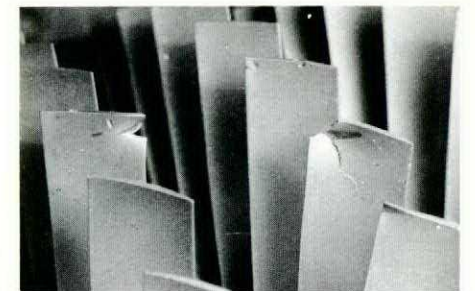
clearing the stall. The aircraft was landed successfully. The photo shows one small portion of the extensive damage done to this engine. Investigators feel sure that the damage had occurred from a foreign object *prior to takeoff*. The offending object was never found.

A small, worthless particle caused thousands of dollars damage.

CF104, FOD Levelling out at 25000 from a climb in afterburner, the pilot reduced to military power whereupon the engine compressor-stalled. The engine was flamed out and relit,

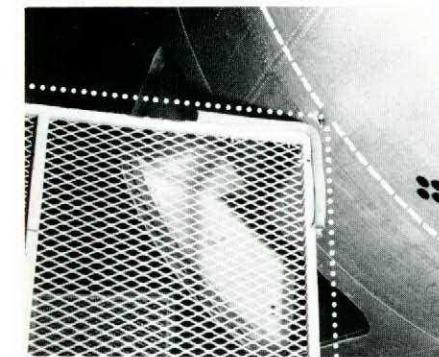
YUKON, LOADING DAMAGE A forklift with a wire basket attachment was being moved to off-load mail from the rear belly. The driver states that "... the gap between the aircraft and the basket was great enough to make reaching across and bringing the mail sacks back to the basket difficult".

This is entirely understandable by a glance at the geometry involved (dotted lines).

Two accidents similar to this occurred less than a year ago; at that time the unit proposed removing sharp corners and installing bumper pads to these baskets.

Certainly, the driver was careless but careless drivers, it seems, will always be with us - isn't it time that the obvious incompatibility of a curved line and a 90° corner is recognized?

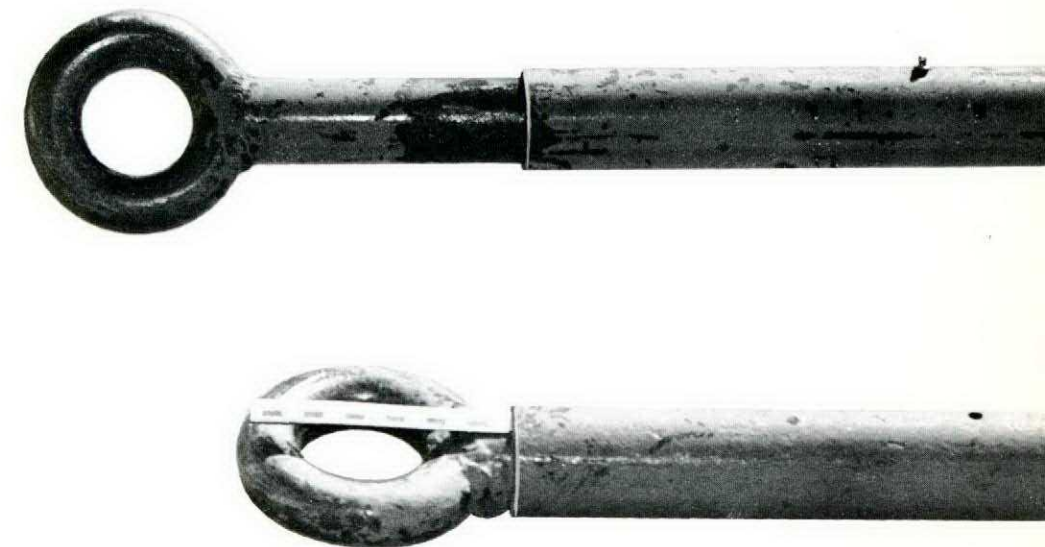
C47, SHORTENED TOW BAR The aircraft was being pushed from the hangar in a manoeuvre the driver had done many times before. When the aircraft was turned with the usual jack-knife the mule and tailplane collided.

Normally, the mule would clear the aircraft in this manoeuvre by over 12 inches but not so with this "modified" tow bar. Someone had "repaired" it and in the process, shortened the bar by approximately 12 inches. The report states "the faulty tow bar was immediately quarantined and returned to ground handling section for further repair to lengthen it to its original configuration..."

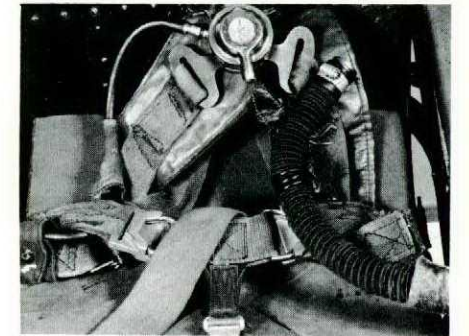
One item which did not escape my notice was the improper installation of the T33 seat securing strap. As shown in the illustration, the automatic harness release cable is improperly positioned under the securing strap. If the harness were tightened as it normally should be, a

Here's a better tie-down method.

CFS has been concerned with the difficulty of keeping pilots aware of the proper tie-down technique, and is presently investigating the feasibility of producing a decal showing the proper tie-down procedure to be affixed to the headrest or back of the seat itself.
