FLIGHT COMMENT

NOVEMBER • DECEMBER • 1966
(SEPT-OCT ISSUE NOT PUBLISHED)

- 2 THE GREAT LAKES - SURVIVAL CHALLENGE
- 7 TRAINING COMMAND'S FLIGHT SAFETY MAINTENANCE AWARD
- 8 GOOD SHOW
- 10 ICE ON WINGS!
- 11 A GOOD SHOW ALL 'ROUND
- 12 BIG DAY AT BORDEN, SASK
- 15 TIE BOLTS TAKE CARE
- 17 THE FORKLIFT HAS ITS POINTS - BUT...
- 17 INTERRUPTED MAINTENANCE - BEWARE
- 18 THE T DISPLAY
- 20 ON THE DIALS
- 21 GEN FROM 210

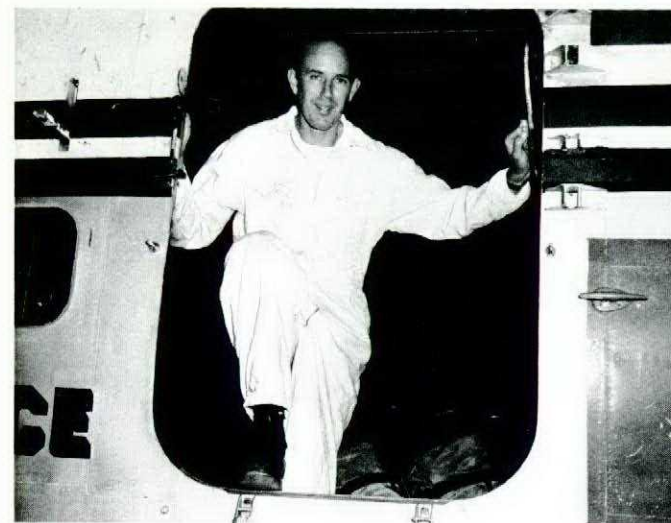
Investigation of the aileron control system revealed that an explosive rivet 1½ inches long, lying loose in the

vicinity of the aileron chain and sprocket assembly located in the cabin roof, had fallen onto the grease-covered sprocket, and stuck there. When the control was moved to starboard the rivet jammed solidly between the sprocket and chain. This inspection had been done immediately after the aircraft had landed, indicating that the rivet may have lodged on the sprocket during the last landing.

Later, five more rivets were found in the area above the sprocket and chains.

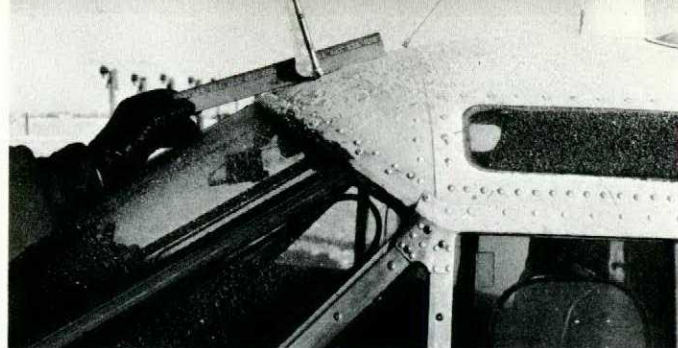
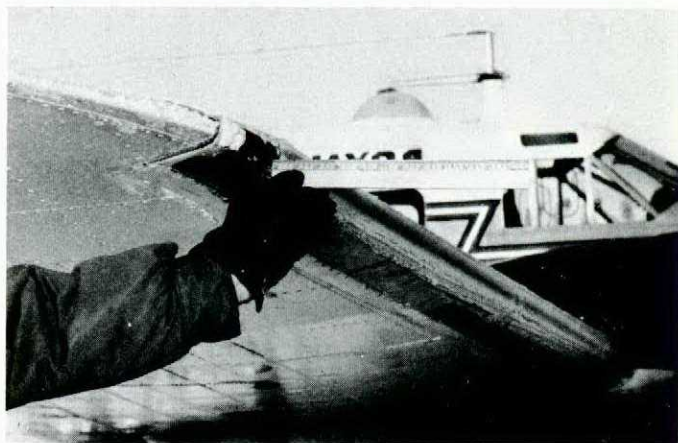
The investigation covered every conceivable possibility such as lack of power, false indication of speed, fuel load, and C of G (this was a TACAN-equipped Expeditor). Later on, returning to the aircraft the pilots observed the leading edge of the mainplanes iced to 1/4 inch and the tailplane approximately 3/8 inch. The top surface of the wings were clear.

1. It appears that the windshield/wiper check is inadequate as a guide for airframe icing.
2. While the TACAN equipment has shifted the centre of gravity, it is insignificant.
3. The captain denied himself (by using an intersection rather than the runway end), approximately 2500 feet of usable takeoff room. If a ravine, for example, is to be the only landing place available, these 2500 feet could come in handy.
4. The icing occurred when there was no clear or rime ice reported at destination or departure airports. The photo shows the considerable ice accumulation on the airframe.

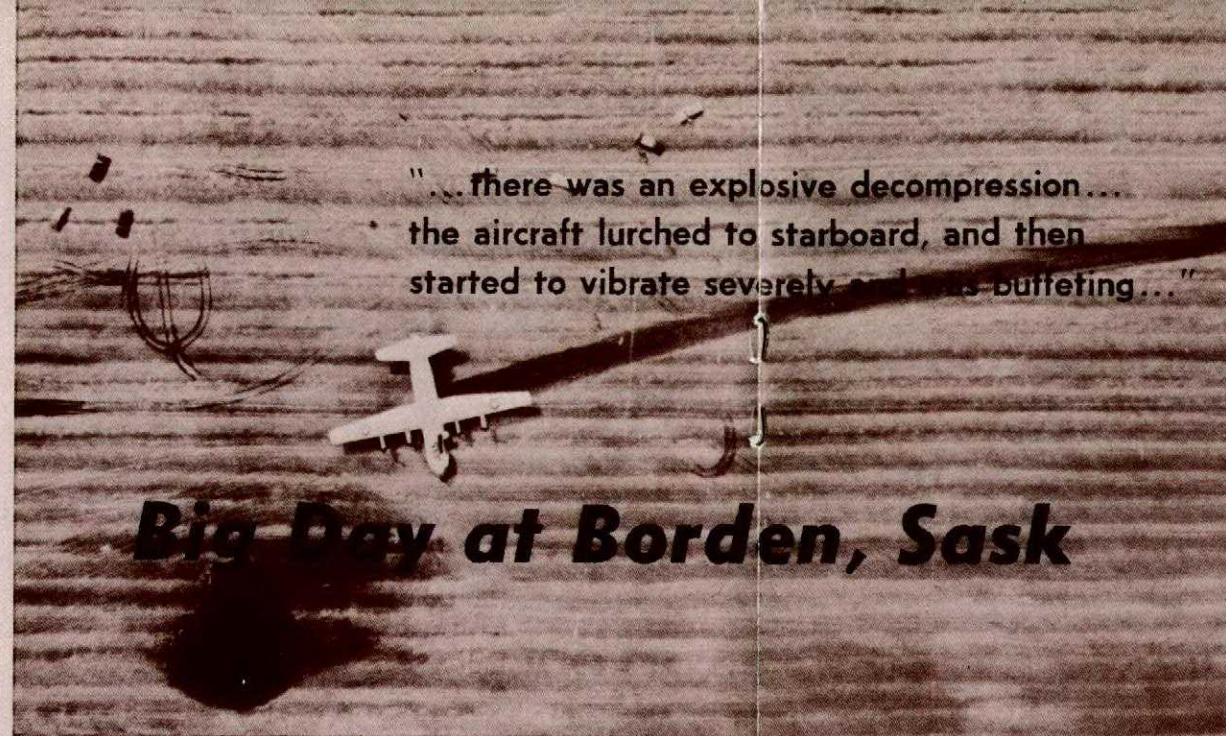
The causes were both material failure and maintenance error. The latching mechanism, consisting of four eyebolts, had failed allowing the door to tear off and with it, the top of the fuselage. The #1 eyebolt tying the door to the fuselage ruptured through over-stressing causing the #2 bolt to fail as the load was transferred to it. The fact that #2 eyebolt failed in this manner is strong evidence that the #1 eyebolt had been overloaded. Laboratory investigation disclosed that the #1 eyebolt had been cracked for some time; only 3/4 of the cross sectional area was carrying the load at the time of its failure. Analysis disclosed that both the initial crack and the ultimate failure were a result of overloading; also, rough machining during manufacture had helped the crack form. Misalignment during door rigging is strongly suspected as creating the overload.

Door locking mechanism failed, tearing away door, fuselage panels, and shredding control and systems connections.
